# ARBORICULTURAL TREE SURVEY

& Impact Assessment  
**BS5837:2012**

**Site Address:** Dandale Stable, Chequers Road, ME12 3SH.

**FellGrove ref:** 1796

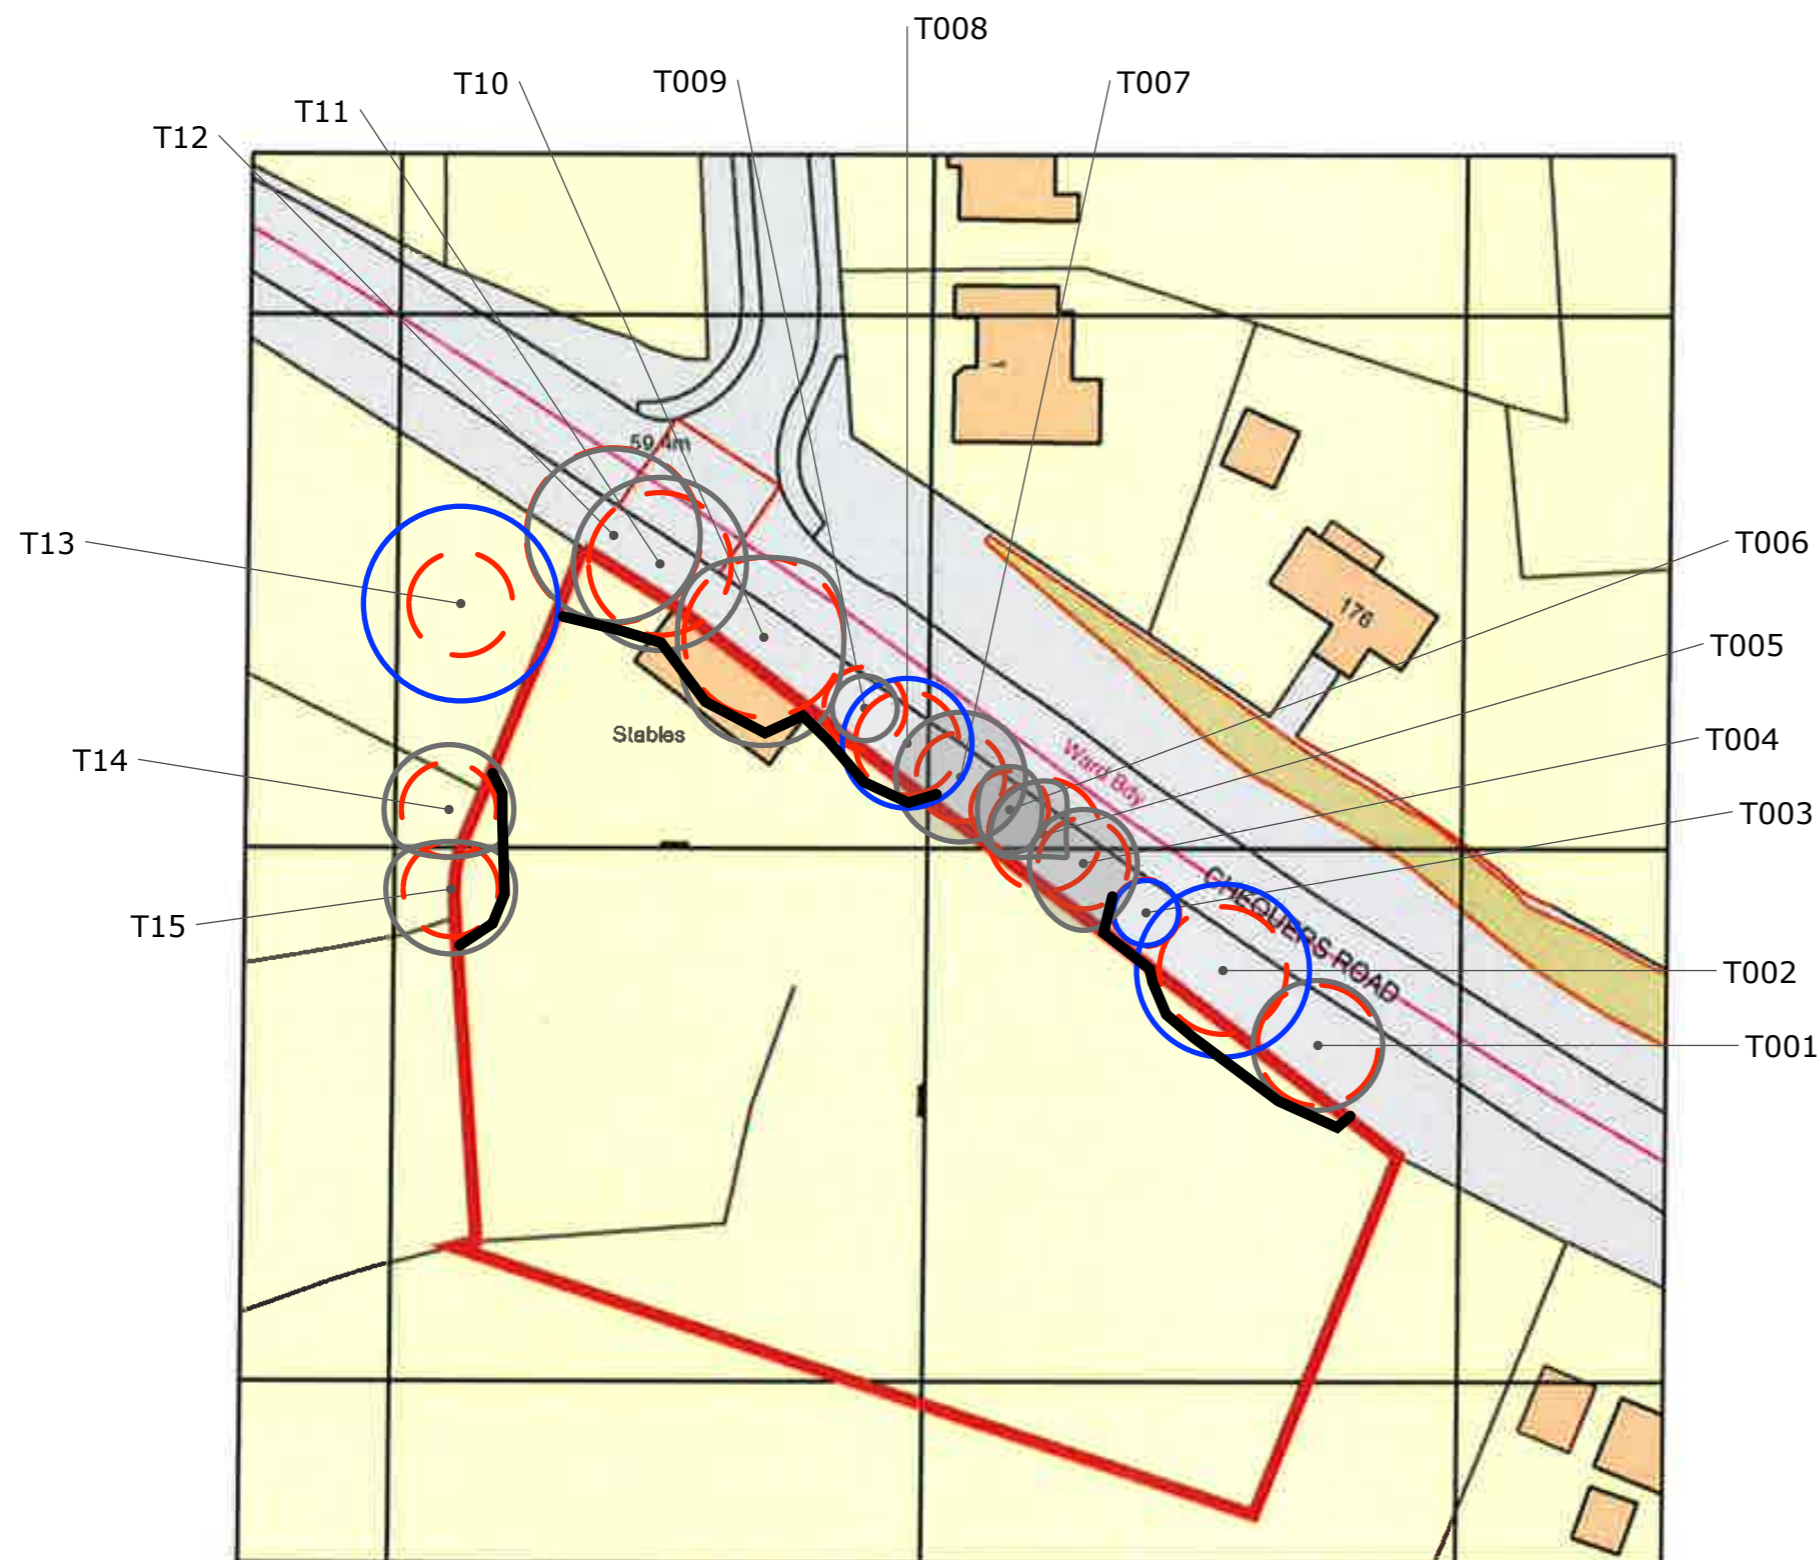
**Tree protection plan - Appendix 4**

Proposed removals - T04, T05, T06 and T07. To facilitate the proposed site access.

**Root protection Areas** - We have adjusted the RPA spread to suit site conditions.

The development proposal will have no impact to the retained trees RPA providing all new foundations, surfaces and service routes remain outside of the tree protection fencing and RPA's.

During the demolition of the Stables building we recommend that the current ground level is left in place. Any foundations remain in place and are not removed unless absolutely necessary.

If foundations do need removing to accommodate the proposed development. We recommend this be undertaken while the site arborist in present. A site specific method statement will need to be adhered to while removing any foundations within the retained tree RPA's.

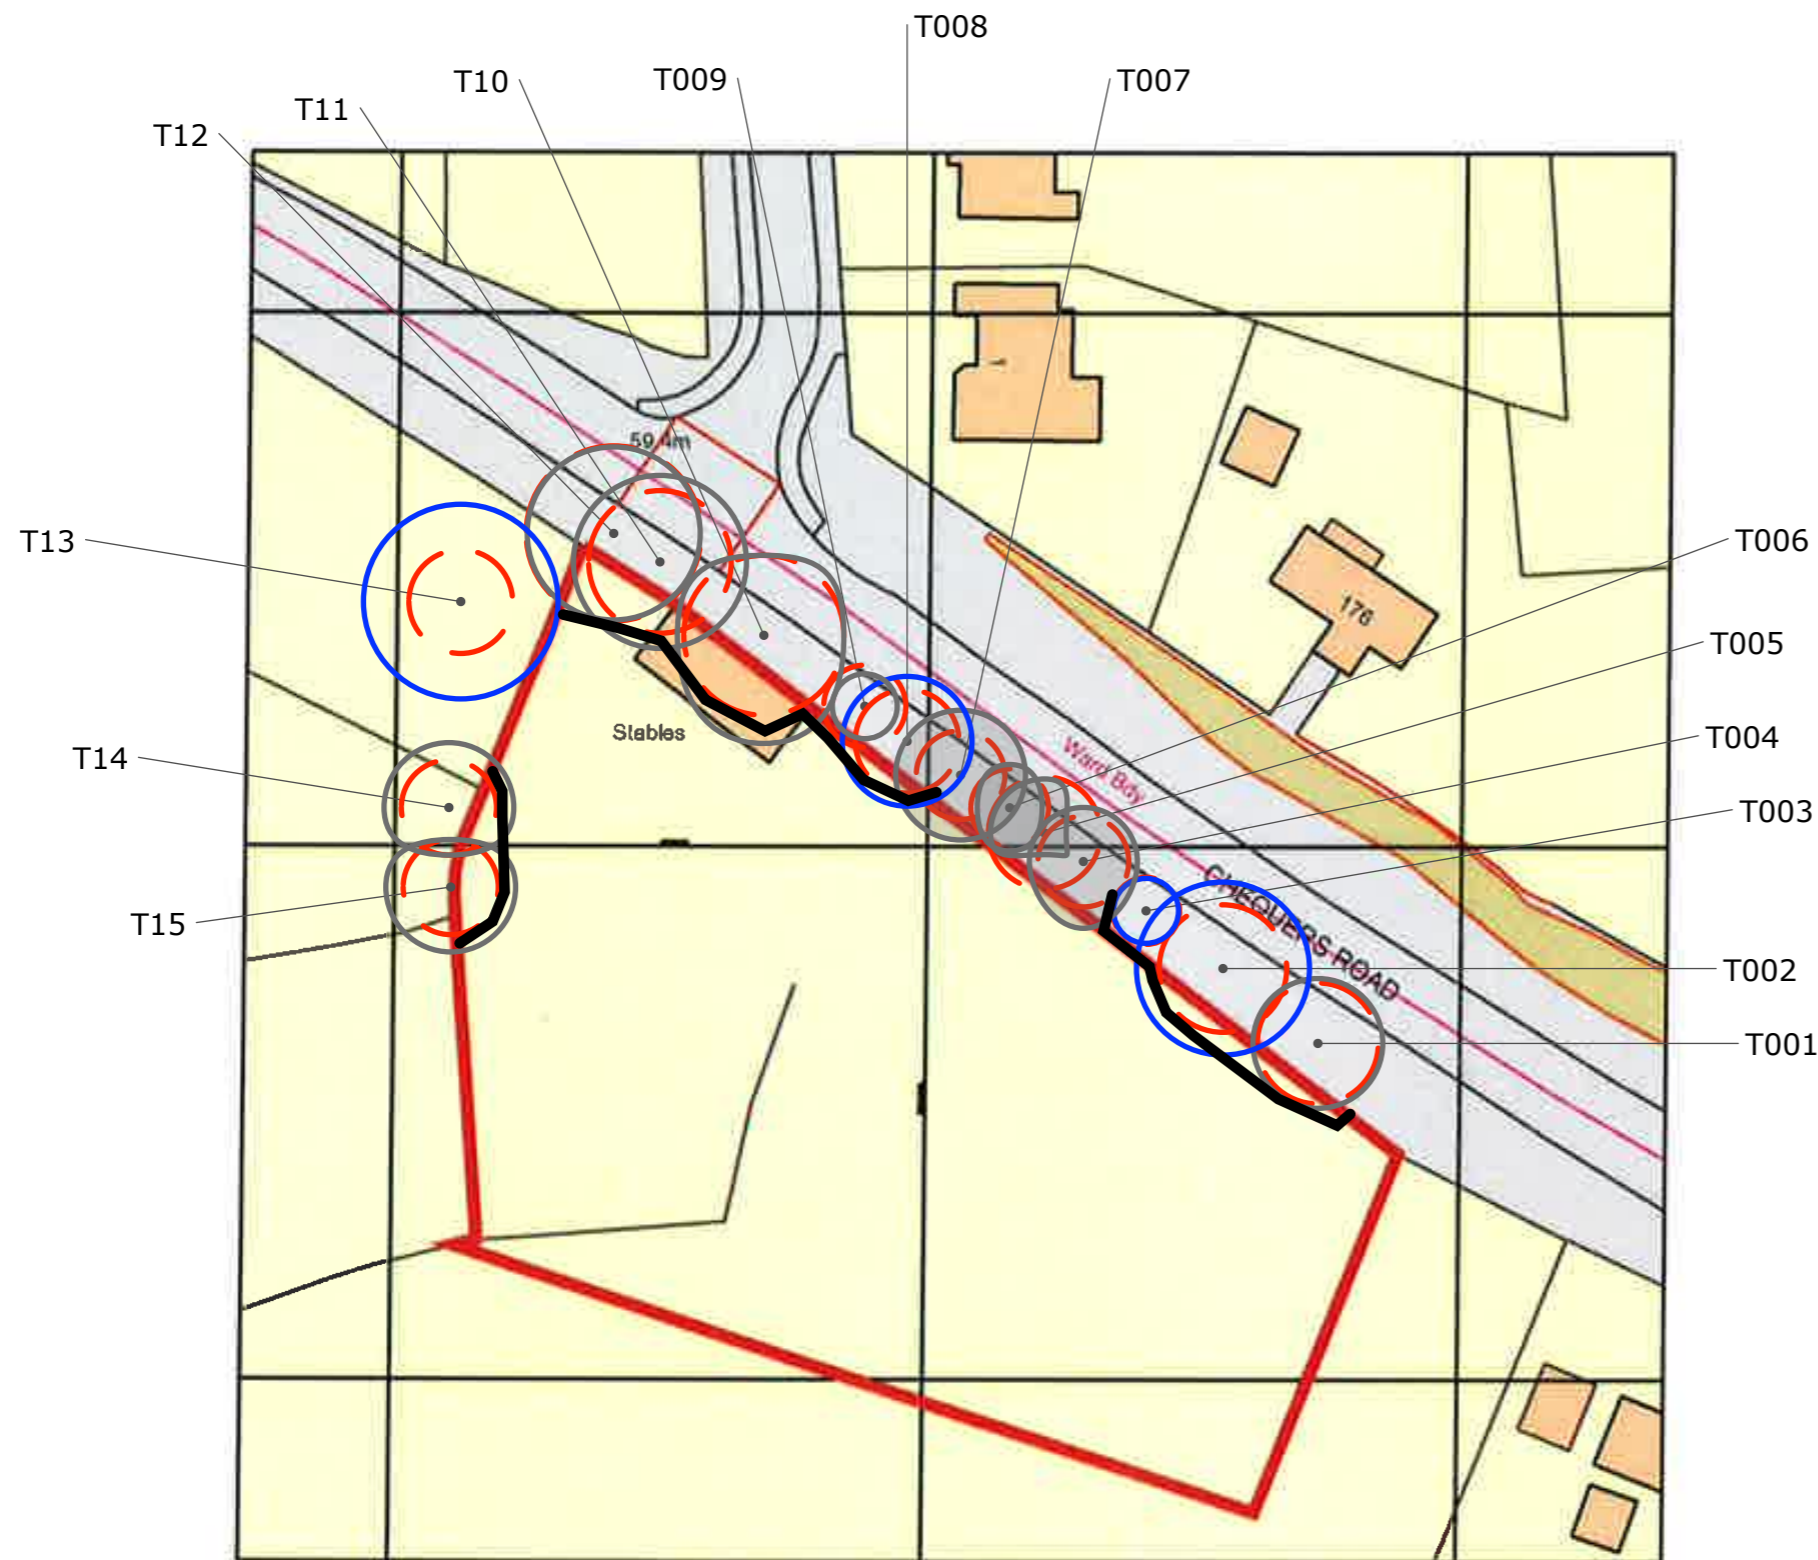
**Impact assessment - Appendix 4**

The overall impact of the proposal on the localised tree population is negligible with 4 trees recommended removal to facilitate the proposal. Management recommendation can be found in Appendix 3 tree schedule. The current site conditions have no impacted the root systems of retained trees. It is our opinion that the proposed development will allow the local authority to ensure the local tree scape is maintained into the future by having a robust replanting schedule accompany the planning application.

The proposed site access will require the removal of low category trees with no impact tot retained trees.

The proposals foundations will no impact on the retained trees RPA

**Services** - No services will impact on the retained trees RPA.

**Ground levels** - No ground level changes will impact on the retained trees RPA.

**Shading** - No shading issues will be encountered

**Leaf litter** - Leaf litter will be encountered around the proposal, to mitigate against this and prevent the need to future pruning we recommend none slip paving and guards on gutters and gullies be installed.
