## **Kent Pedestrian Guard Railing Assessment**

### **Sittingbourne – Consultation Report**

**Project Number B1555300**

Client: Kent Highway Services  
 Project: Kent Guard Railing Assessment Job No: B1555300  
 Document Title: Sittingbourne Guard Railing Assessment

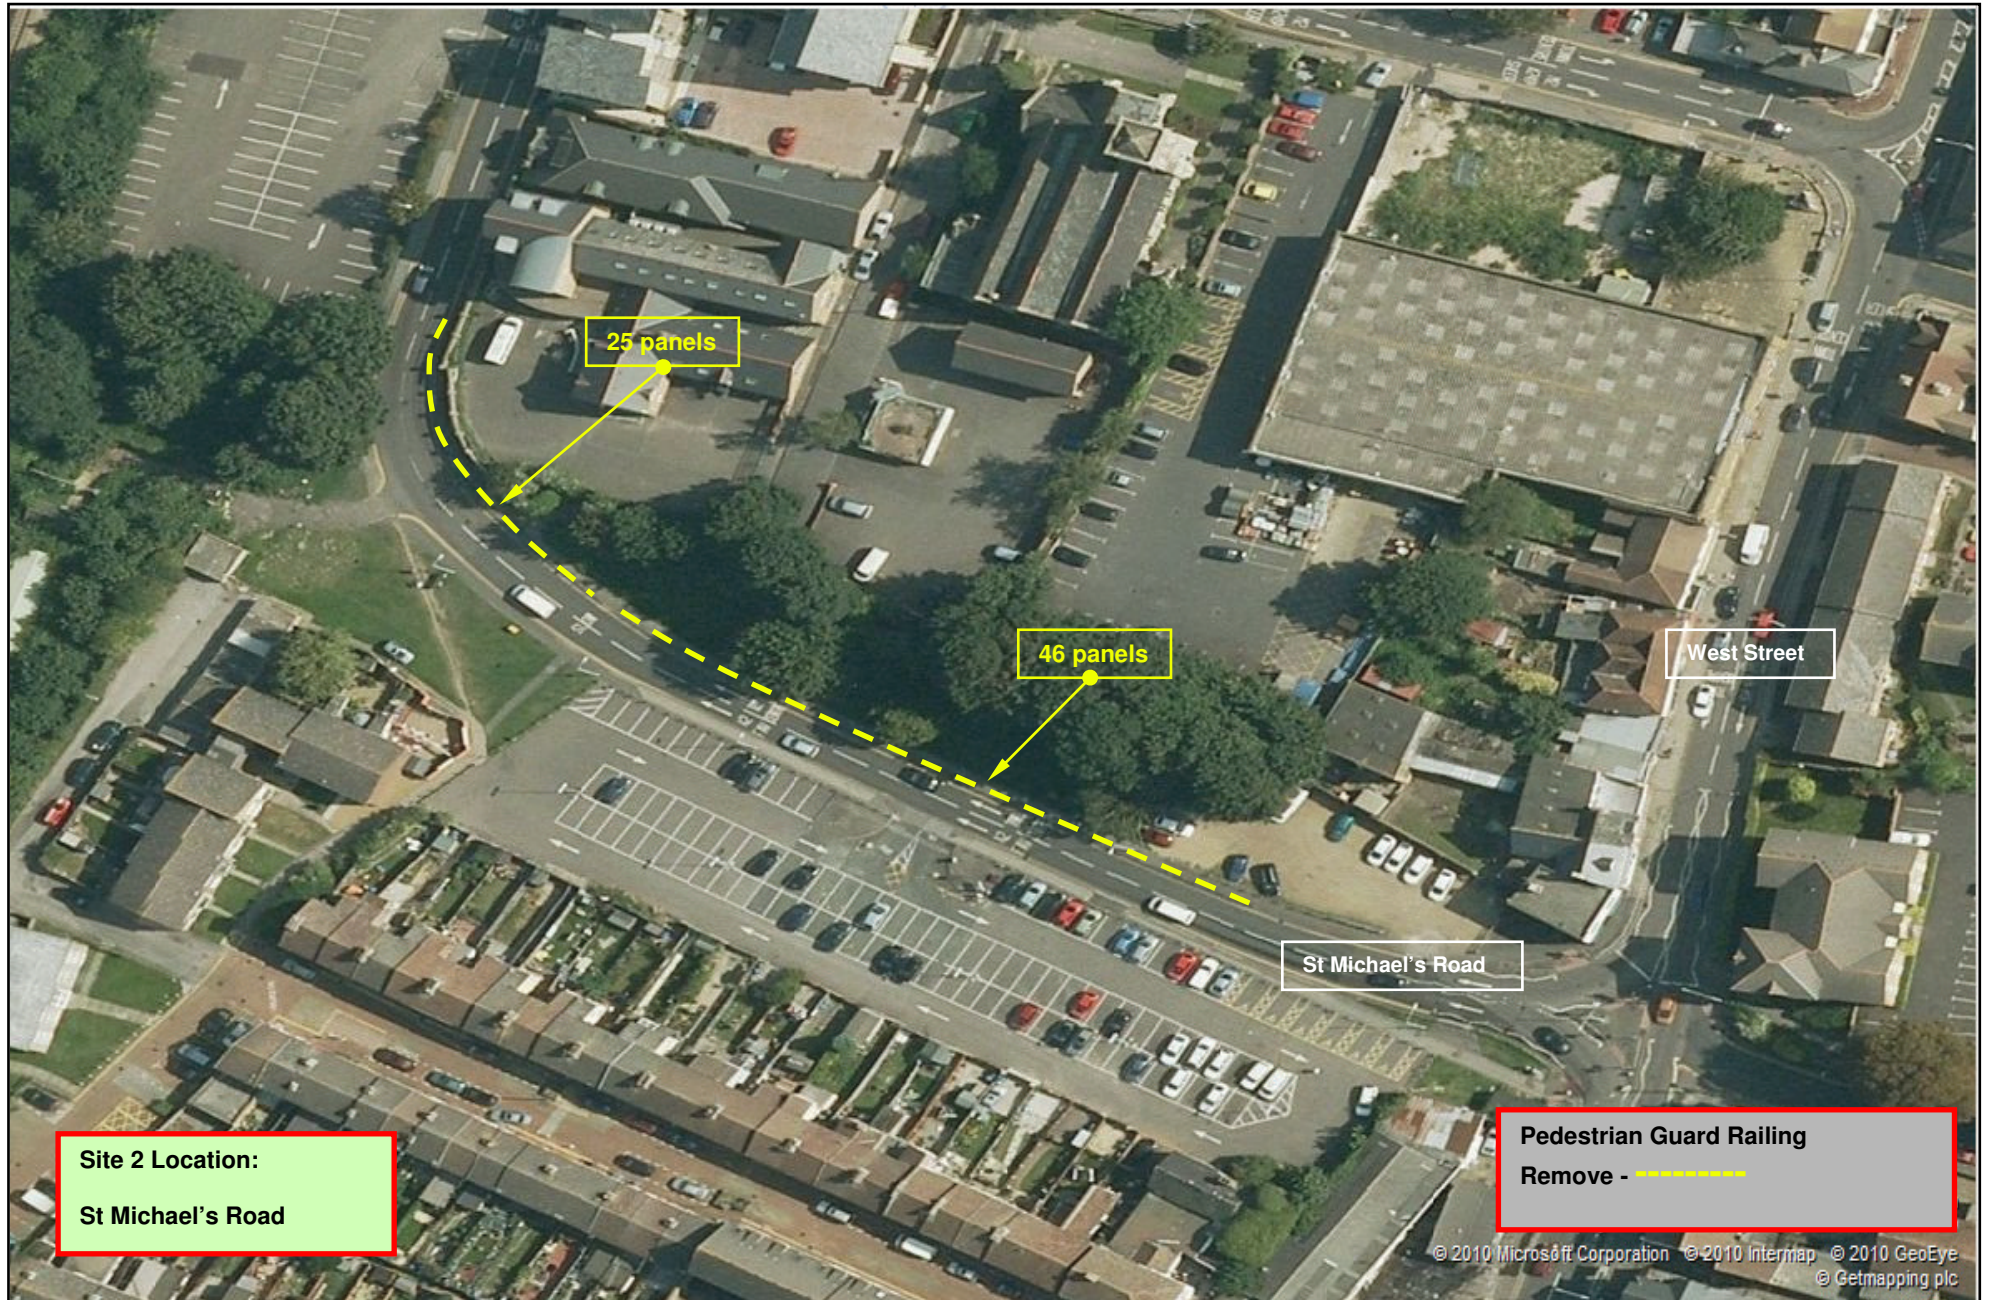
**Illustrated Diagram of site 2**

Site 2 is located on St. Michael's Road.

The site has a car park on the western side and a wide grassed verge on the eastern side with walled residential properties at the northern end of the site.

The site has a high volume of vehicular traffic and moderate pedestrian use.

The pedestrian guard railings at the site offer little benefit as a guide or protective device.

25 panels

46 panels

- **It is recommended to remove the pedestrian guard railings at site 2.**

Pedestrian Guard Railing  
Remove - - - - -

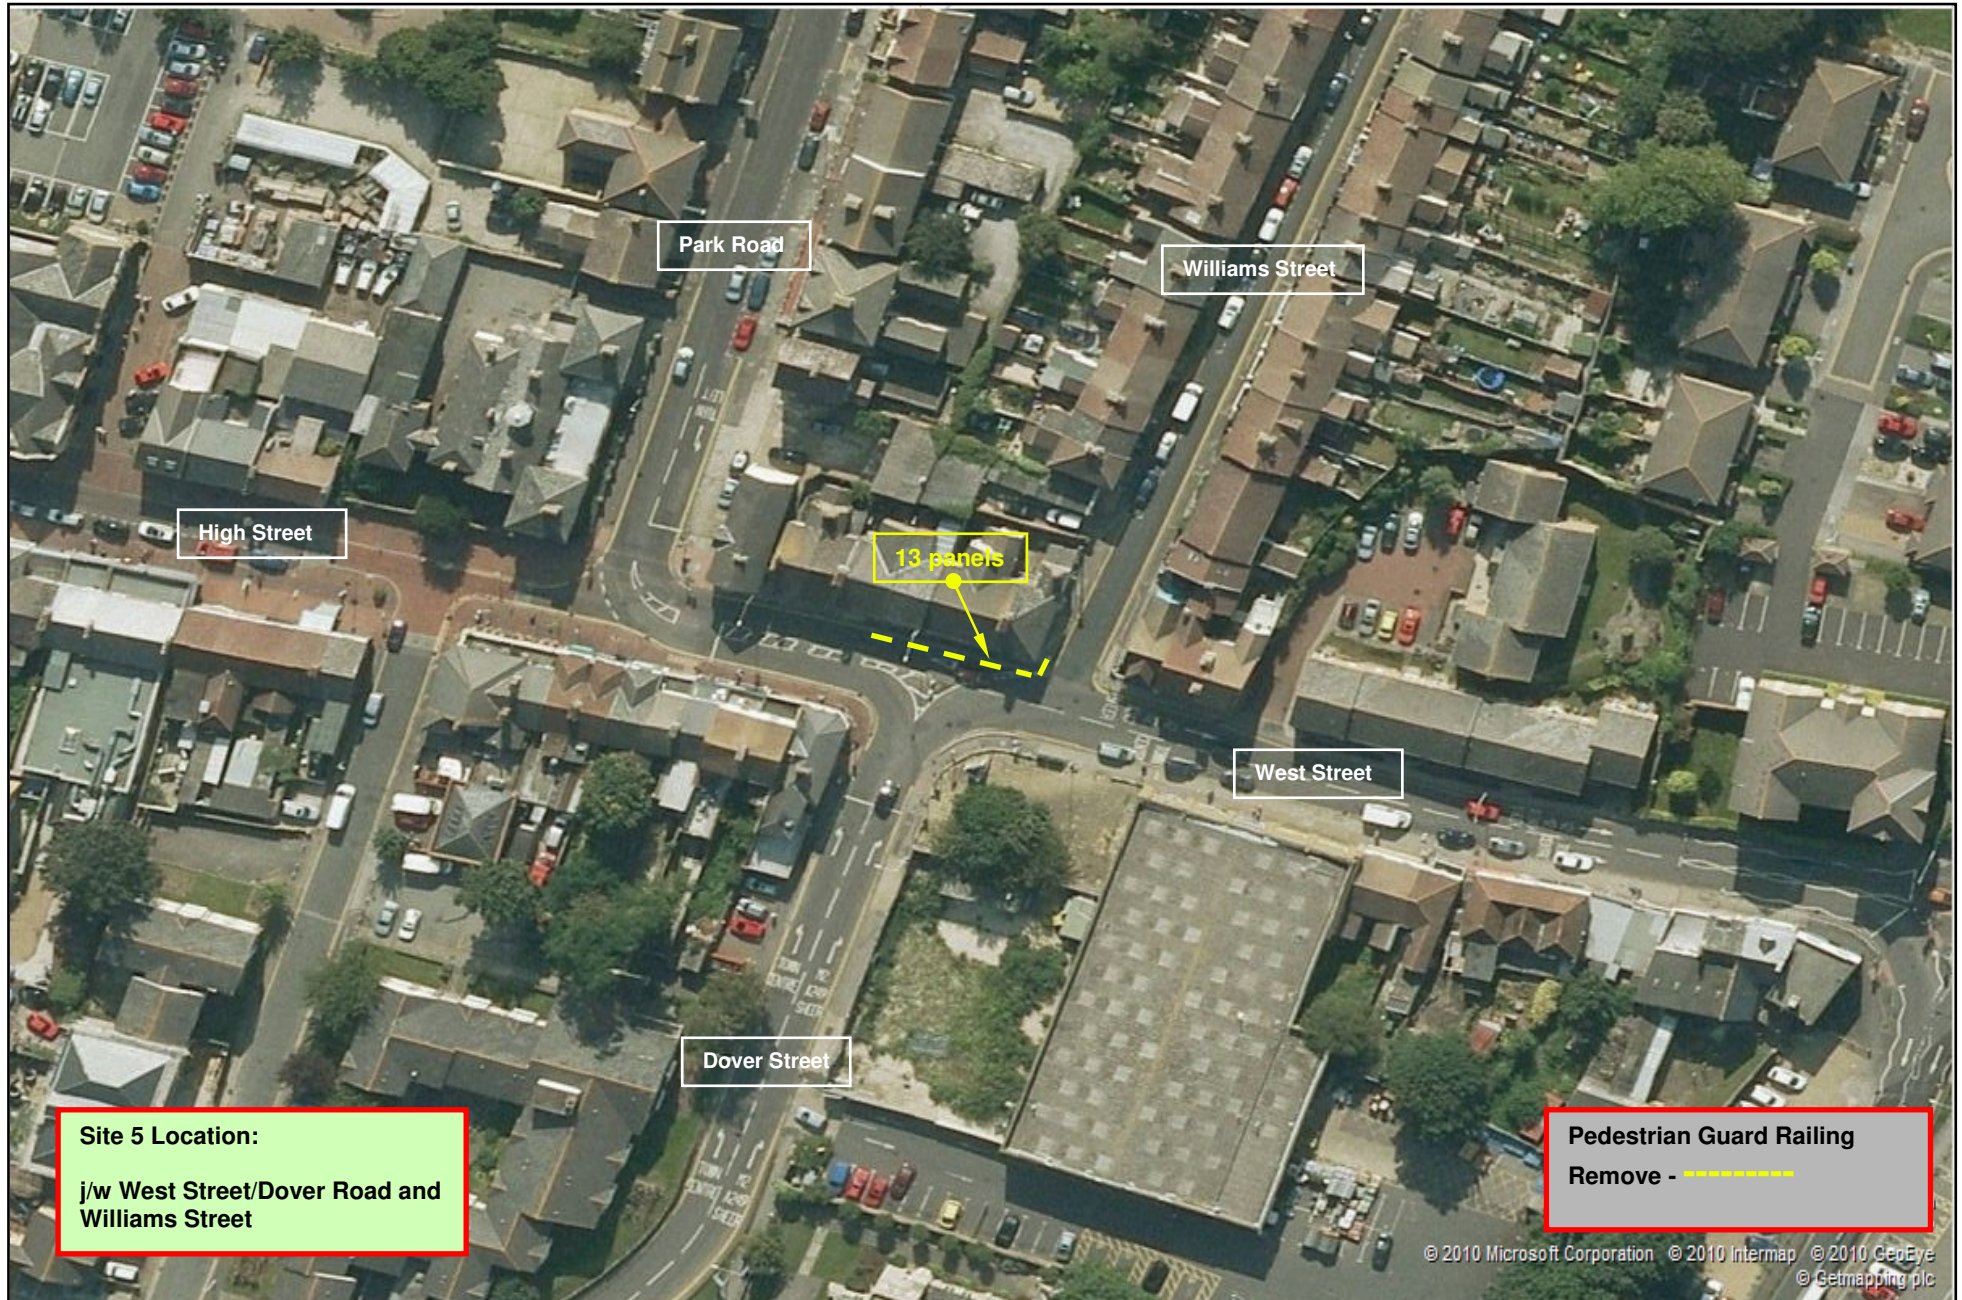
**Illustrated Diagram of site 5**

Site 5 is located at the junction of West Street and Dover Road.

The site is located mainly where there are retail outlets and is an access to the High Street and Sittingbourne Railway Station.

The site has both a high volume of vehicular traffic and pedestrian use.

The pedestrian guard railing at the site offers little benefit as a guide or protective device.

- **It is recommended to remove the pedestrian guard railings at site 5.**

**Pedestrian Guard Railing  
Remove - - - - -**

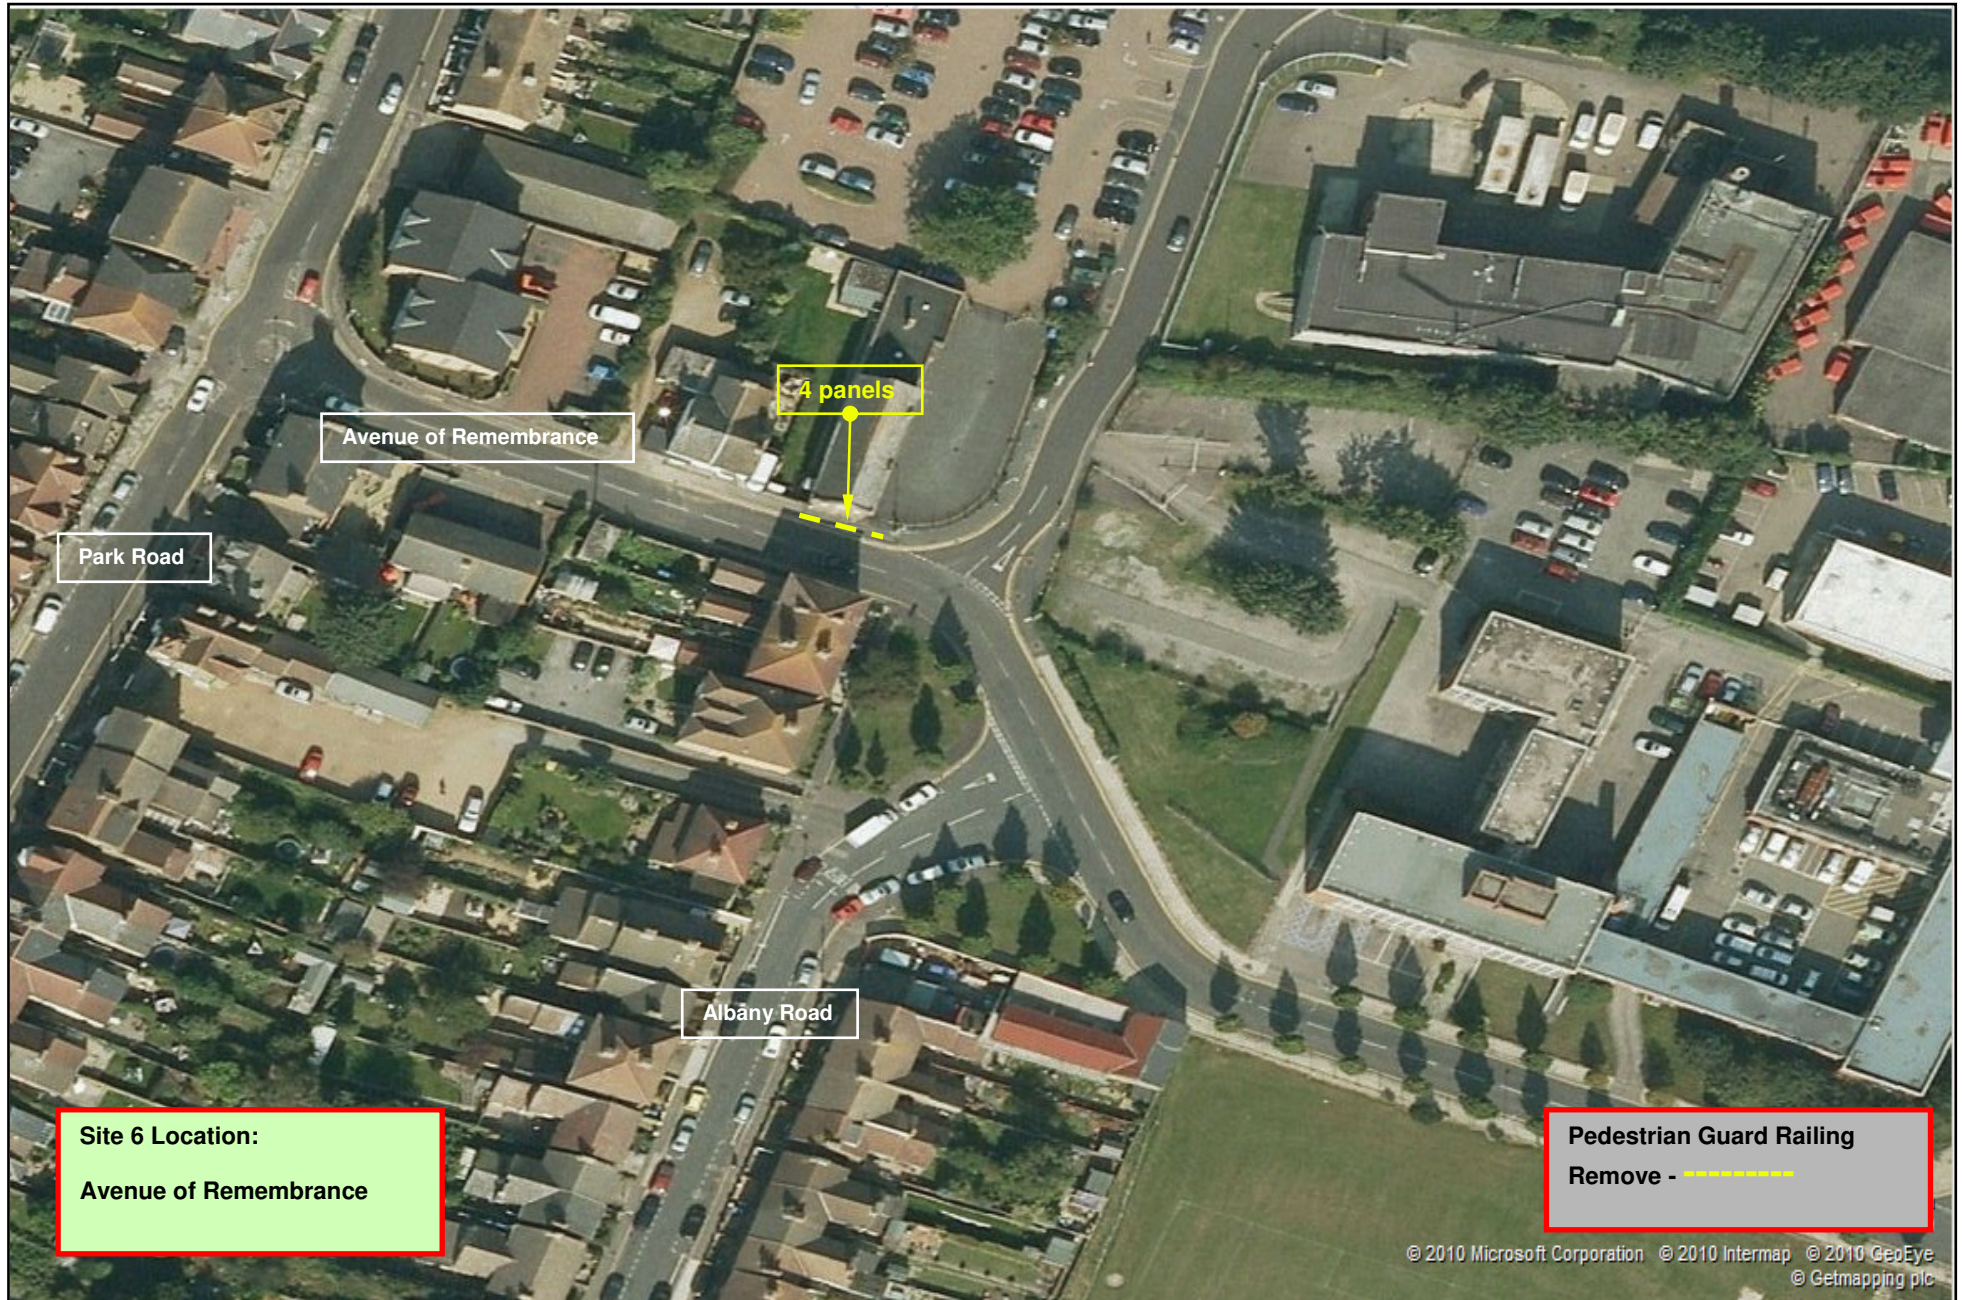
**Illustrated Diagram of site 6**

Site 6 is located on the Avenue of Remembrance near the junction of Albany Road.

The site has residential properties and the Borden Grammar School on the southern side and a block of offices on the north eastern side.

The site has a moderate volume of vehicular traffic and low pedestrian use.

The pedestrian guard railing at the site offers no benefit as a guide or protective device.

- **It is recommended to remove the pedestrian guard railings at site 6.**

**Pedestrian Guard Railing  
Remove - - - - -**

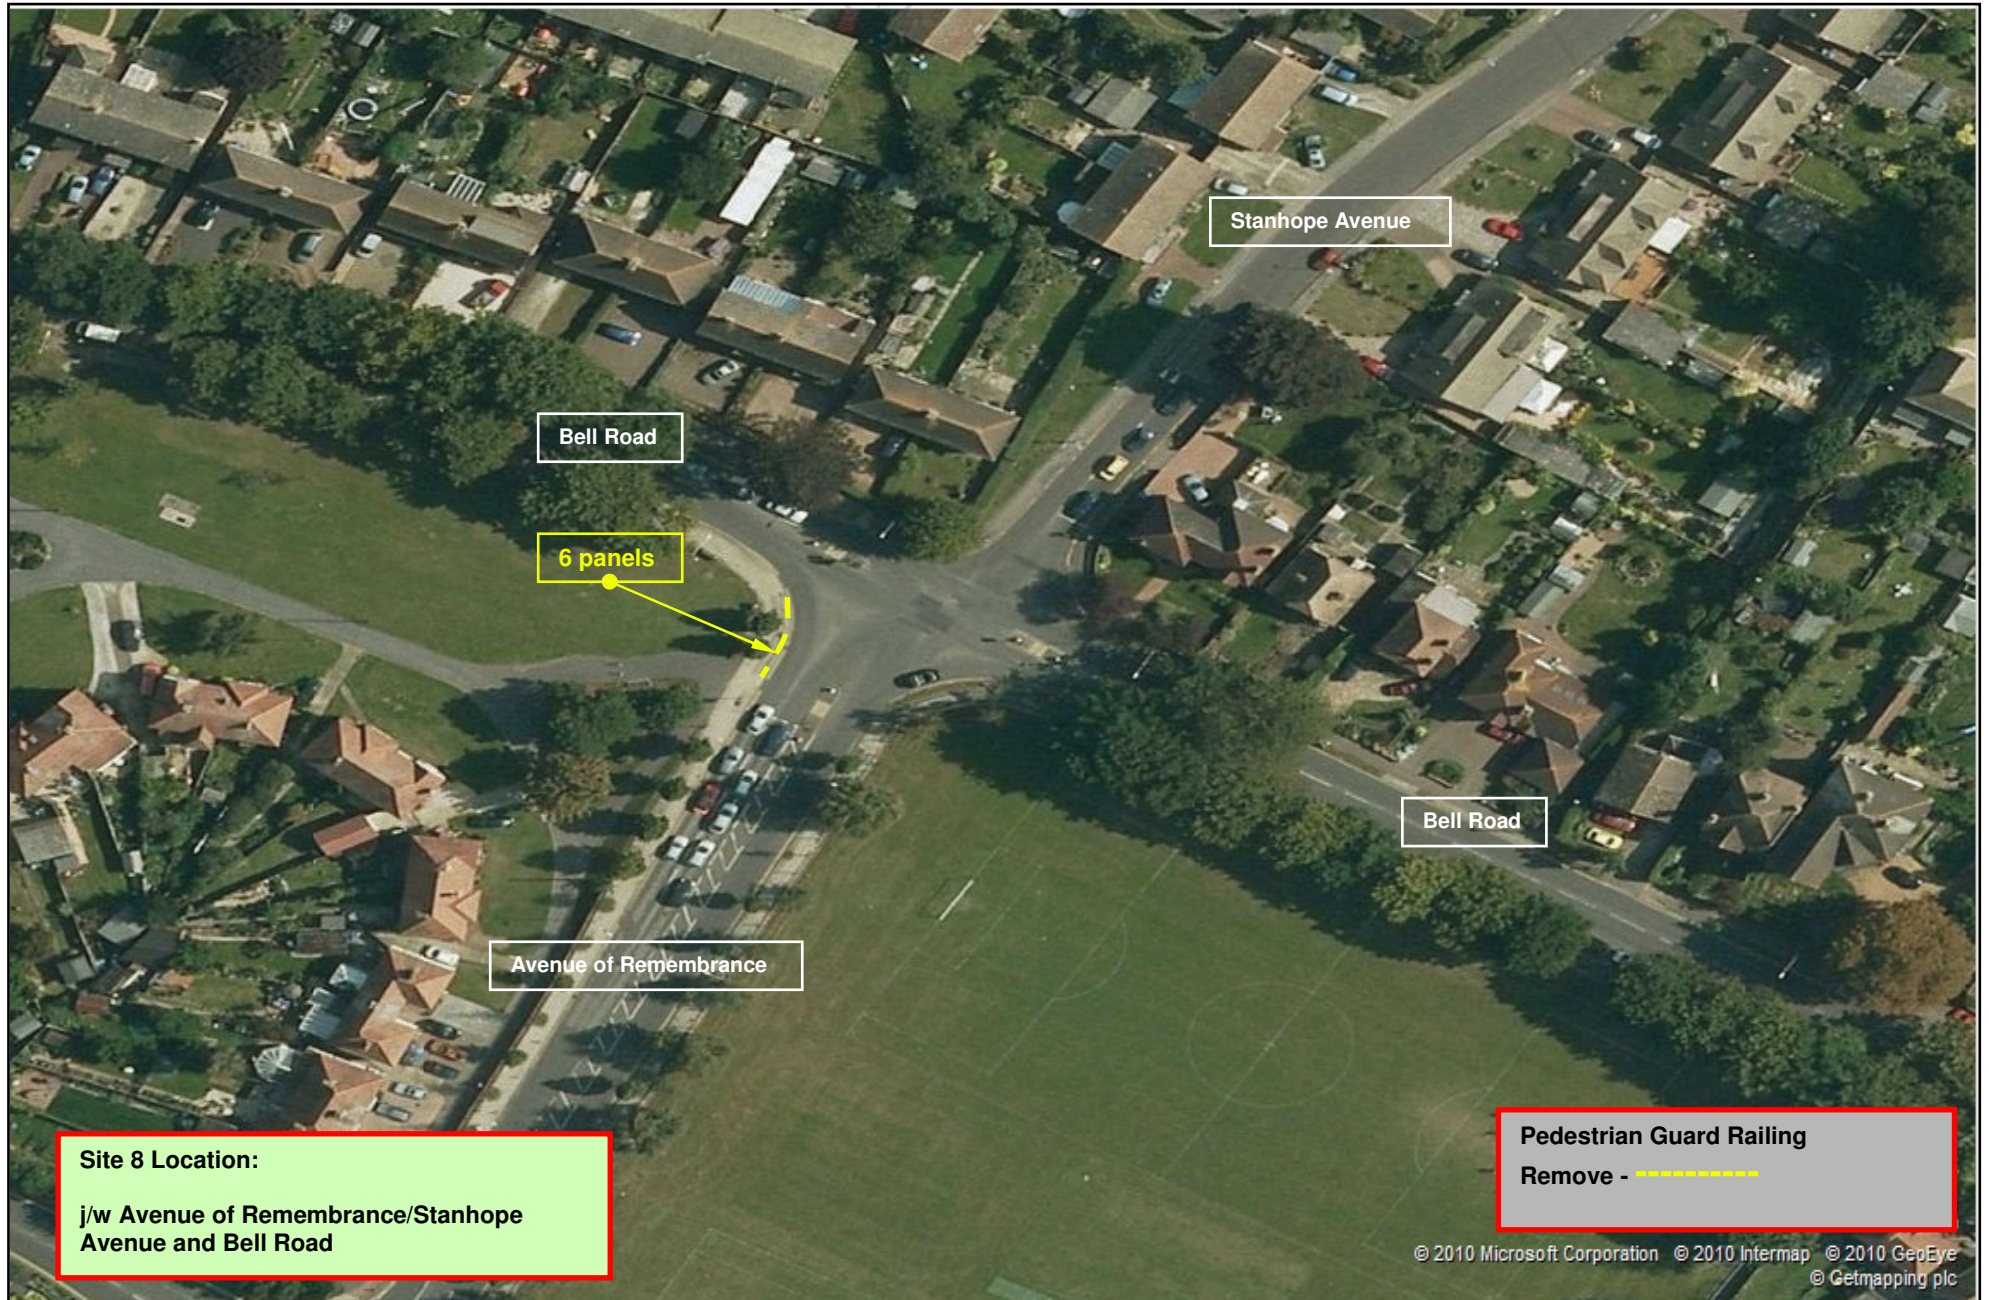
**Illustrated Diagram of site 8**

Site 8 is located at the junction of Avenue of Remembrance/Stanhope Avenue and Bell Road.

The site has residential properties on the northern, north eastern and south eastern sides of the site and the Borden Grammar School football field on the southern side.

The site has moderate volume of vehicular traffic and low pedestrian use.

The 6 pedestrian guard railing panels either side of the carriageway offer little benefit as a guide or protective device.

- **It is recommended to remove the pedestrian guard railings at site 8.**

**Pedestrian Guard Railing**  
Remove - - - - -

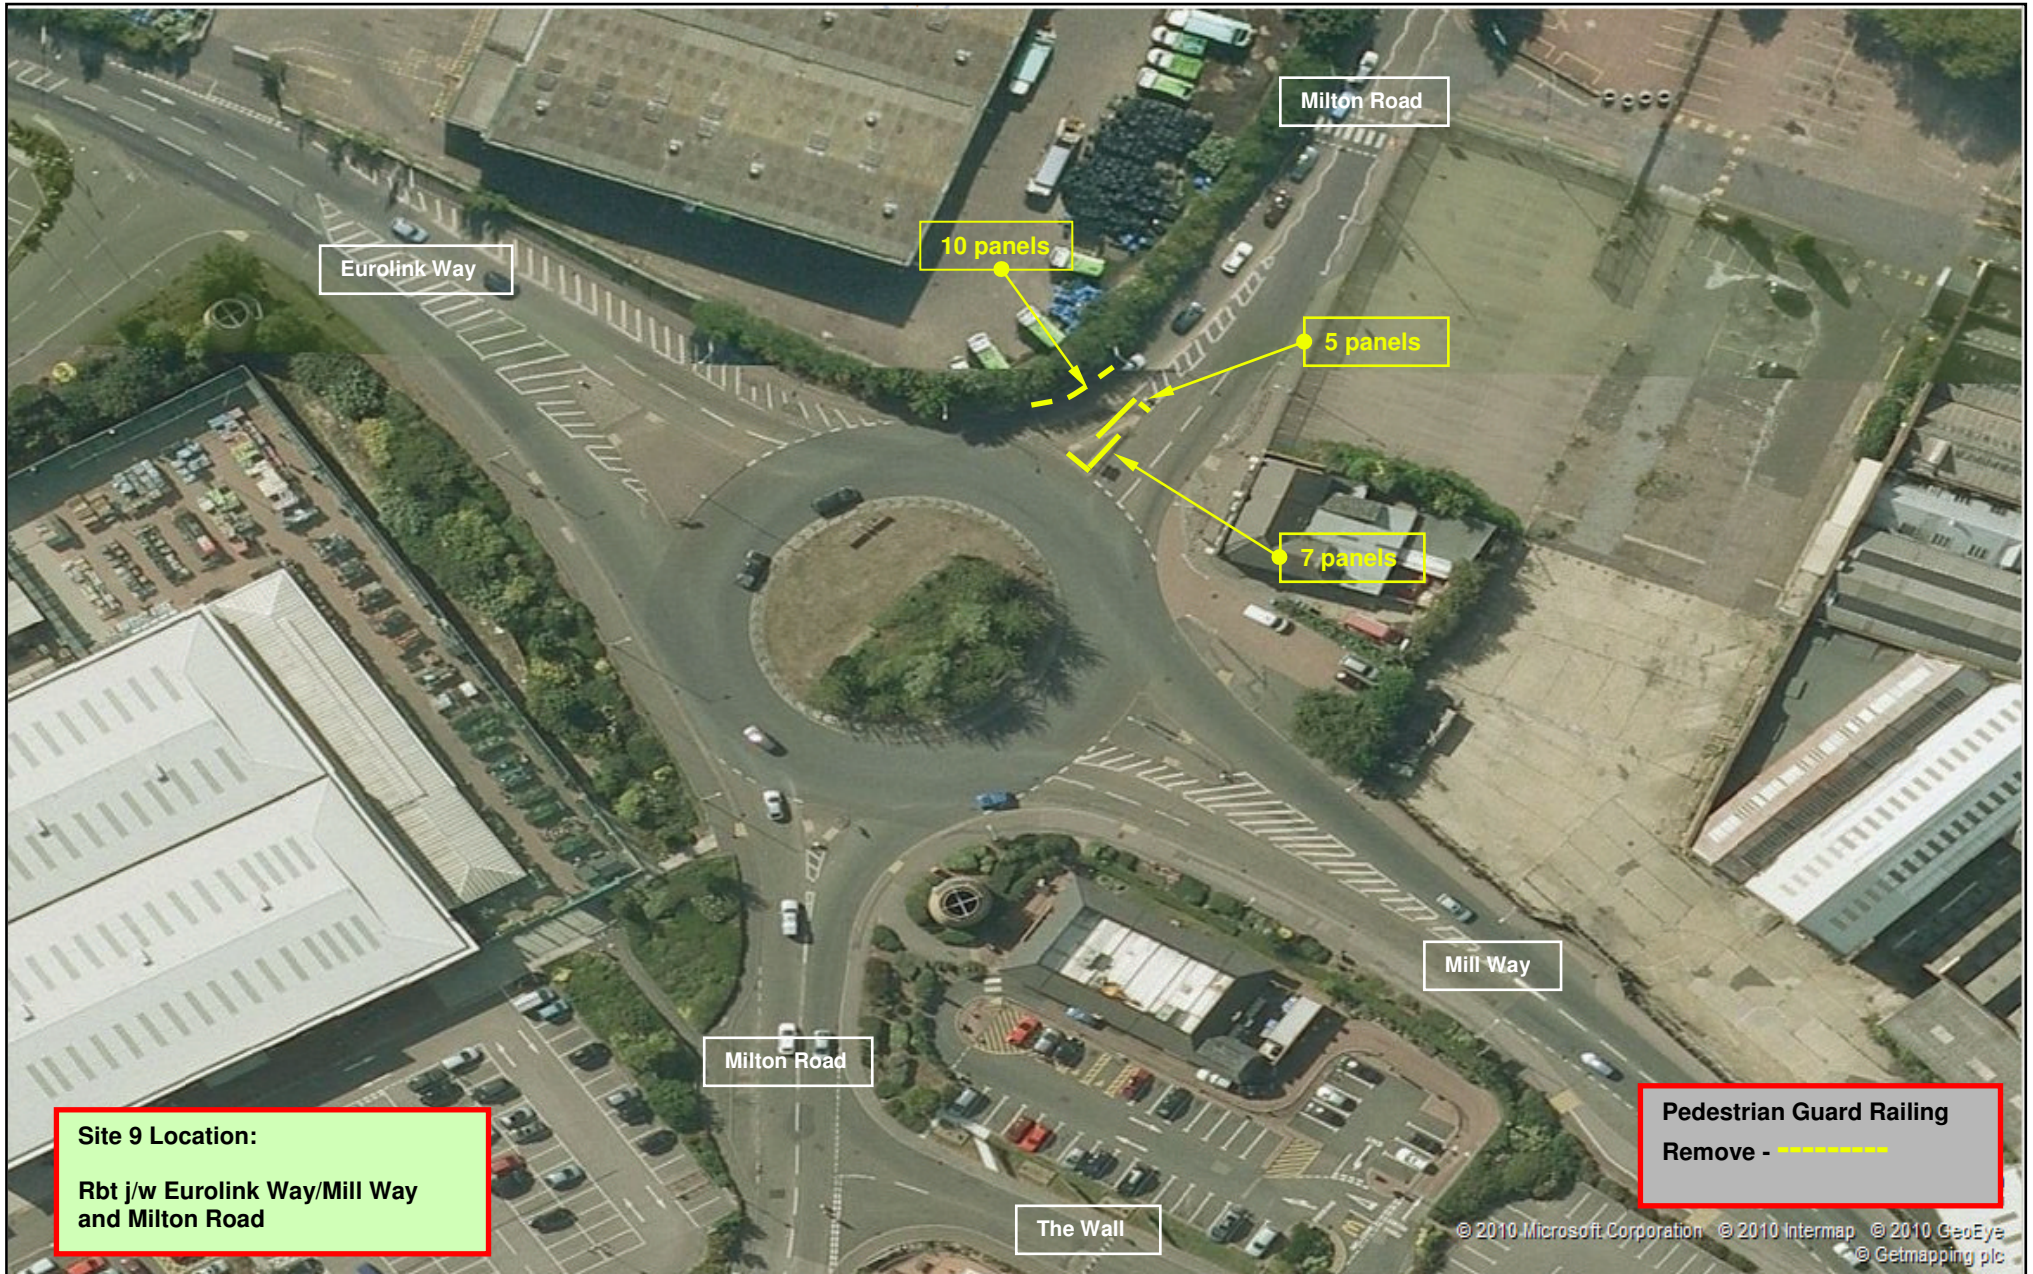
**Illustrated Diagram of site 9**

Site 9 is located at the roundabout junction of Eurolink Way/Mill Way and Milton Road.

The site is at the large roundabout bordered by industrial premises with residential properties on the northern, north eastern and south eastern sides of the site and the Borden Grammar School football field on the southern side.

The site has a high volume of vehicular traffic and low pedestrian use.

The pedestrian guard railing offers little benefit as a guide or protective device.

- **It is recommended to remove the pedestrian guard railings at site 9.**

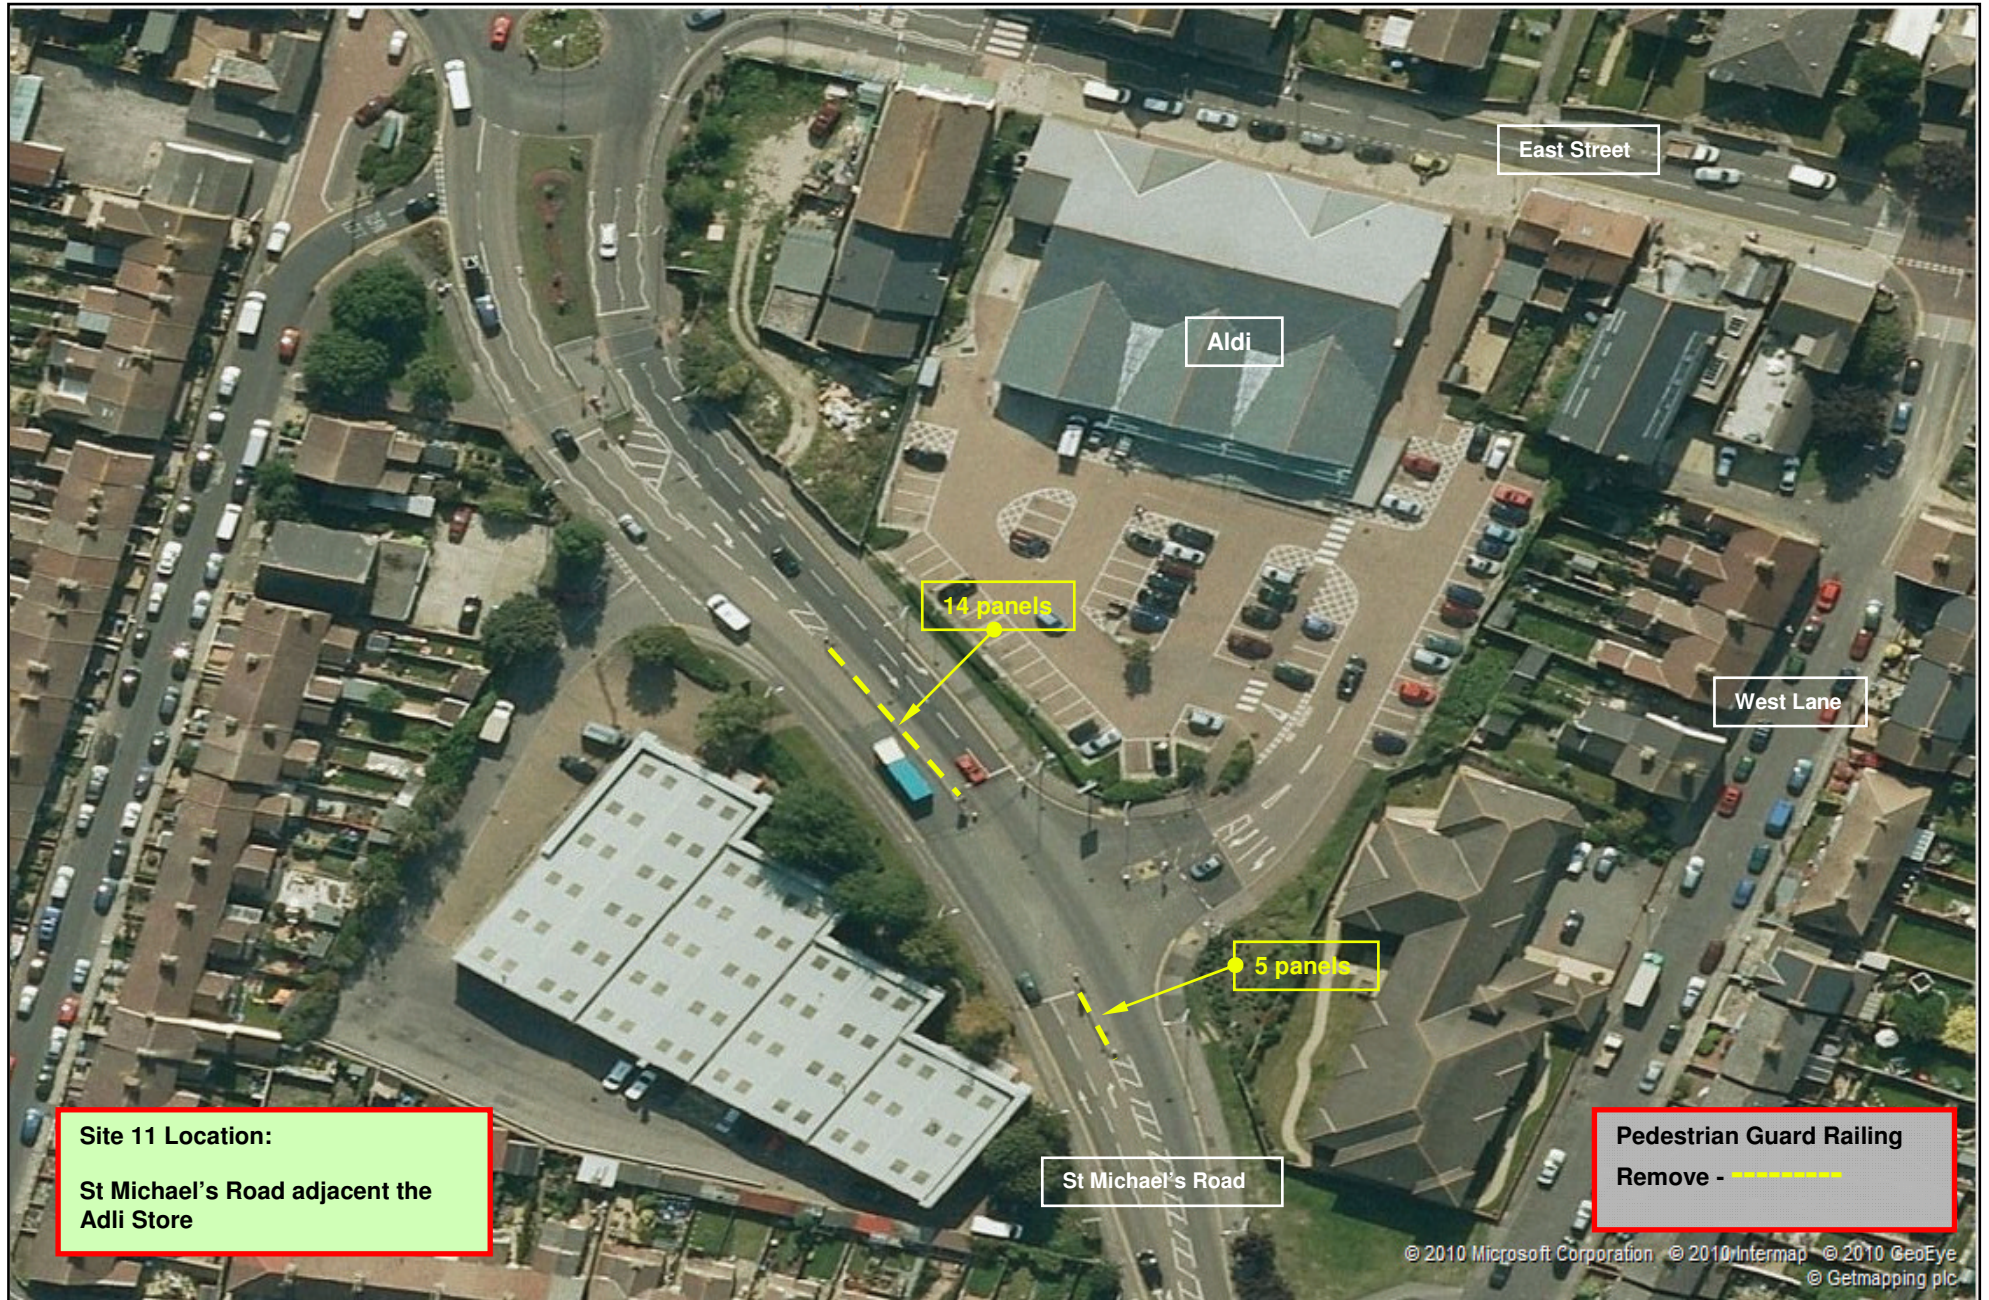
**Illustrated Diagram of site 11**

Site 11 is located on St Michael's Road at the access to the Aldi Store.

The site is at the access to the Aldi Store and opposite some business outlets and approximately 70metres south east of residential properties.

The site has a high volume of vehicular traffic and moderate pedestrian use.

The central reservation guard railings offer little benefit as a guide or protective device.

- **It is recommended to remove the central reservation guard railings at site 11.**

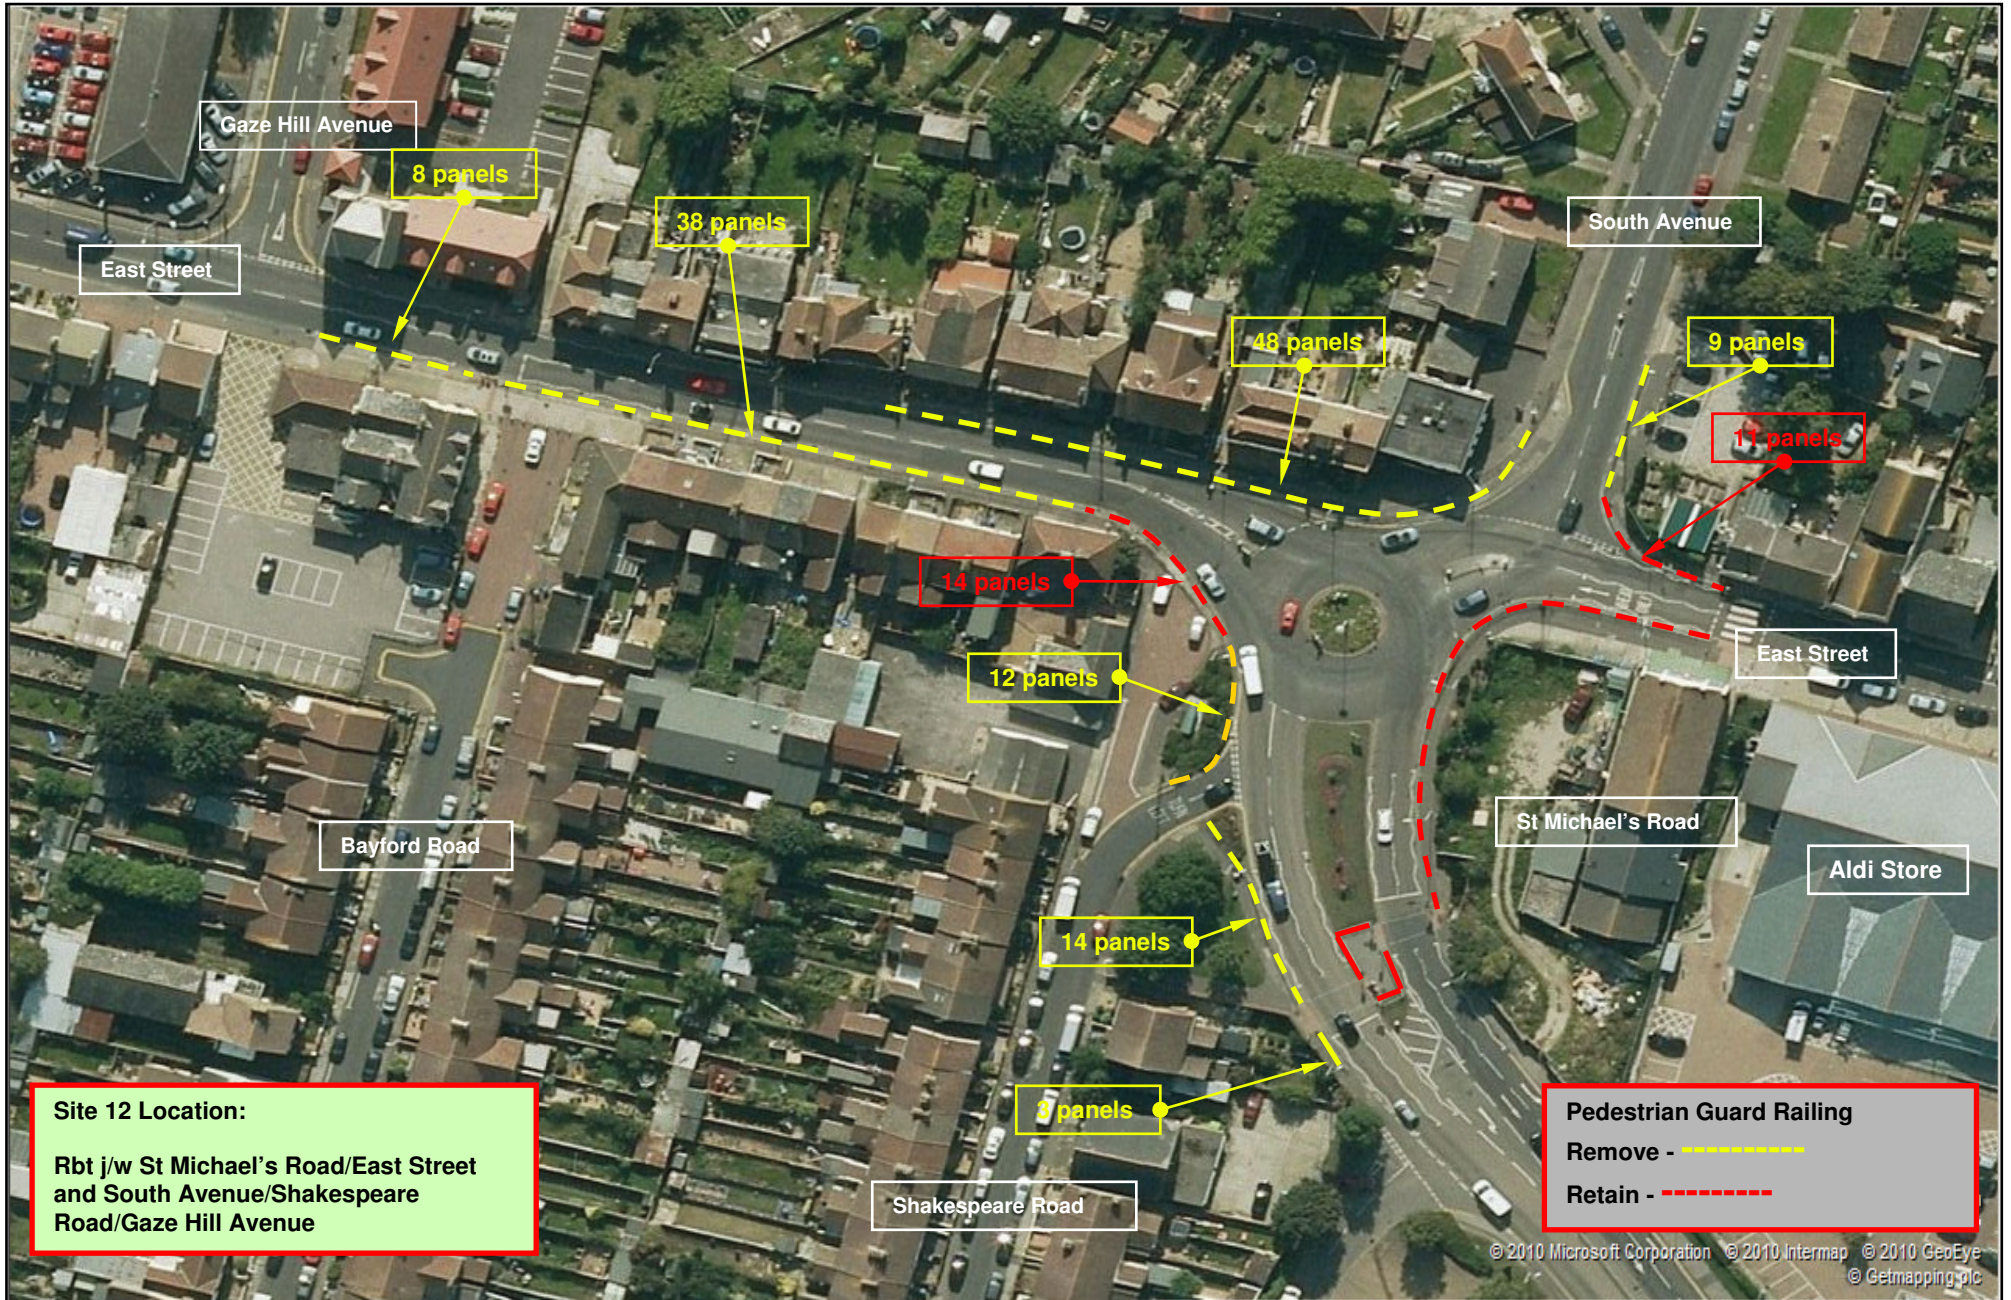
**Illustrated Diagram of site 12**

Site 12 is located from the roundabout junction of St Michael's Road/East Street and Shakespeare Road/South Avenue to adjacent to the 'Cherry Tree' public house at the junction of Gaze Hill Avenue.

The site is located mainly in a residential area with an Aldi store and some retail business outlets on the north eastern side.

The site has a high volume of vehicular traffic and moderate pedestrian use.

The site has two types of pedestrian guard railings installed, 'key clamp fencing' which are in poor condition and the 'see through' type.

The pedestrian guard railings assessed for removal offer little benefit as the guide or protective device.

- **It is recommended to partially remove the pedestrian guard railings at site 12.**
