Kent Pedestrian Guard Railing Assessment

Sittingbourne – Consultation Report (Version 3)

Project Number B1649000

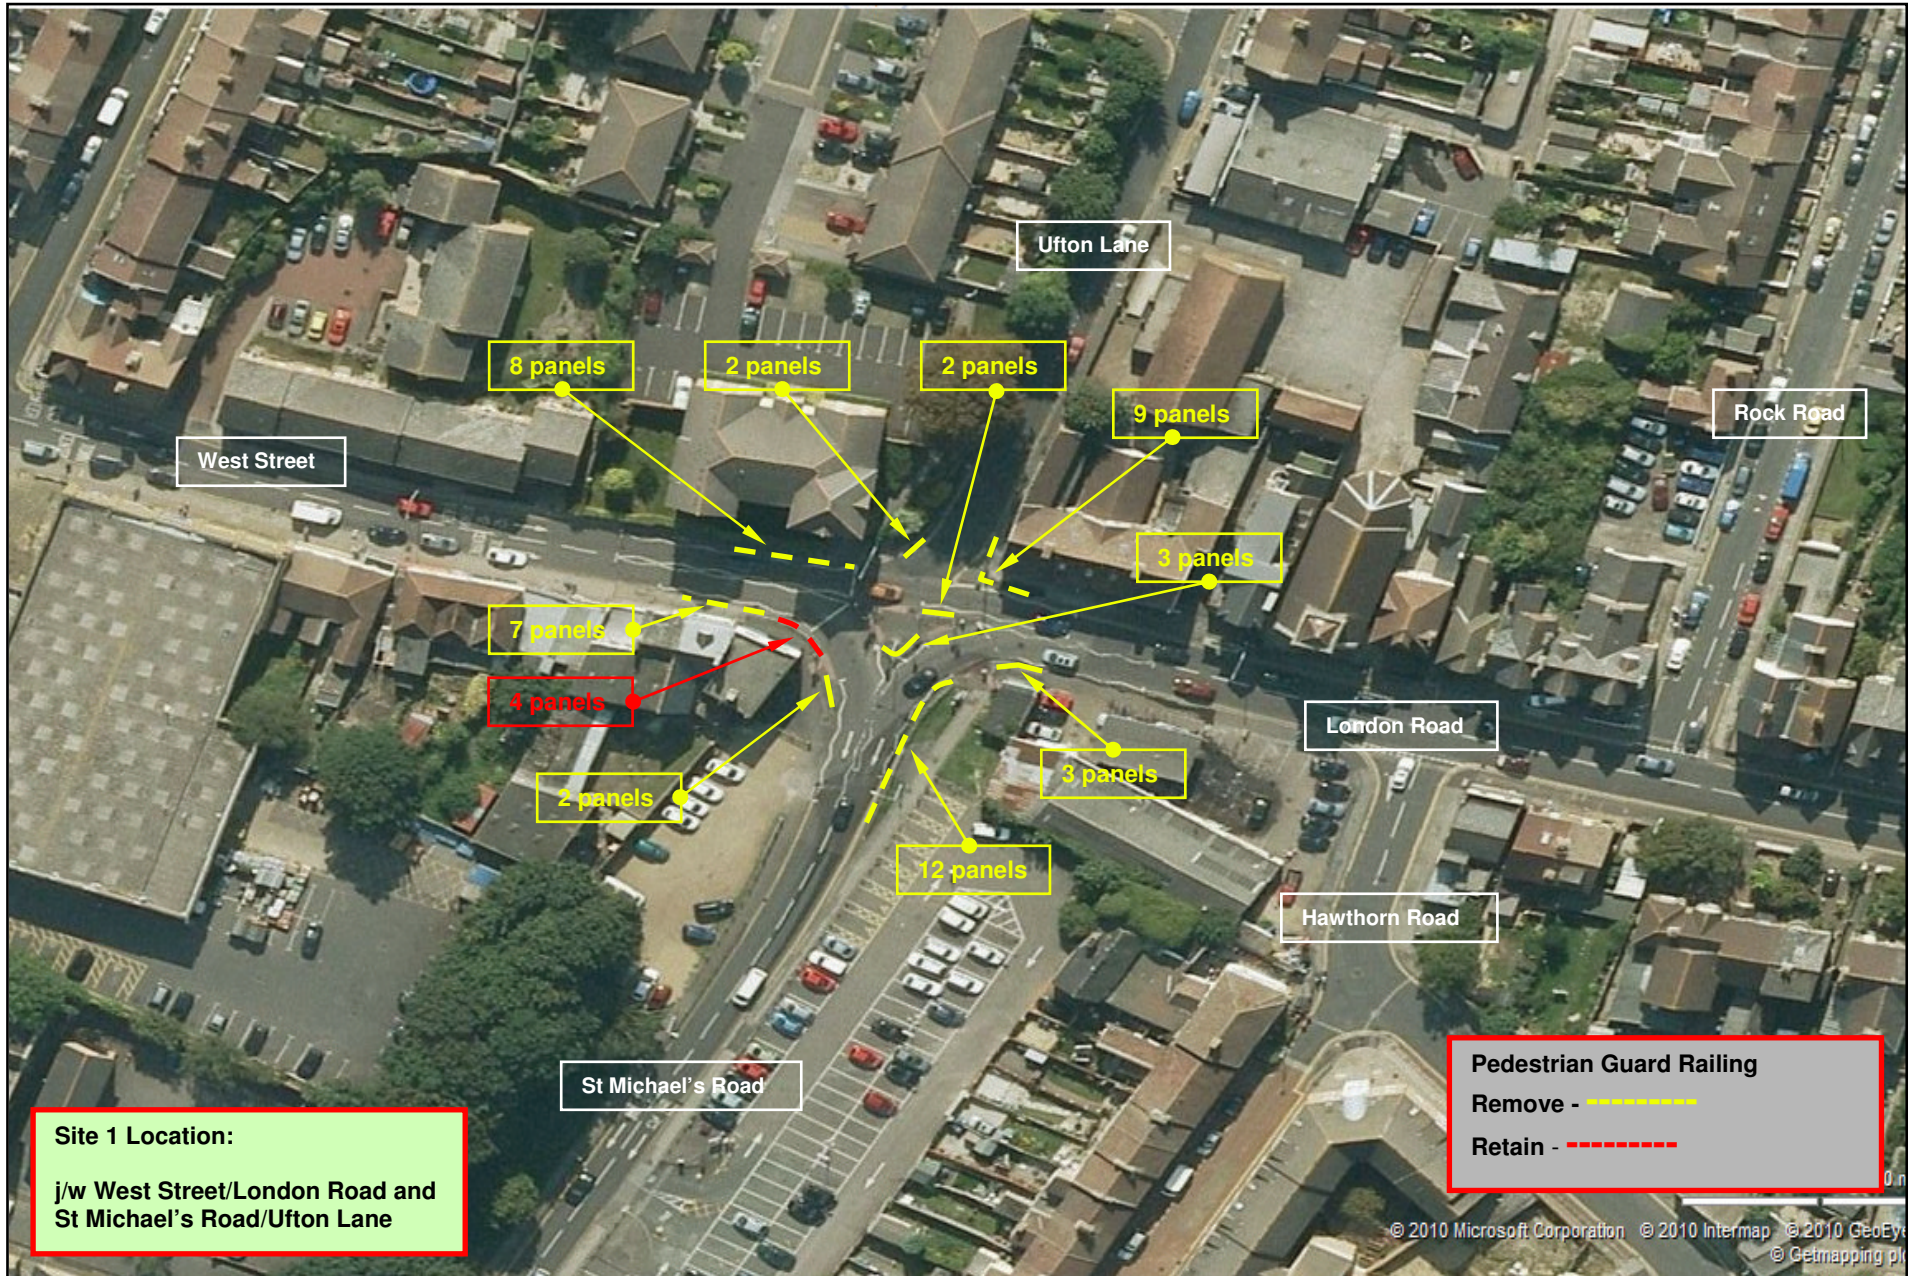
Illustrated Diagram of site 1

Site 1 is located at the junction of West Street/London Road and St. Michael's Road/Ufton Lane.

Dropped kerbs with tactile paving will need to be re-located for new desire line.

The site has a mixture of residential properties and small retail outlets and a car parking facility on St Michael's Road. St Michael's Road is an access from the residential properties to the Sittingbourne Railway Station.

The site has a high volume of vehicular traffic and moderate pedestrian use.

The pedestrian guard railings at the site are a mixture of standard and see through. Those assessed for removal offer little benefit as a guide or protective device.

Pedestrian movements will need to be monitored.

- **It is recommended to partially remove the pedestrian guard railings at site 1.**

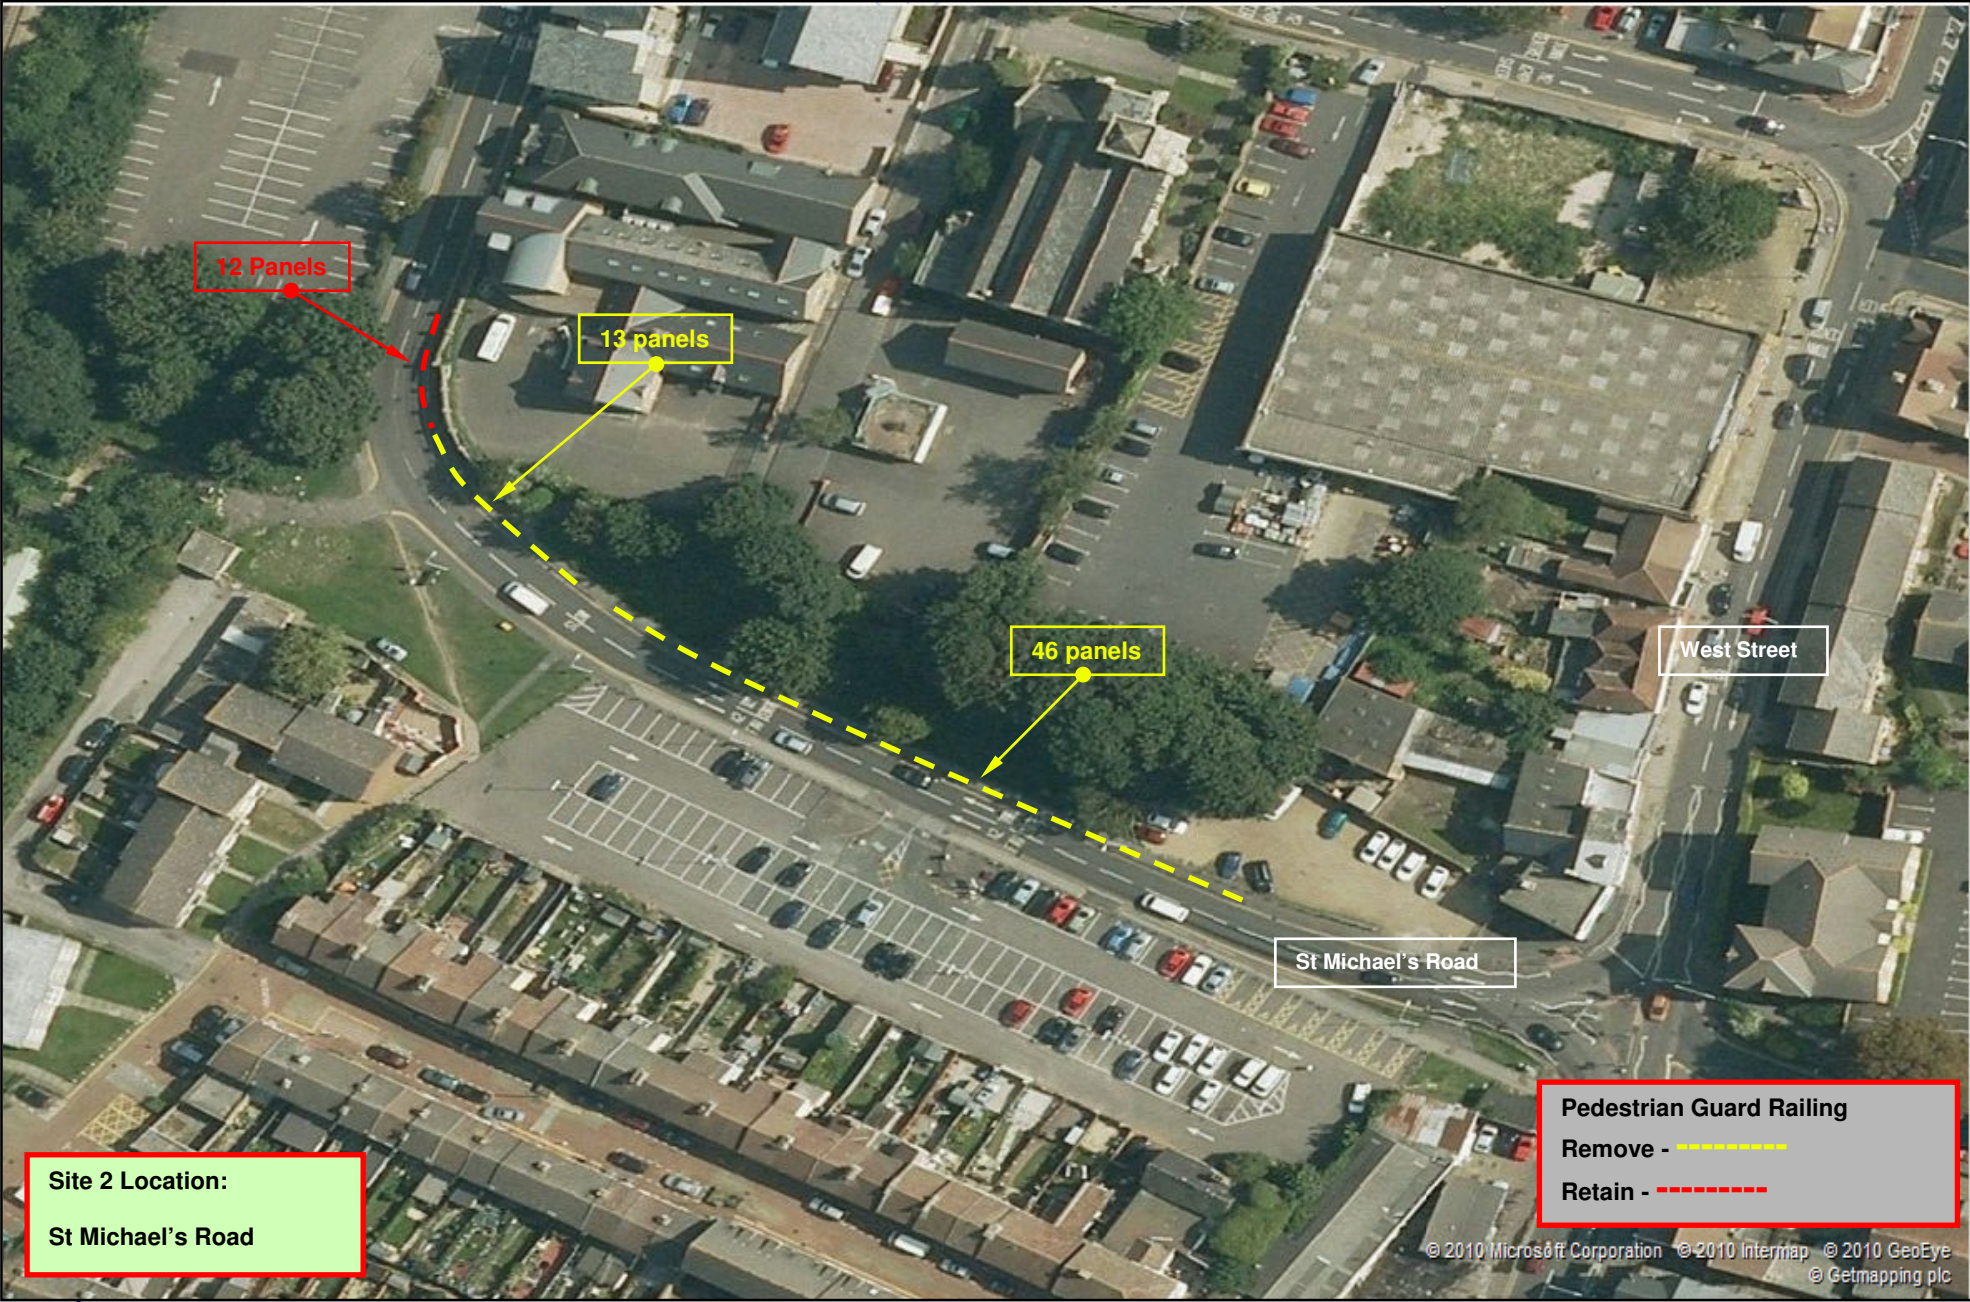
Illustrated Diagram of site 2

Site 2 is located on St. Michael's Road.

- a) Risk of vehicles mounting the pavement on the tight bend on St Michaels Road.
- b) Tactile paving should be installed at existing crossing point at northern end of car park.

The site has a car park on the western side and a wide grassed verge on the eastern side with walled residential properties at the northern end of the site.

The site has a high volume of vehicular traffic and moderate pedestrian use.

The pedestrian guard railings at the site offer little benefit as a guide or protective device.

- a) This site has been further assessed. The footway is very narrow at this point and the pedestrian guard rail reduces it further. There needs to be a balance between the substandard footway width and the chance of vehicle overhang. The pedestrian railing should be set back 450mm from the edge of the carriageway to maximise the width of the carriageway. A realignment is required in the future, in the meantime the 12 panels at the northern end should be retained.
- b) Any change in pedestrian desire lines should be monitored.

- **It is recommended to remove the pedestrian guard railings at site 2.**

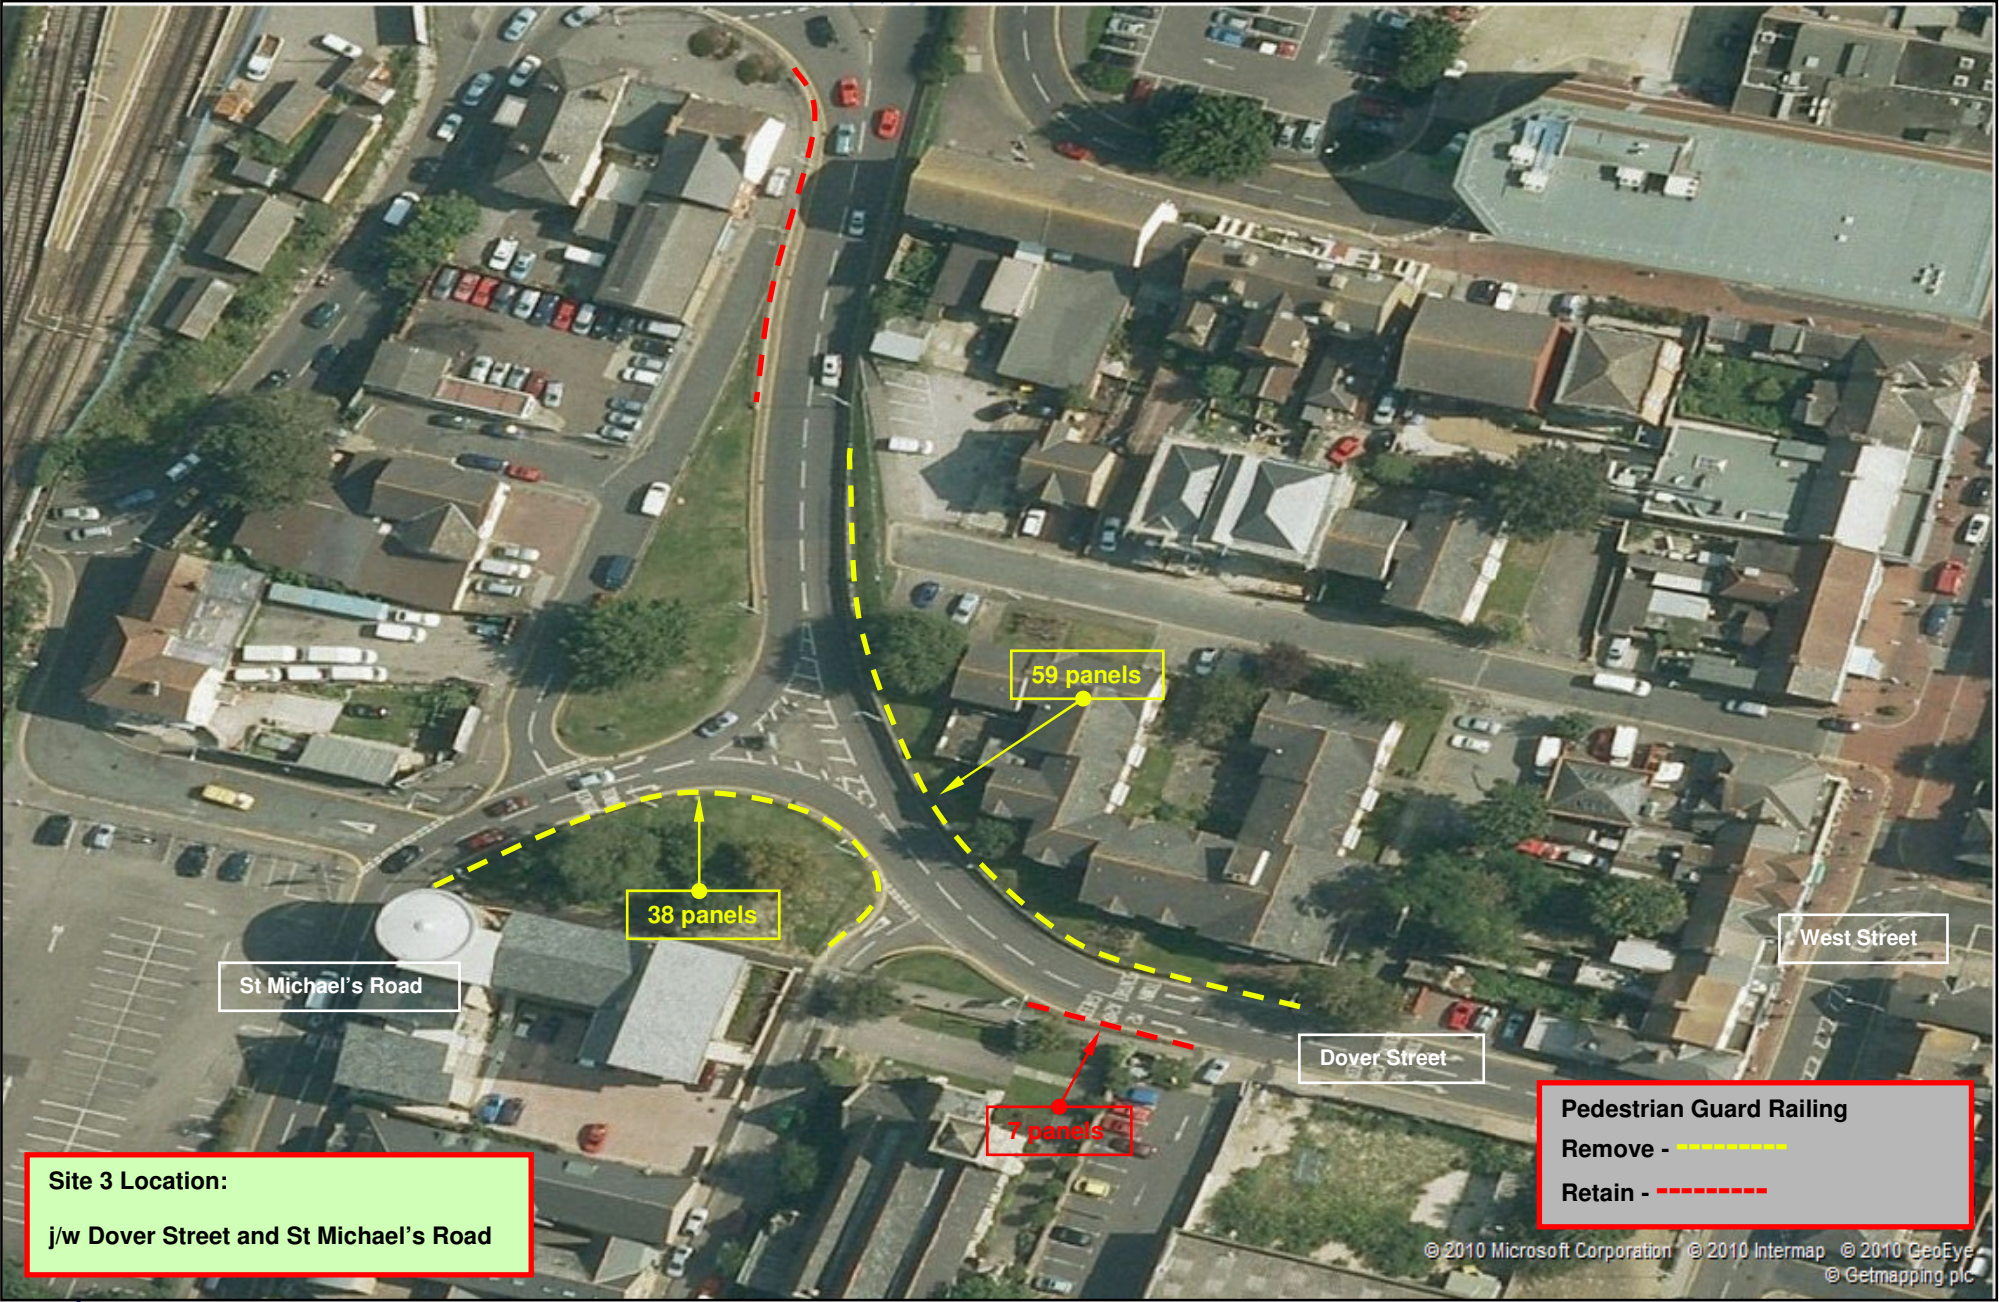
Illustrated Diagram of site 3

Site 3 is located at the junction of St. Michael's Road and Dover Street.

The 7 panels outside Holy Trinity offer protection as there is a difference in levels between the footway and the carriageway.

The site on the western side is located on an extended semi-circular grass verge, adjacent to a block of flats with half on St Michael's Road and the other on Dover Street and seven panels on a wall adjacent the footway outside the Holy Trinity church.

On the eastern side the guard railings are located on a boundary wall of elevated residential flats.

On the northern side the guard railing is located on a wall adjacent to the elevated Fountain Street and footway and as a protective device should be retained to prevent pedestrians falling into the carriageway below.

The site has a high volume of vehicular traffic and low pedestrian use.

The pedestrian guard railings assessed for removal offer little benefit as a guide or protective device.

The site has been reassessed and these panels are recommended to be retained.

- **It is recommended to partially remove the pedestrian guard railings at site 3.**

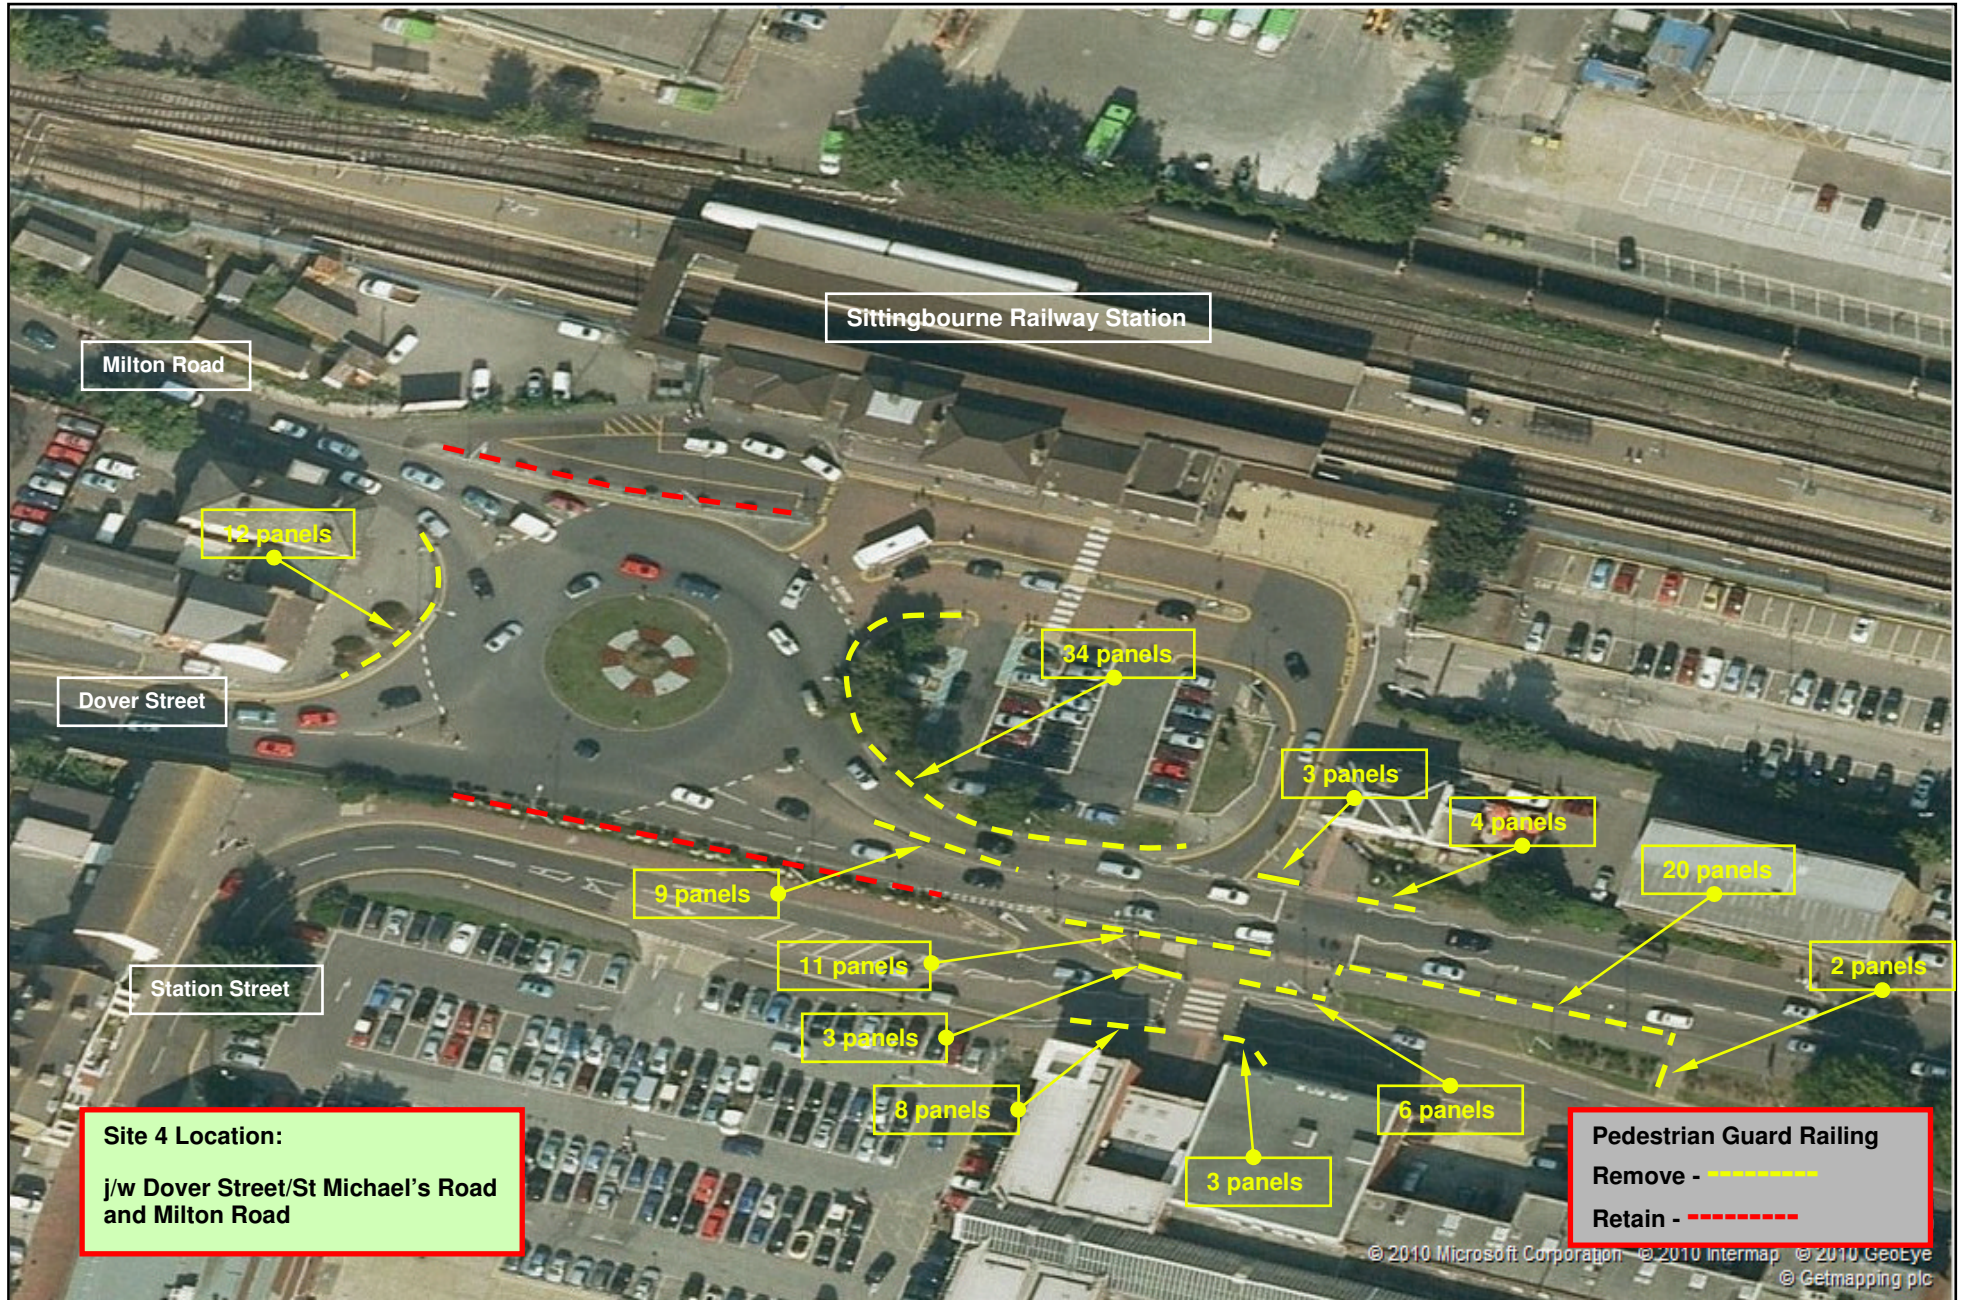
Illustrated Diagram of site 4

Site 4 is located at the roundabout junction of St. Michael’s Road/Dover Street and Milton Road.

Concern over removals because the area is heavily used by school children.

Located on the northern side of the site is Sittingbourne Railway Station with mainly retail outlets on the eastern, western, and southern sides.

The site has a high volume of vehicular traffic and moderate pedestrian use.

The pedestrian guard railings at the site are a mixture of standard and see through. Those assessed for removal offer little benefit as a guide or protective device.

The railing around the car park is redundant. Sight lines are unobstructed, vital guard railing is to be retained

- **It is recommended to partially remove the pedestrian guard railings at site 4.**

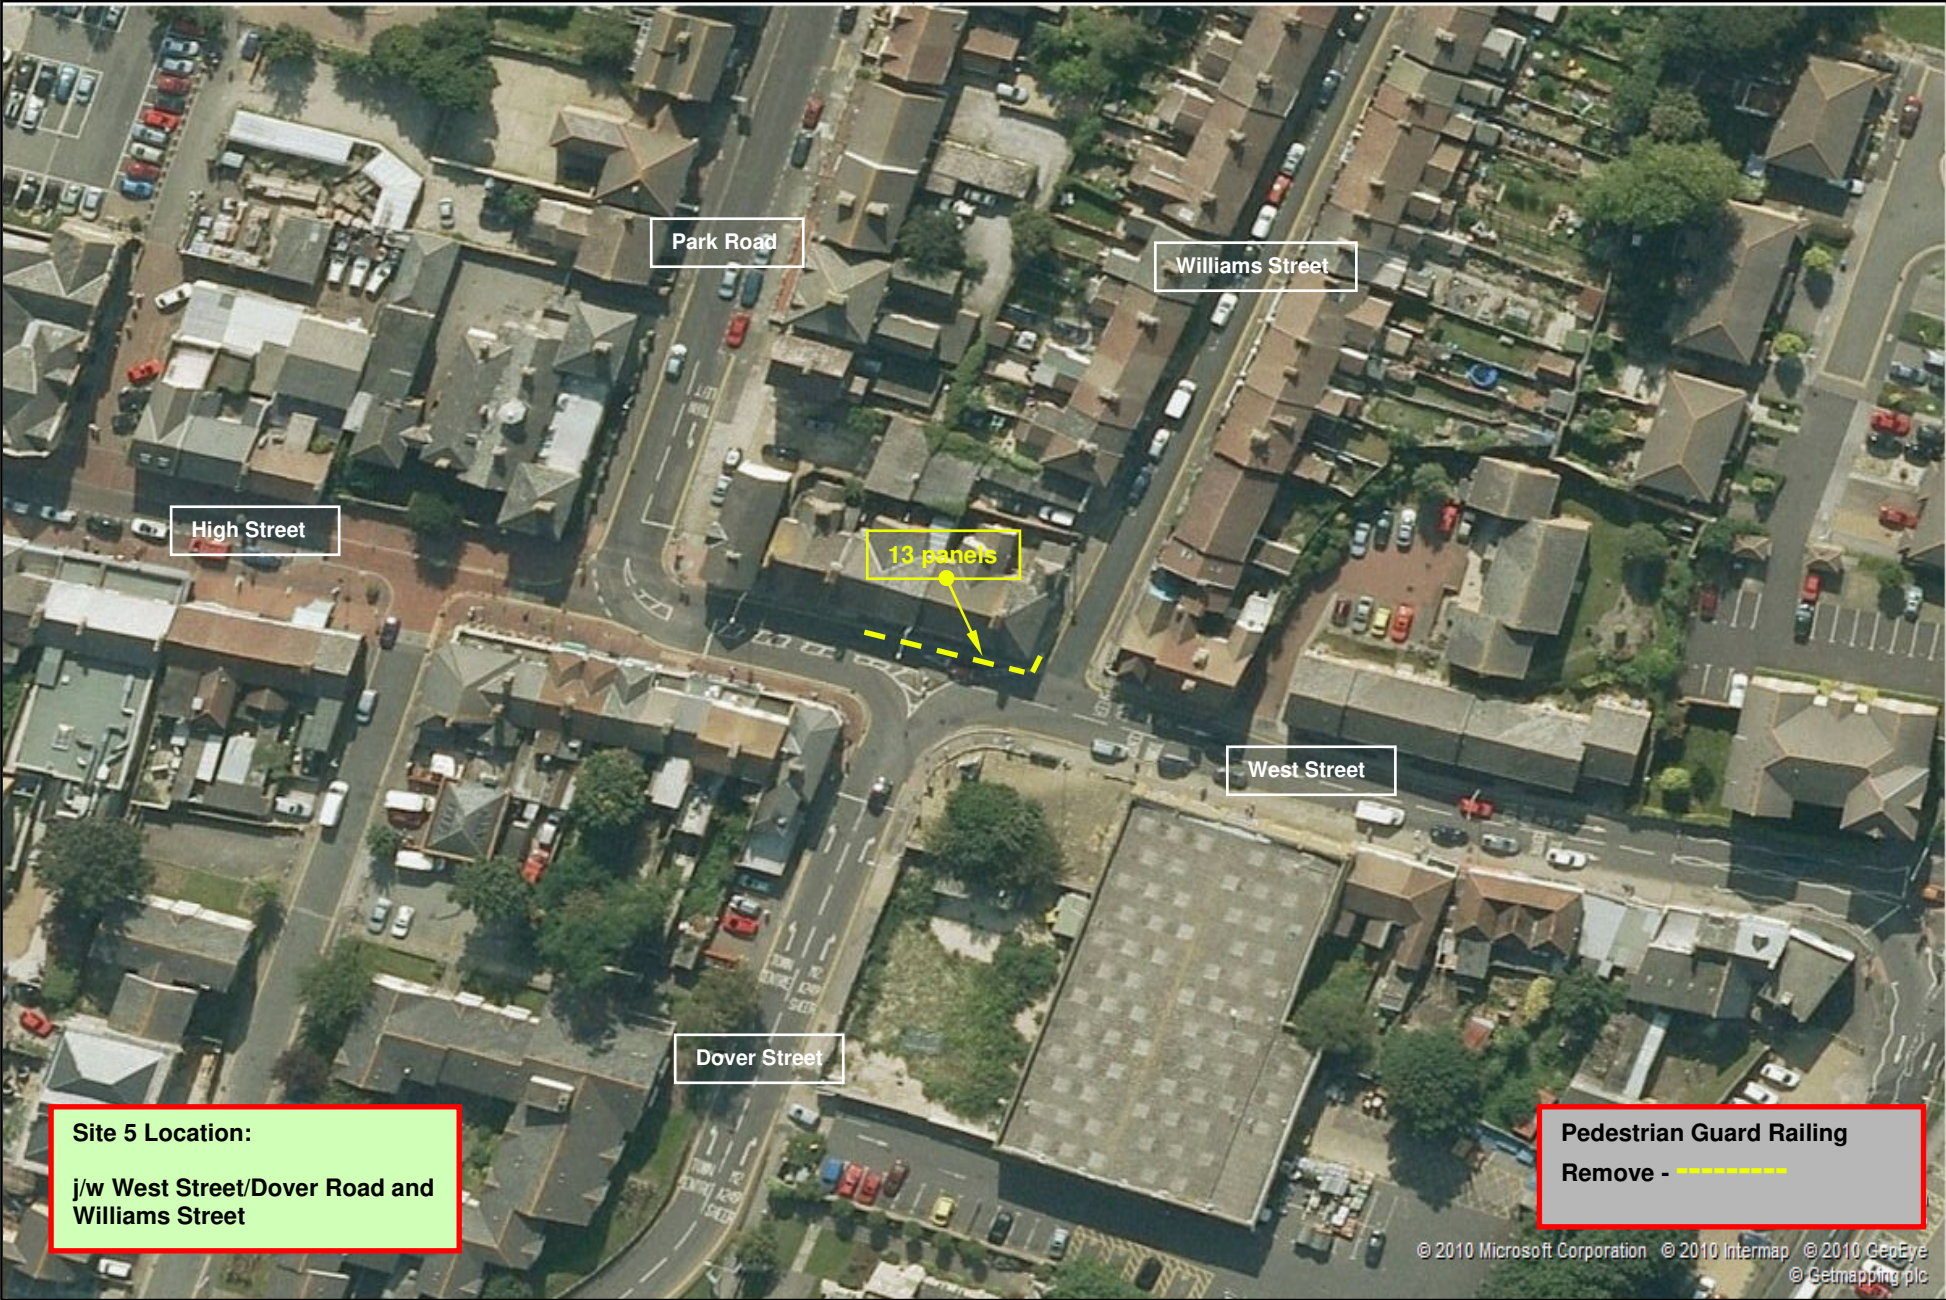
Illustrated Diagram of site 5

Site 5 is located at the junction of West Street and Dover Road.

Dropped kerbs with tactile paving will need to be re-located for new desire line.

The site is located mainly where there are retail outlets and is an access to the High Street and Sittingbourne Railway Station.

The site has both a high volume of vehicular traffic and pedestrian use.

The pedestrian guard railing at the site offers little benefit as a guide or protective device.

The pedestrian movements will need to be monitored and a case made.

- **It is recommended to remove the pedestrian guard railings at site 5.**

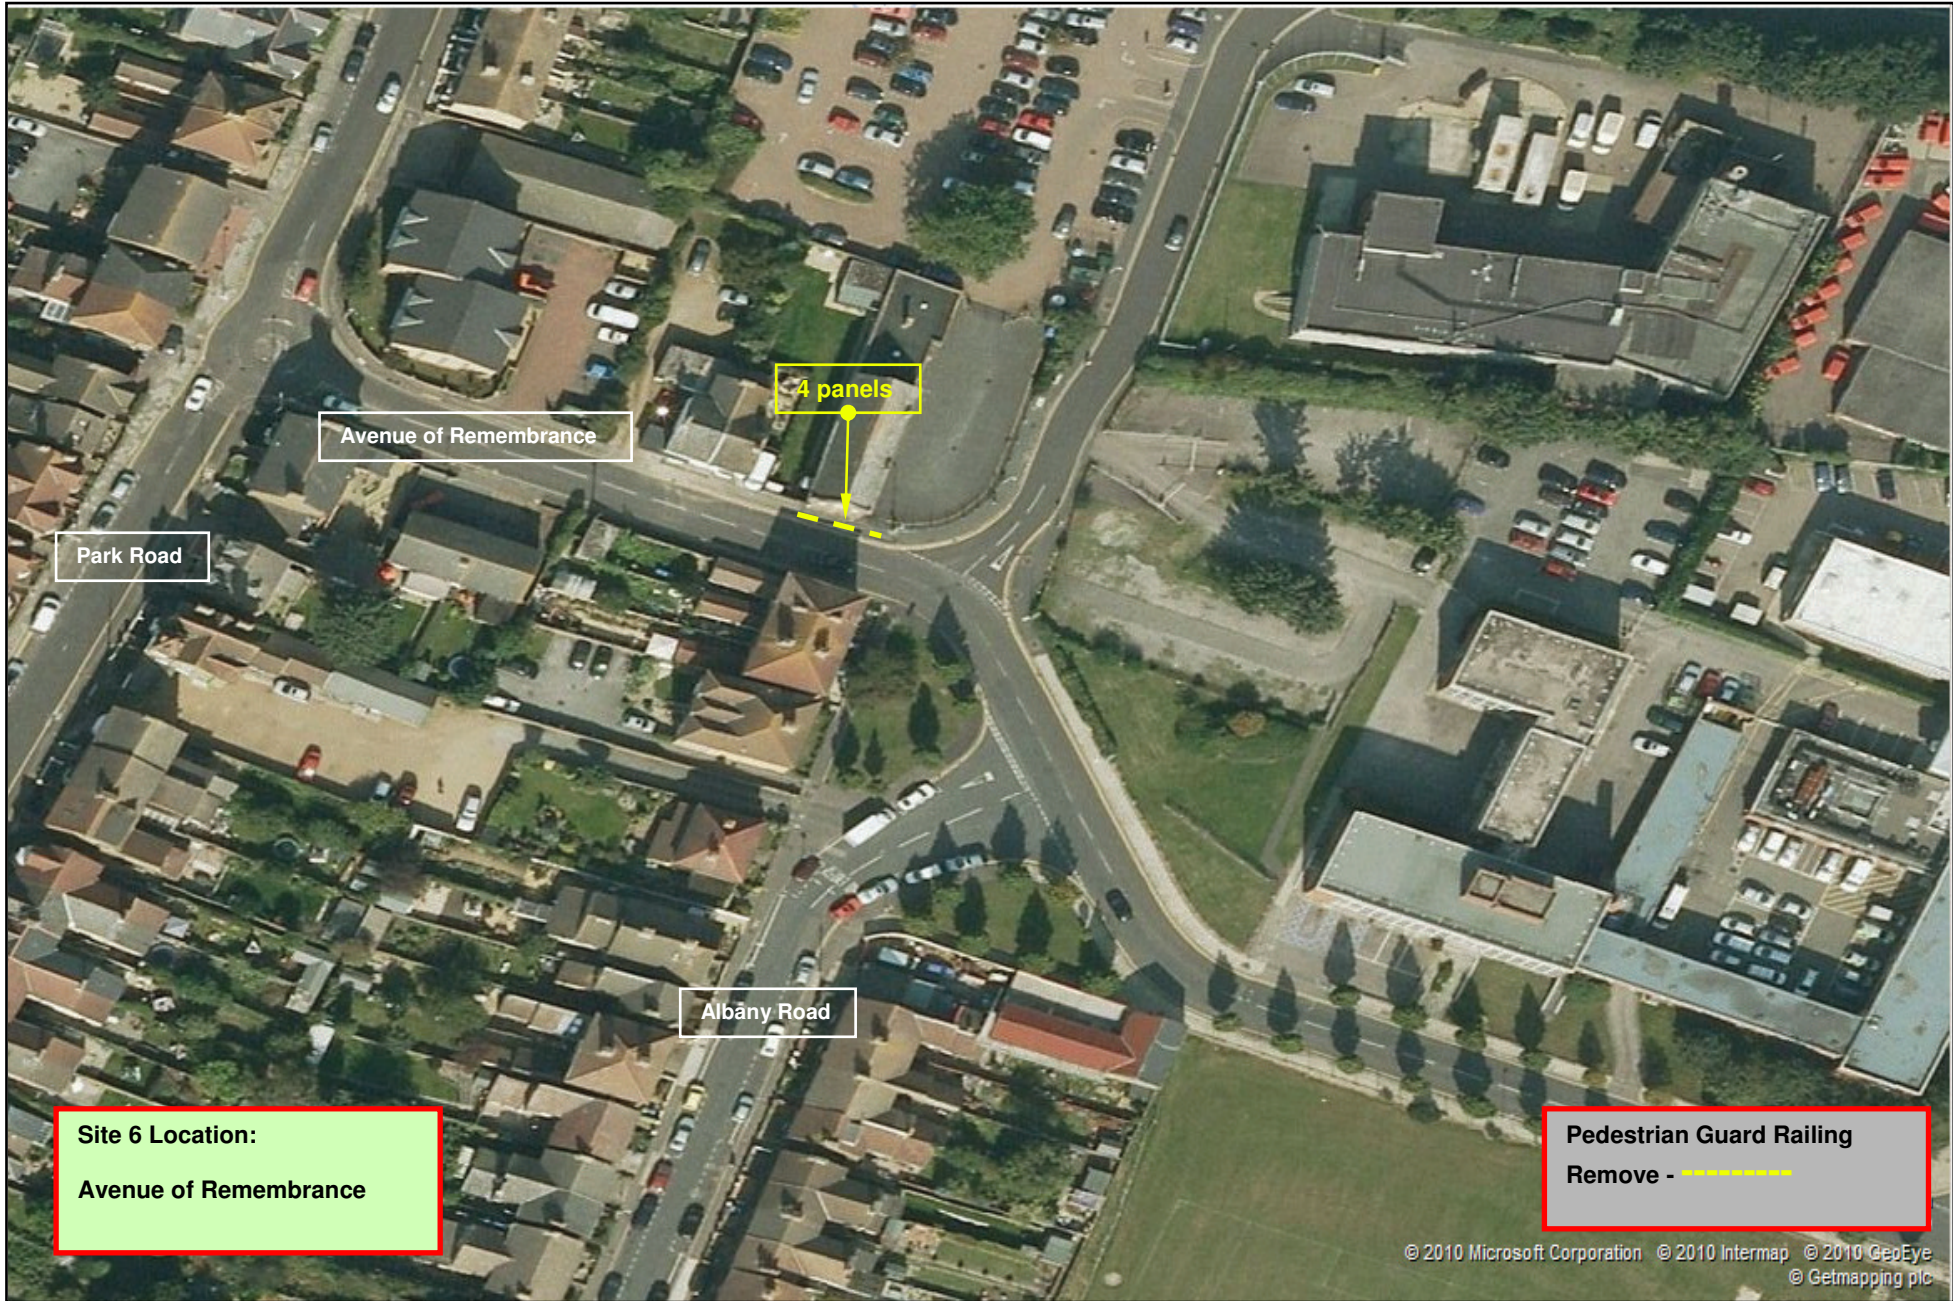
Illustrated Diagram of site 6

Site 6 is located on the Avenue of Remembrance near the junction of Albany Road.

Concern due to proximity of schools

The site has residential properties and the Borden Grammar School on the southern side and a block of offices on the north eastern side.

The site has a moderate volume of vehicular traffic and low pedestrian use.

The pedestrian guard railing at the site offers no benefit as a guide or protective device.

The pedestrian guard railing here reduces the footway width. Historically the pedestrian guard railing may have had a purpose but it is now redundant. Formally this was a Masonic Hall – not aware that this still being used by children.

- **It is recommended to remove the pedestrian guard railings at site 6.**

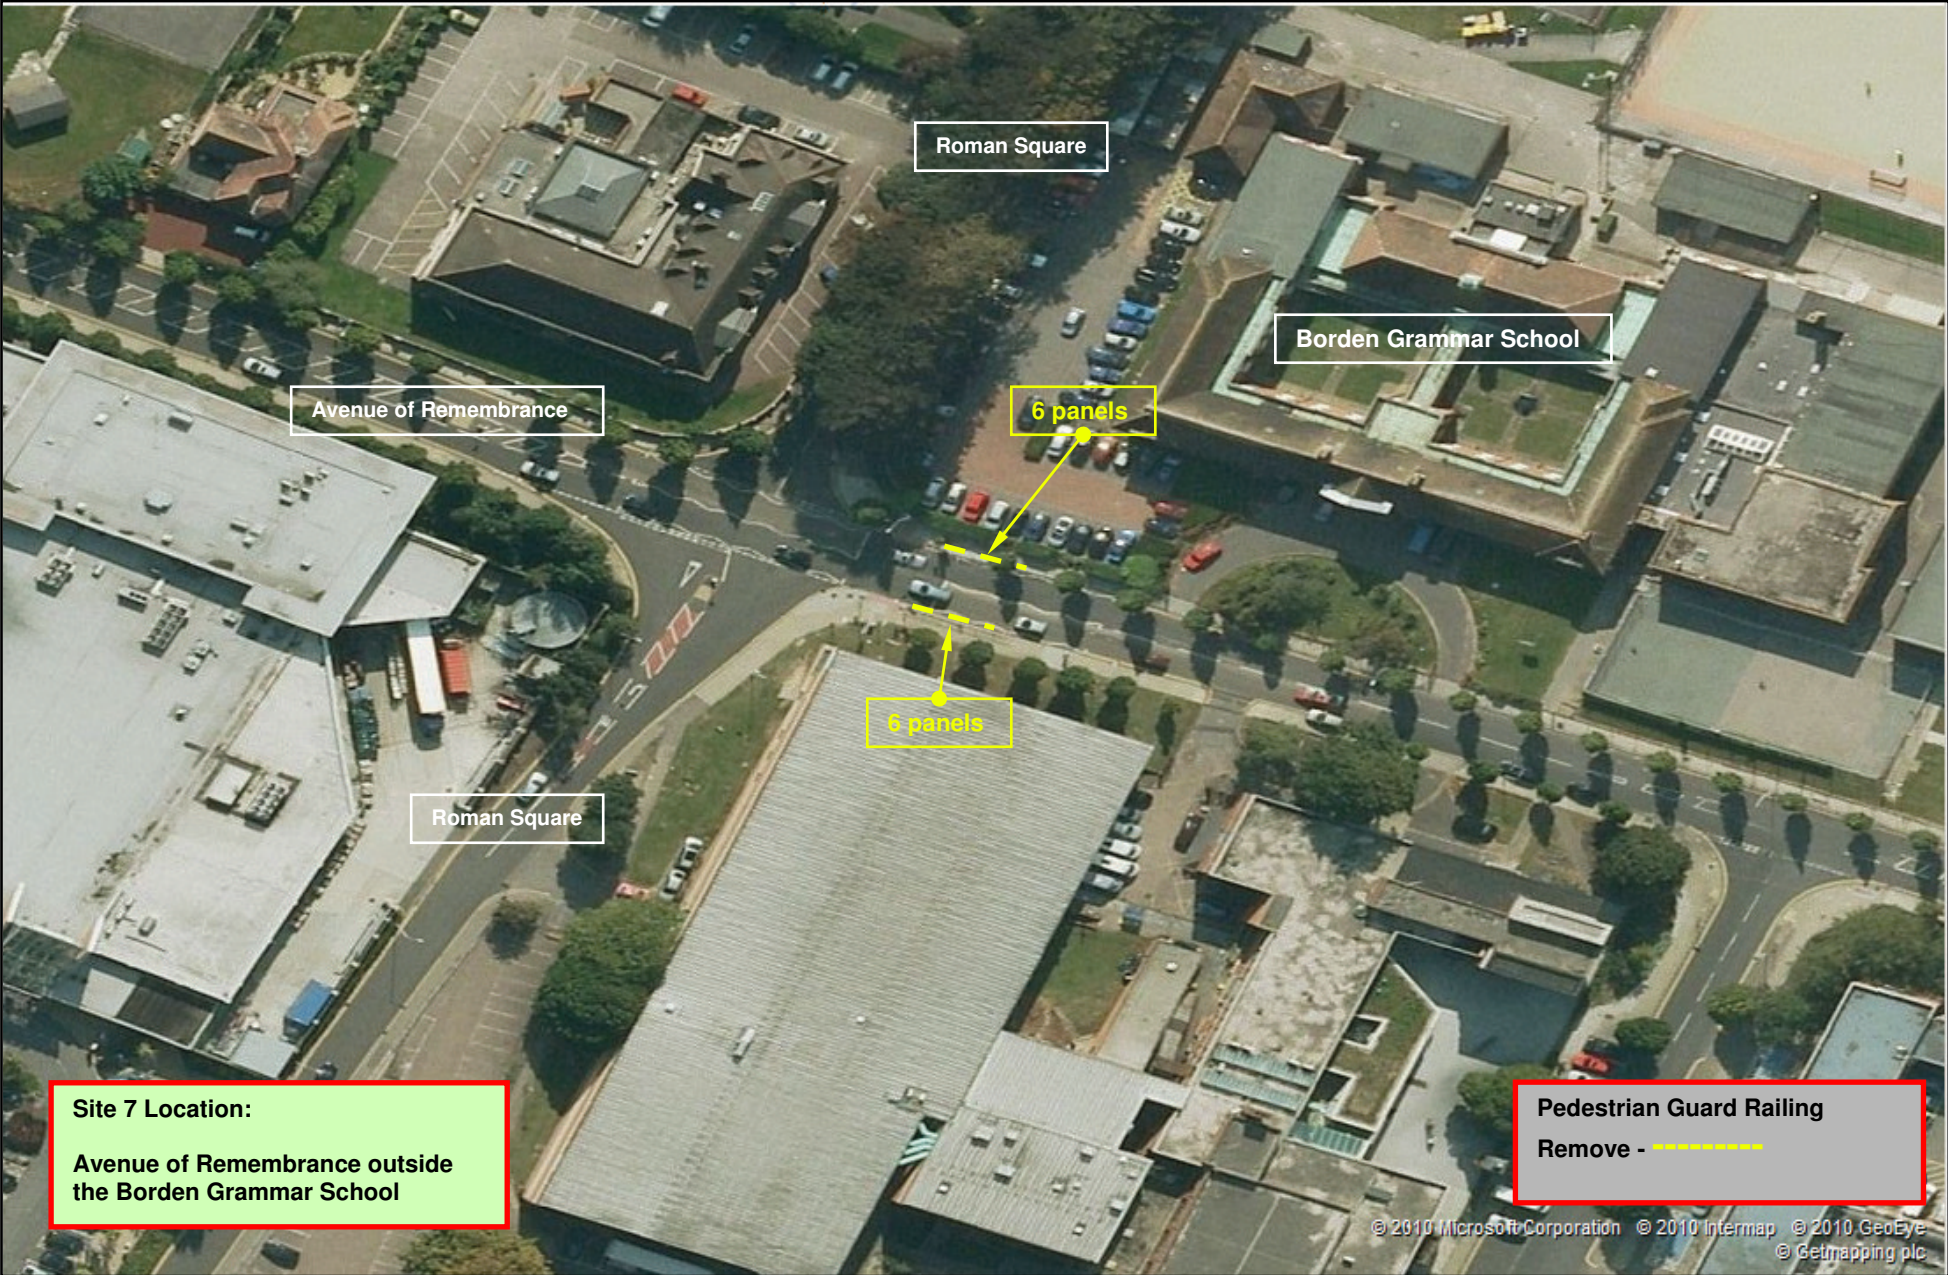
Illustrated Diagram of site 7

Site 7 is located on the Avenue of Remembrance outside the Borden Grammar School.

The site is located near the UK Paper Leisure Club, some business premises and outside the Borden Grammar School.

The site has a moderate volume of vehicular traffic and low pedestrian use.

The 6 pedestrian guard railing panels either side of the carriageway offer little benefit as a guide or protective device.

- **It is recommended to remove the pedestrian guard railings at site 7.**

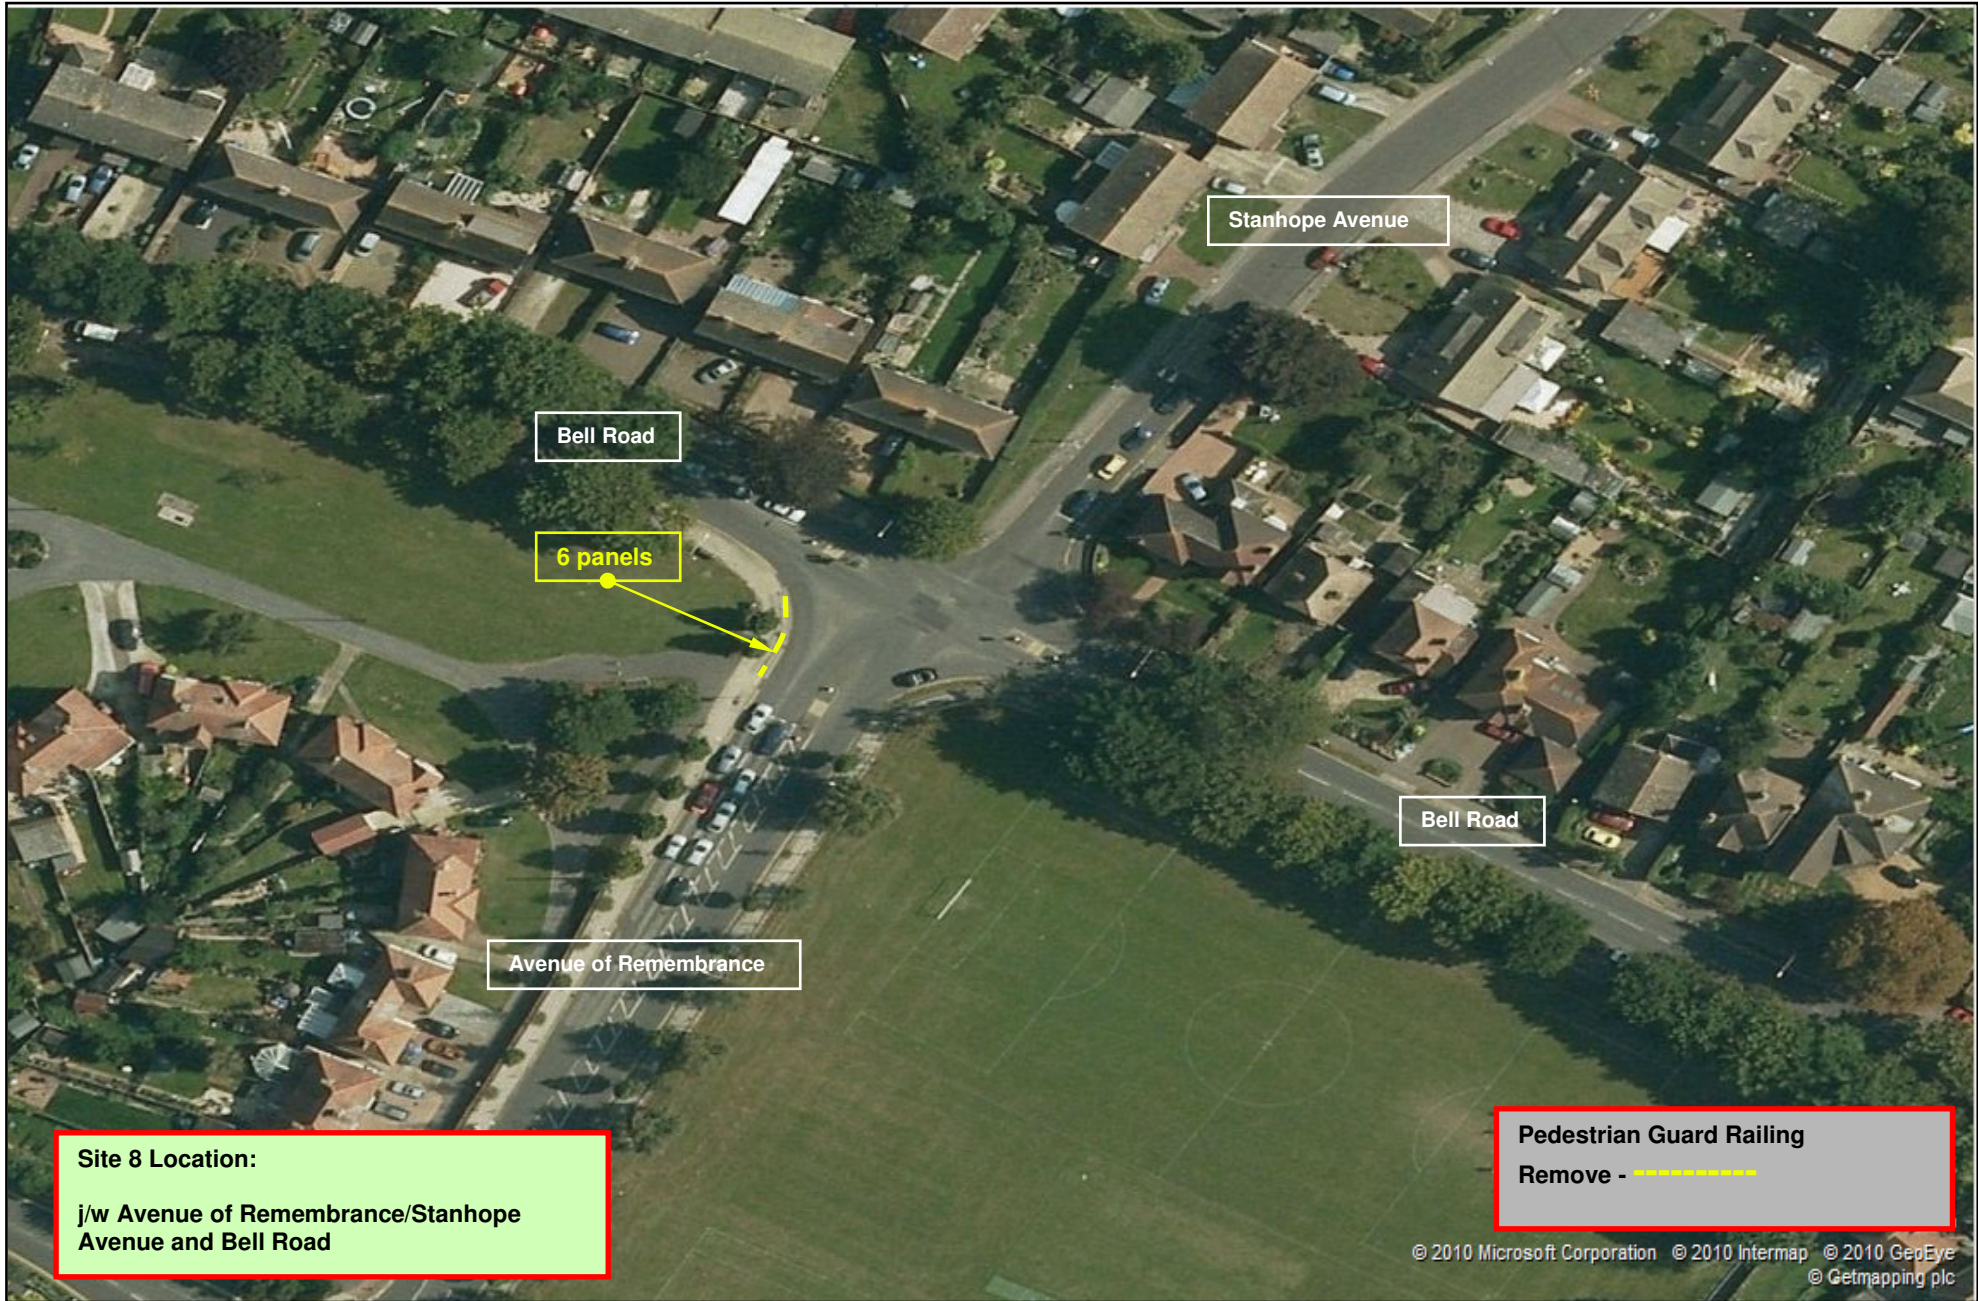
Illustrated Diagram of site 8

Site 8 is located at the junction of Avenue of Remembrance/Stanhope Avenue and Bell Road.

Concern due to proximity of schools.

The site has residential properties on the northern, north eastern and south eastern sides of the site and the Borden Grammar School football field on the southern side.

The site has moderate volume of vehicular traffic and low pedestrian use.

The 6 pedestrian guard railing panels either side of the carriageway offer little benefit as a guide or protective device.

This is an open site with evidence of pedestrians walking across the grass. The pedestrian guard railing does not need to act as a guide as there is good visibility.

- **It is recommended to remove the pedestrian guard railings at site 8.**
