Kent Pedestrian Guard Railing Assessment

Sittingbourne – Consultation Report (Version 3)

Project Number B1649000

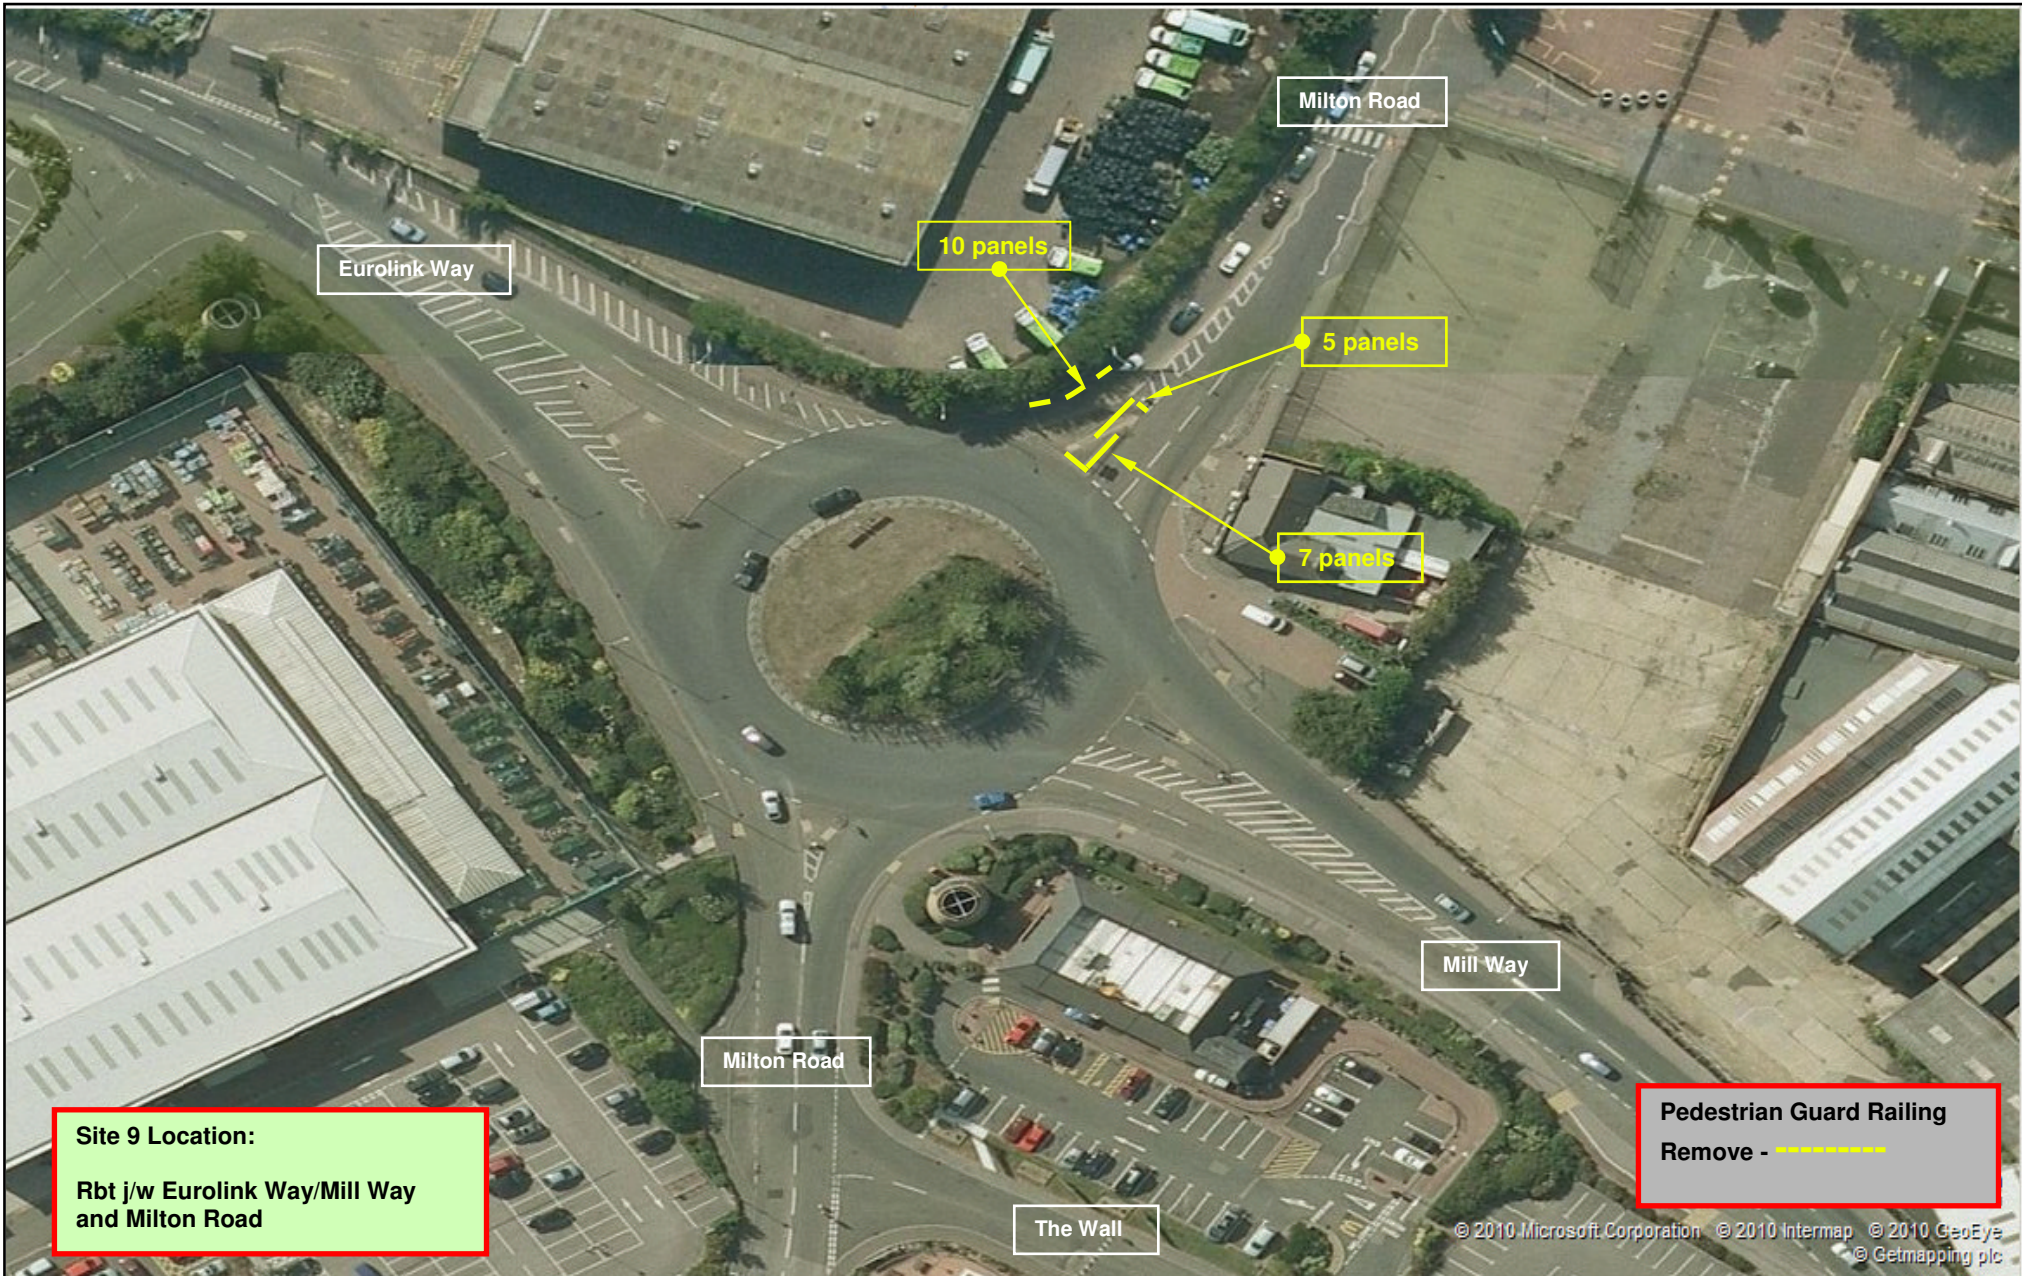
Illustrated Diagram of site 9

Site 9 is located at the roundabout junction of Eurolink Way/Mill Way and Milton Road.

The site is at the large roundabout bordered by industrial premises with residential properties on the northern, north eastern and south eastern sides of the site and the Borden Grammar School football field on the southern side.

The site has a high volume of vehicular traffic and low pedestrian use.

The pedestrian guard railing offers little benefit as a guide or protective device.

- **It is recommended to remove the pedestrian guard railings at site 9.**

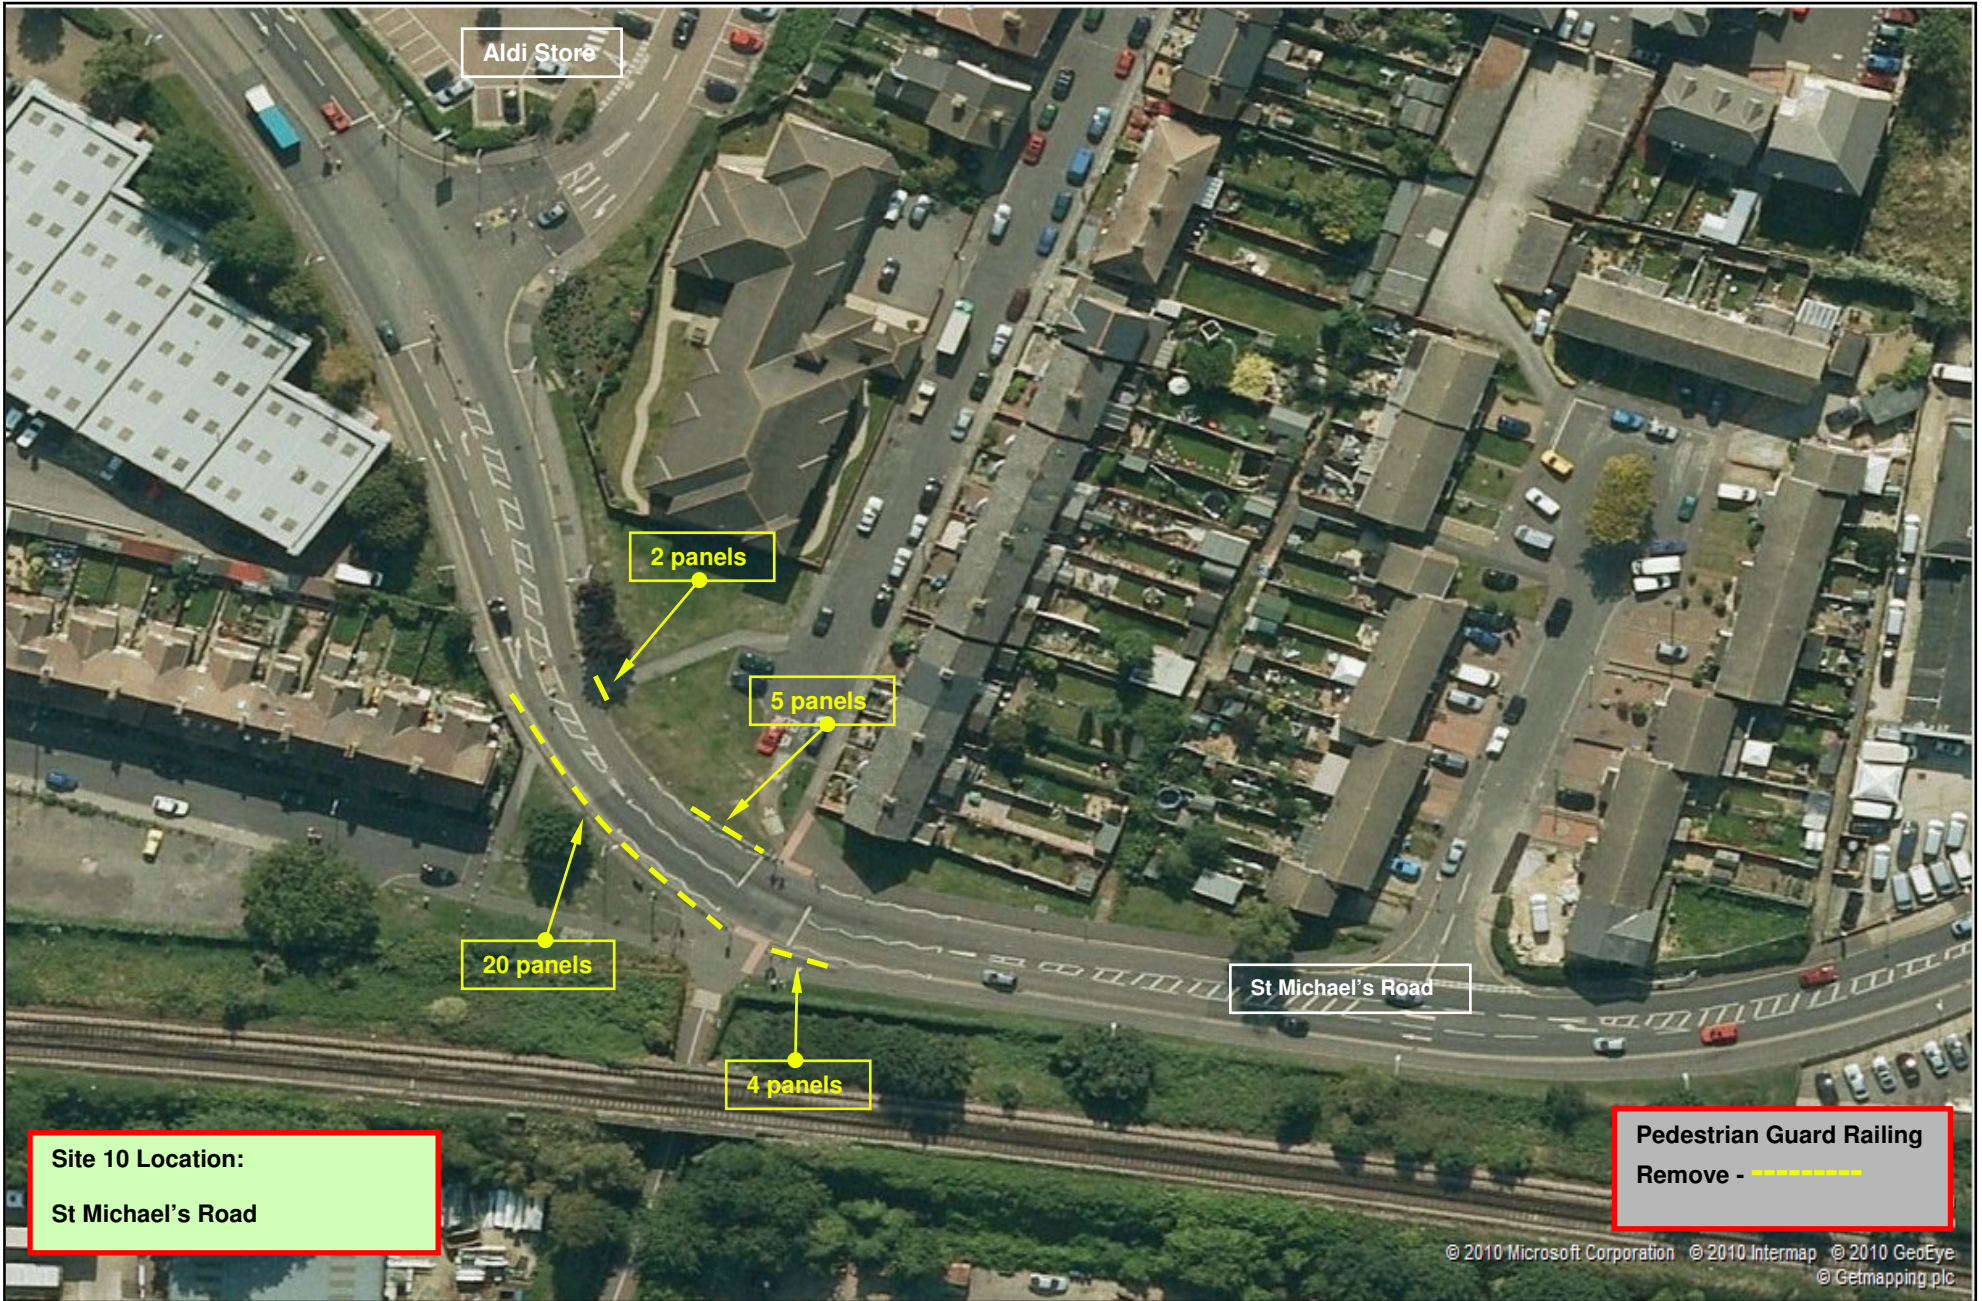
Illustrated Diagram of site 10

Site 10 is located on St Michael’s Road approximately 50metres south east of the Aldi Store.

The site has mainly residential properties with some business outlets on the north and south eastern side of the site.

The site has a high volume of vehicular traffic and moderate pedestrian use.

The pedestrian guard railing offers little benefit as a guide or protective device.

- **It is recommended to remove the pedestrian guard railings at site 10.**

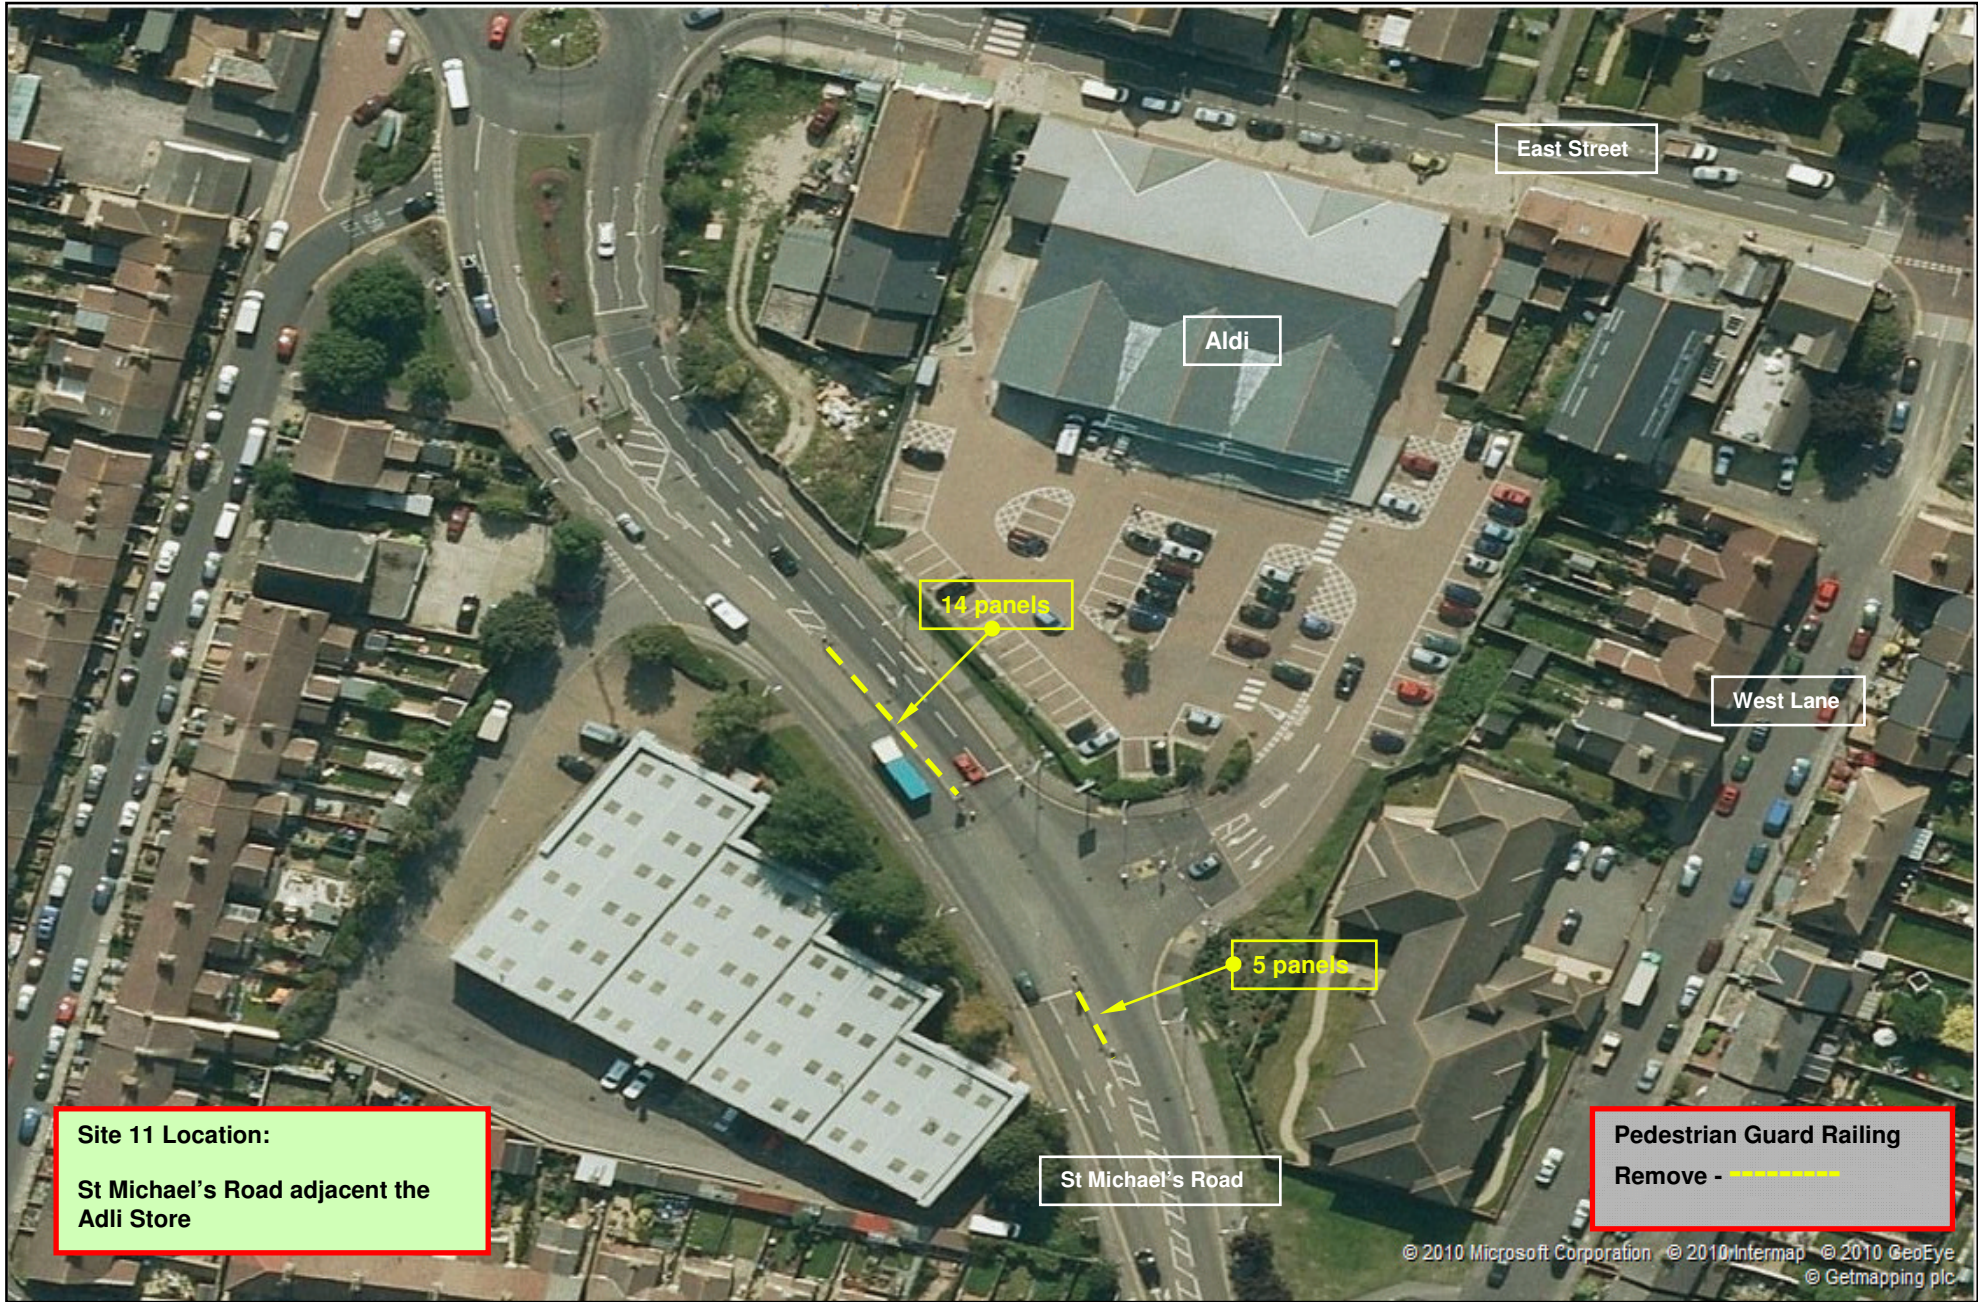
Illustrated Diagram of site 11

Site 11 is located on St Michael’s Road at the access to the Aldi Store.

The site is at the access to the Aldi Store and opposite some business outlets and approximately 70metres south east of residential properties.

The site has a high volume of vehicular traffic and moderate pedestrian use.

The central reservation guard railings offer little benefit as a guide or protective device.

- **It is recommended to remove the central reservation guard railings at site 11.**

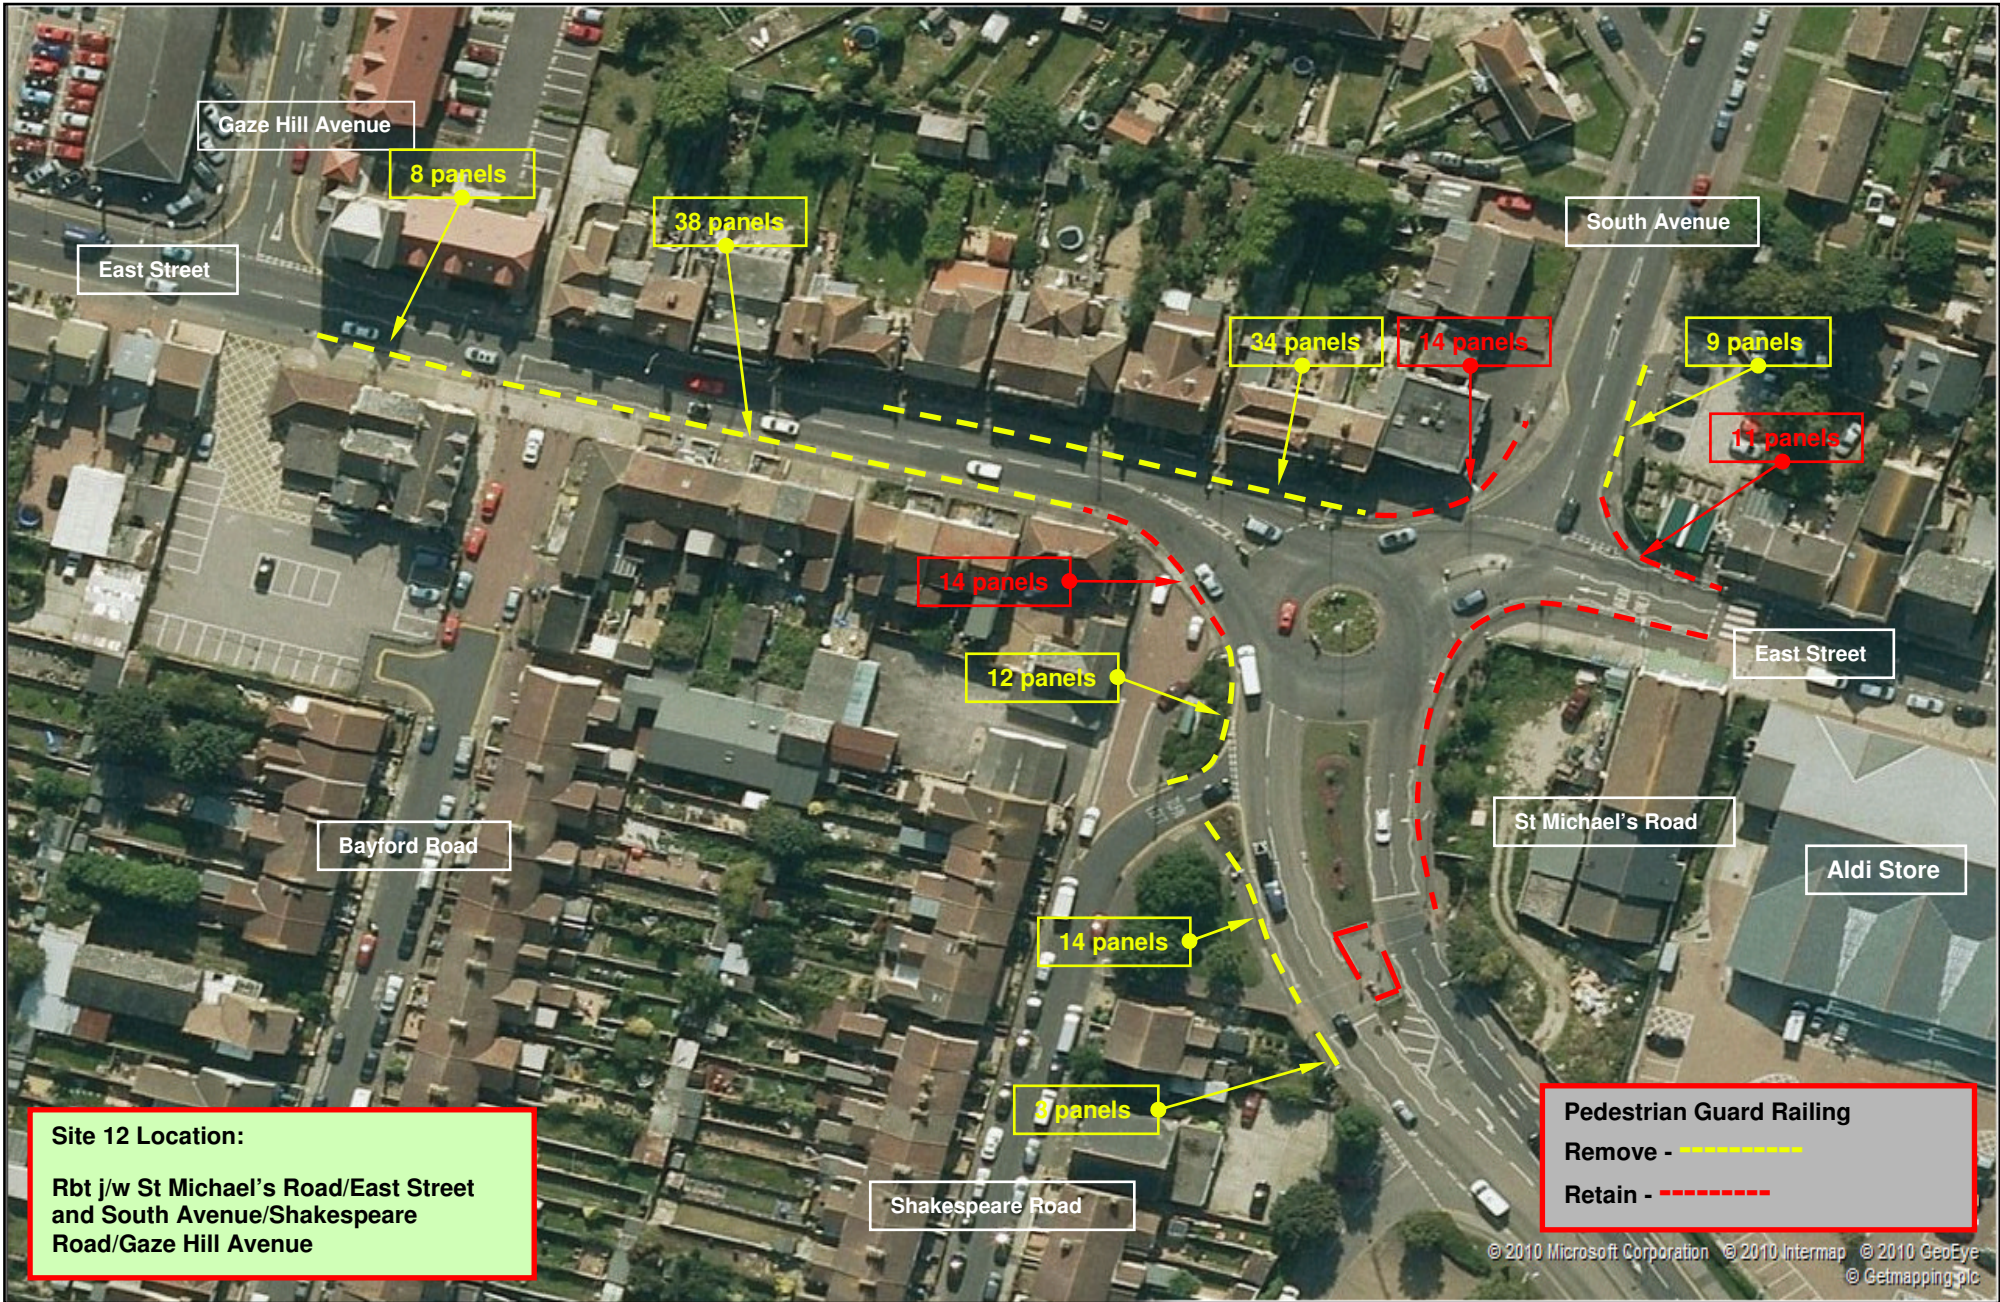
Illustrated Diagram of site 12

Site 12 is located from the roundabout junction of St Michael's Road/East Street and Shakespeare Road/South Avenue to adjacent to the 'Cherry Tree' public house at the junction of Gaze Hill Avenue.

- a) concern over removal due to proximity of schools.
- b) South Avenue – dropped kerbs with tactile paving will need re-locating for any new desire line.

The site is located mainly in a residential area with an Aldi store and some retail business outlets on the north eastern side.

The site has a high volume of vehicular traffic and moderate pedestrian use.

The site has two types of pedestrian guard railings installed, 'key clamp fencing' which are in poor condition and the 'see through' type.

The pedestrian guard railings assessed for removal offer little benefit as the guide or protective device.

- a) the site has been reassessed. 14 panels are to be retained around the corner of East Street into South Avenue as there is the possibility of fast moving vehicles may cause a problem with overrun. The panels are to be retained on each side of the roundabout. The panels on East Street total around 100m – it is unusual to have this amount.
- b) pedestrian desire lines will need to be monitored and a case made.

- **It is recommended to partially remove the pedestrian guard railings at site 12.**
