## **Sittingbourne Adult Education Centre, Sittingbourne**

**On behalf of:** Frankham Consultancy Group

**Date:** October 2020

**Cogent Heritage Ref:** 0151

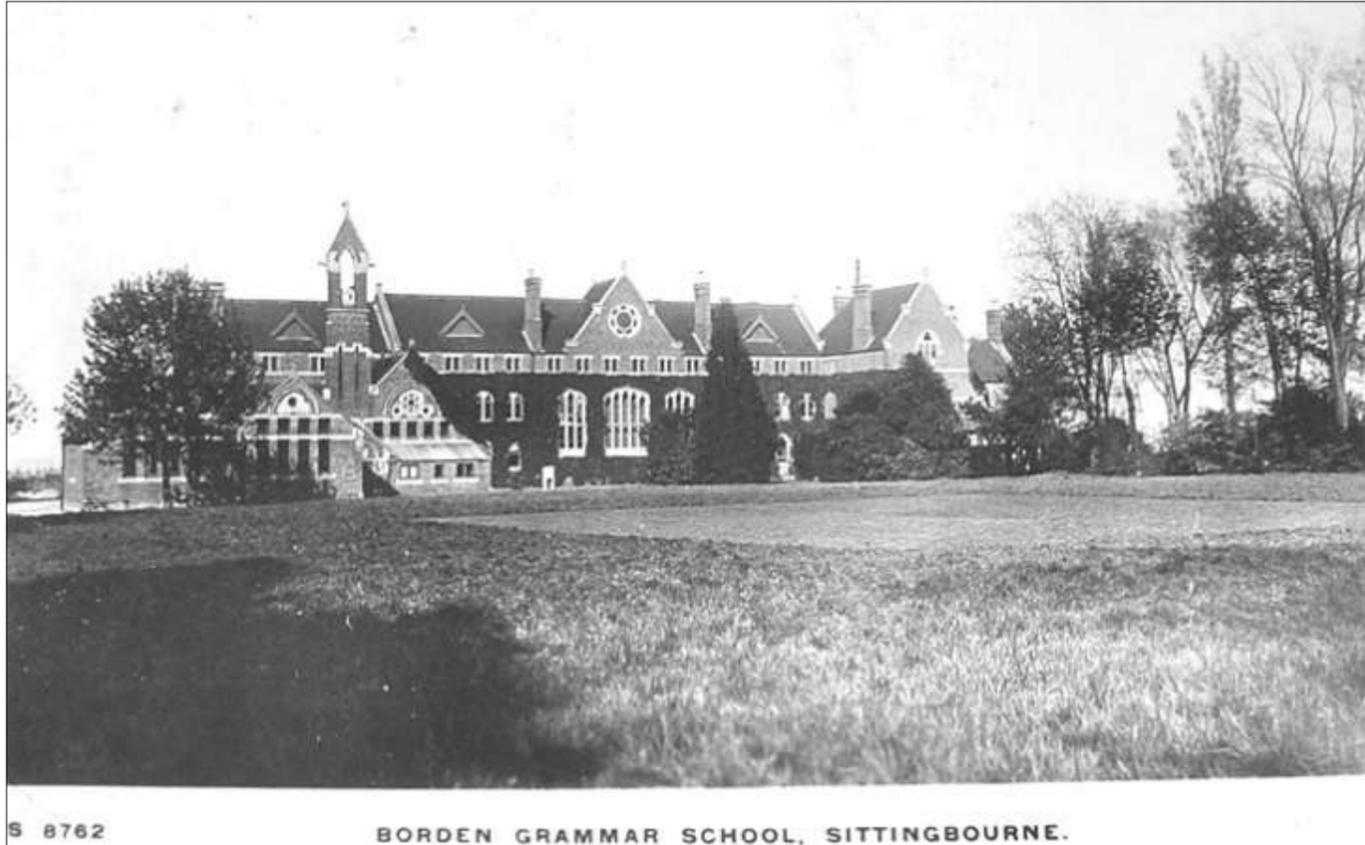
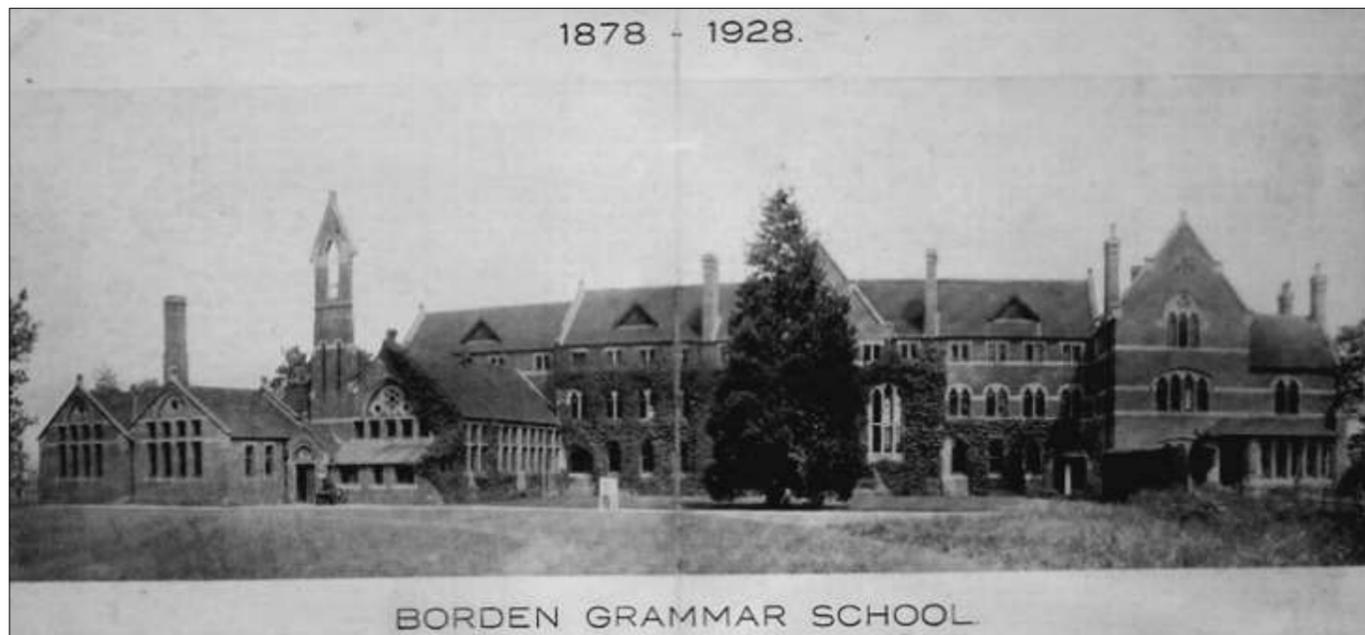
**Figure 9:** A undated, early 20th century photo of the school.

**Figure 10:** The school, c. 1928.

- Neither of the other two images of the school (one undated and the other in commemoration of the school's 50-year tenure in 1928) at **Figures 9 & 10** show notable changes, and they both show the striking tall bell tower, which acted as something of a counterfoil to the headmaster's house.

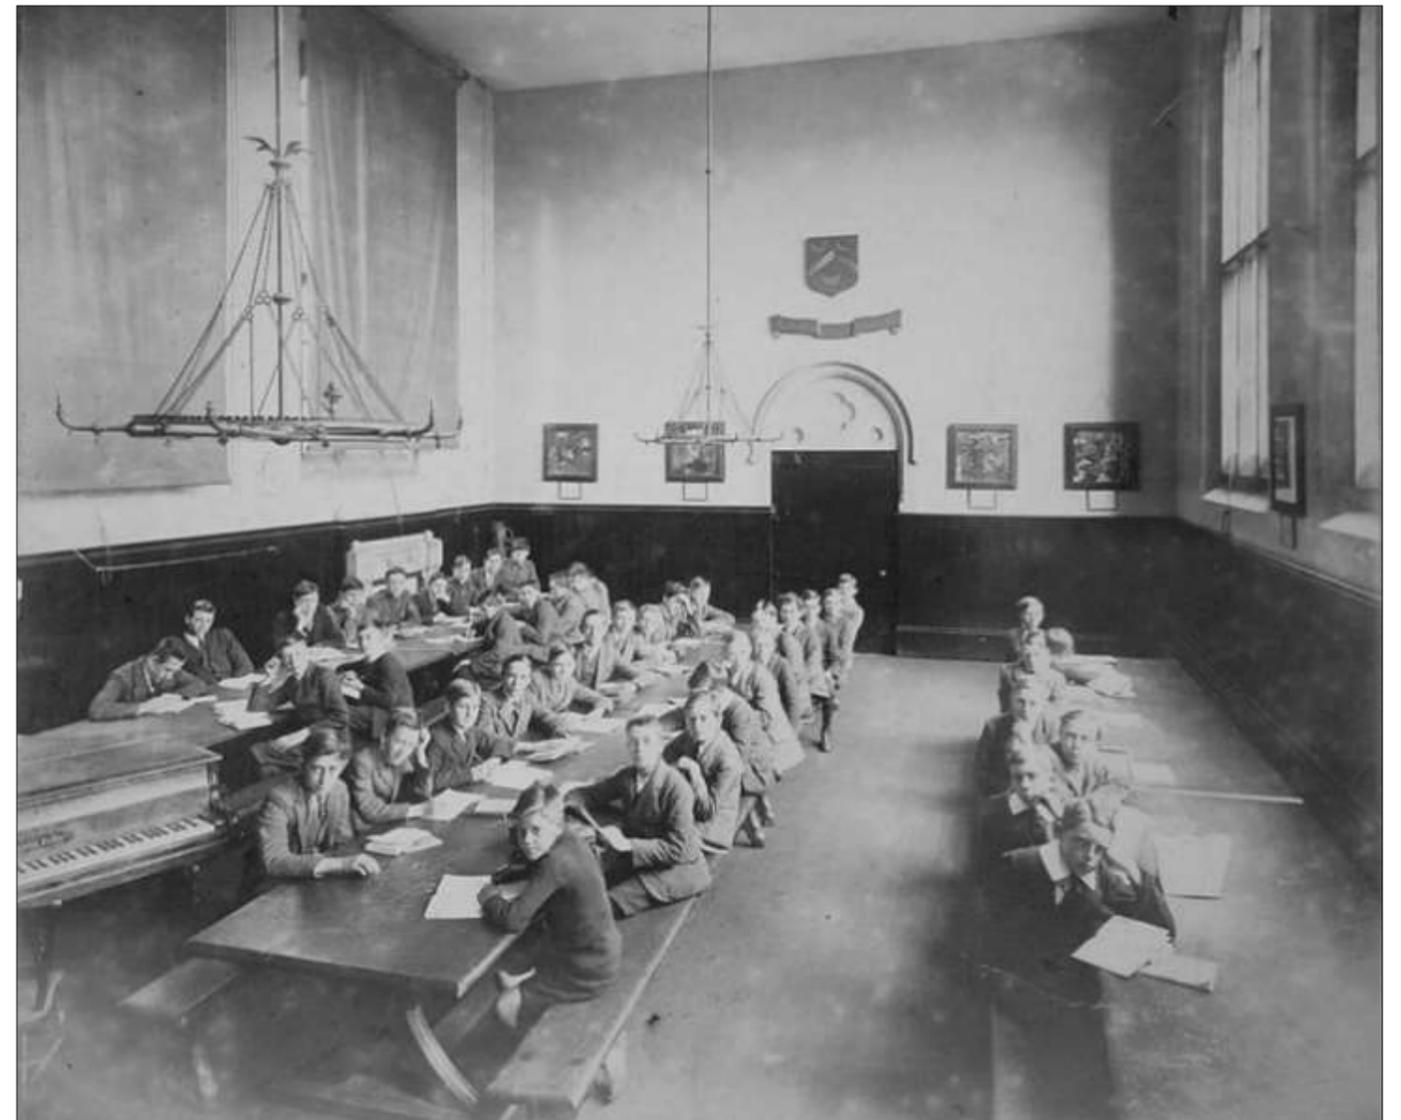
- An undated photo, which must have been taken during the school's tenure, judging from the piano and the pupils, shows the hall as a sparsely decorated space with only the dado panelling and one of the chimneypieces, in addition to the wall-mounted crest and framed images on the NW wall. Two large chandeliers lit the room. There was a hood with plate tracery above the door at the NW end of the hall. It is notable that the windows to both sides of the hall were of the same proportions, with equal sill heights to both sides of the room, something that was lost when the present-day infill rear extension was added.

**Figure 11:** A undated photo of the hall.

29. The modern infill structure has overlapped the hall windows, as can be seen from the photo of the hall at **Figure 11**. It has an unsightly flat felt roof with roof lights and vents (**Photo 5**). The extent of alteration to the building is more apparent at the rear elevation than the front, where the original windows have almost all been replaced (aside from the remnant hall windows and the first floor windows to the service wing), chimneystacks have been truncated and former windows have been blocked (**Photo 6**). The elevation is also disfigured by clutter and addresses a vast, unsightly tarmac car parking area.

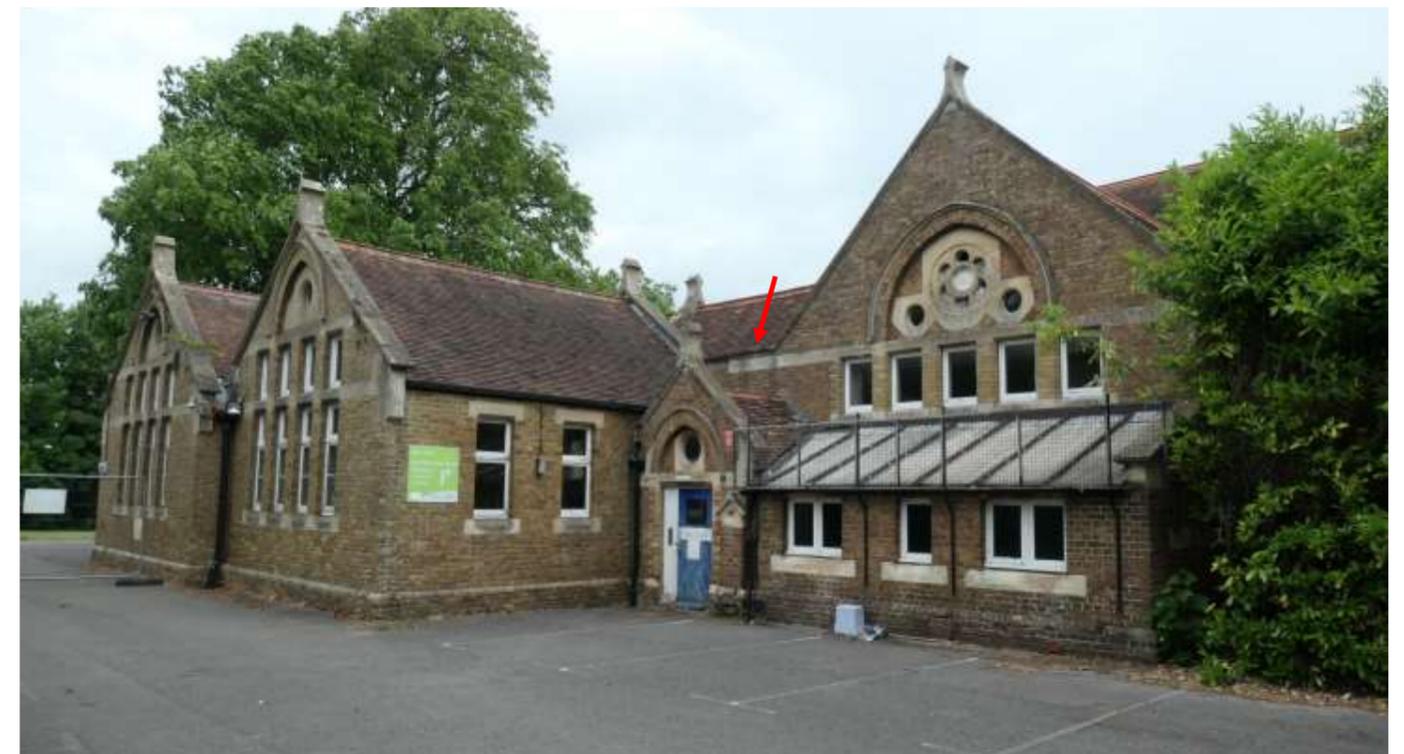
**Photo 1:** The single storey staggered school room ranges, including the NW extension. The red arrow shows the location of the former bell tower.

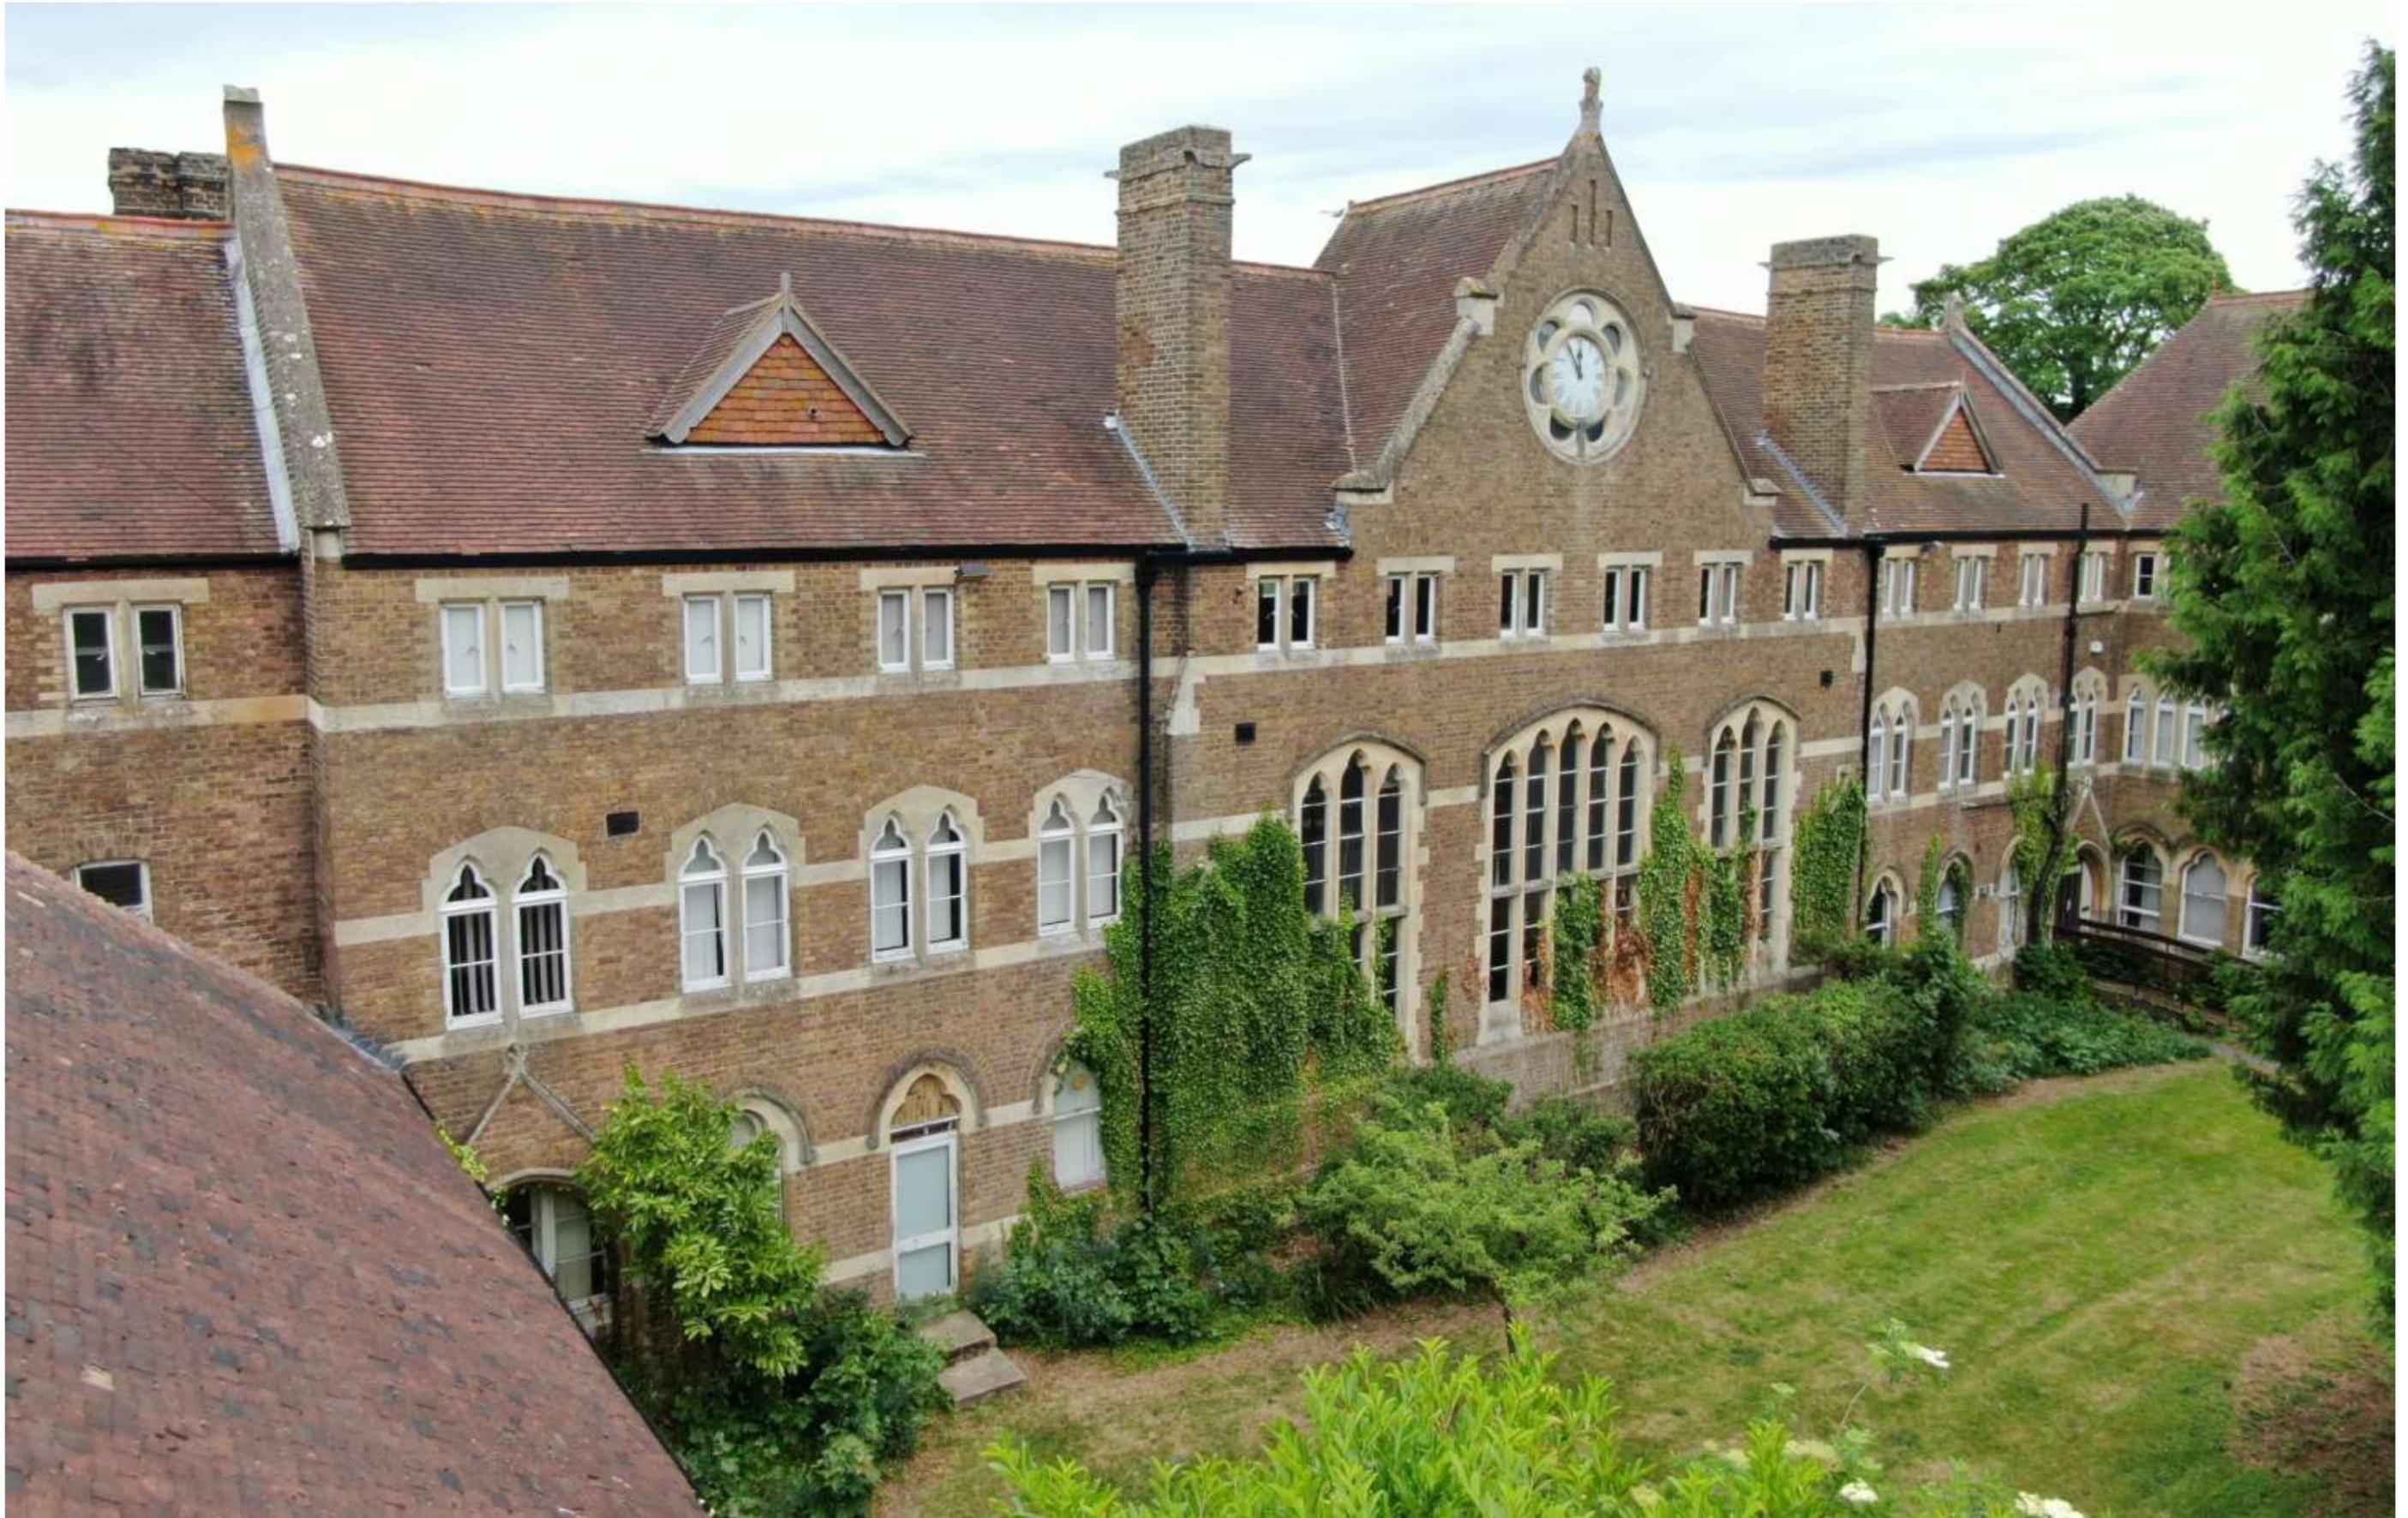
**Photo 2:** A drone photo of the main (SW) frontage of the hall and flanking wings, from the west.

28. The back of the school (**Photo 2**) is subservient to the front, but nevertheless shows self-conscious design and formal composition in the symmetry of the hall and the flanking cross-wings. However, the symmetry then disappears beyond the cross-wings, on the north side of which is the heavily altered single storey toilet block (**Photo 6**) with classrooms above, where former window openings have been blocked. On the south side is the more domestically proportioned service wing. The single storey 'infill' structure between the cross-wings and abutting the halls is modern, although the Ordnance Survey maps show historically there would have been a structure in this location, perhaps classrooms.

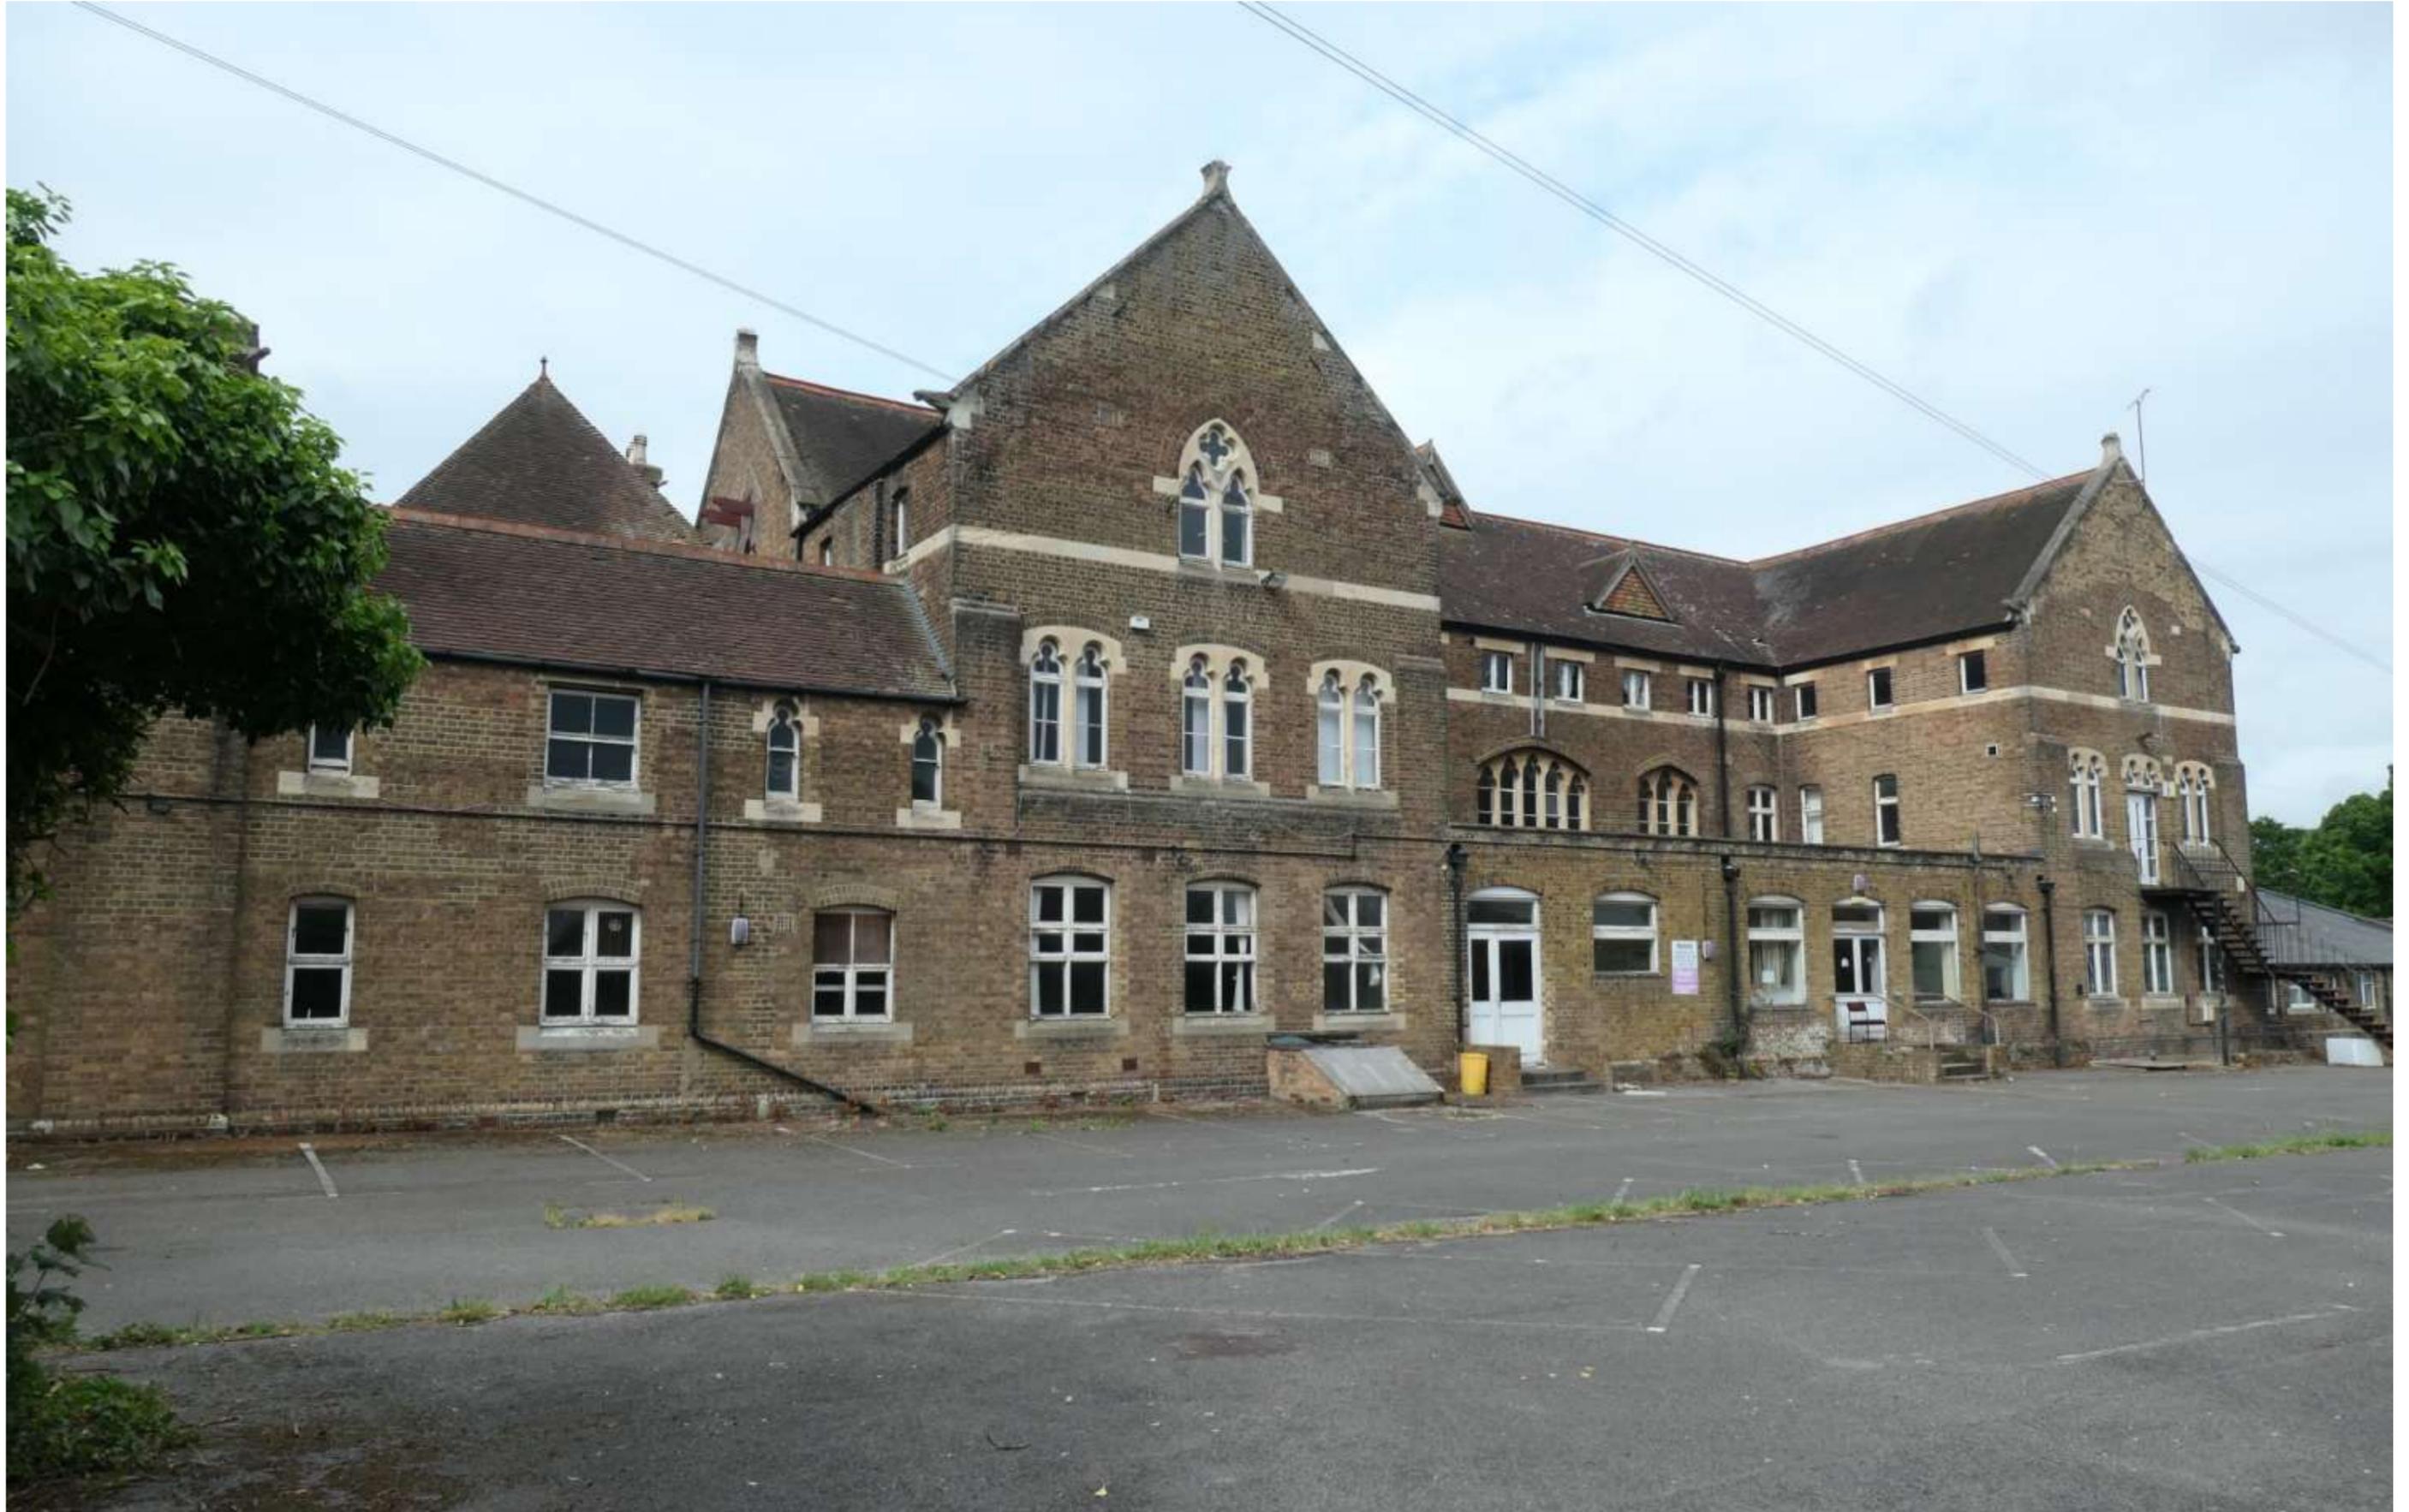
Photo 3: The rear elevation, from the east.

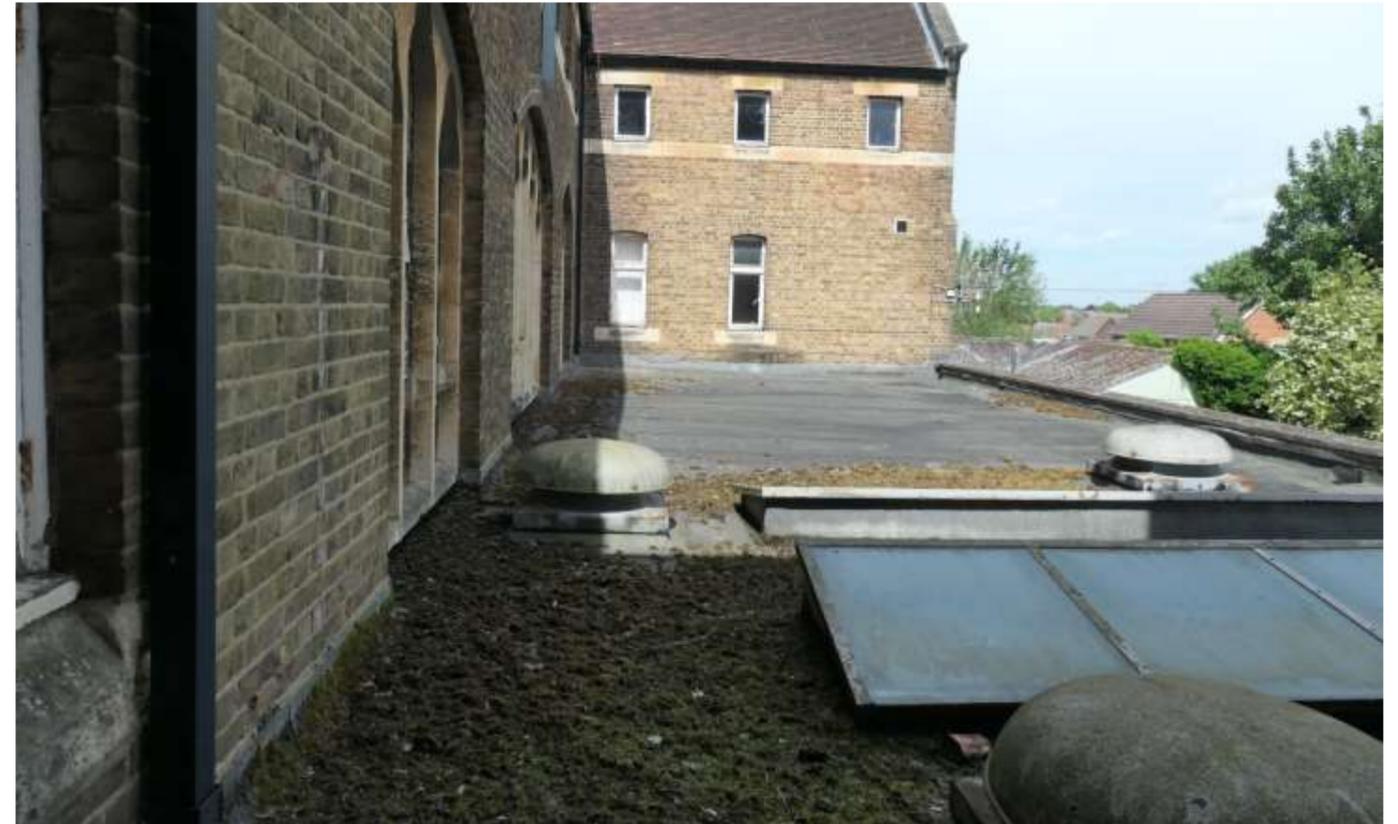
**Photo 5:** The roof of the rear infill extension.

- ### The proposed external changes
69. The proposed external changes, aside from repairs already mentioned, are relatively limited. The clutter, such as the large steel fire escape staircase at the back of the building, and the walkway connecting with the modern structures, will be removed. The poor quality modern infill extension would be replaced with a better quality one that is glazed and set back from the cross-wings, better articulating this as a modern structure and revealing the Victorian form of the building. A green roof to this structure is proposed, and this would be an additional enhancement, compared with the present felt roof (see **Photo 5** on page 13).

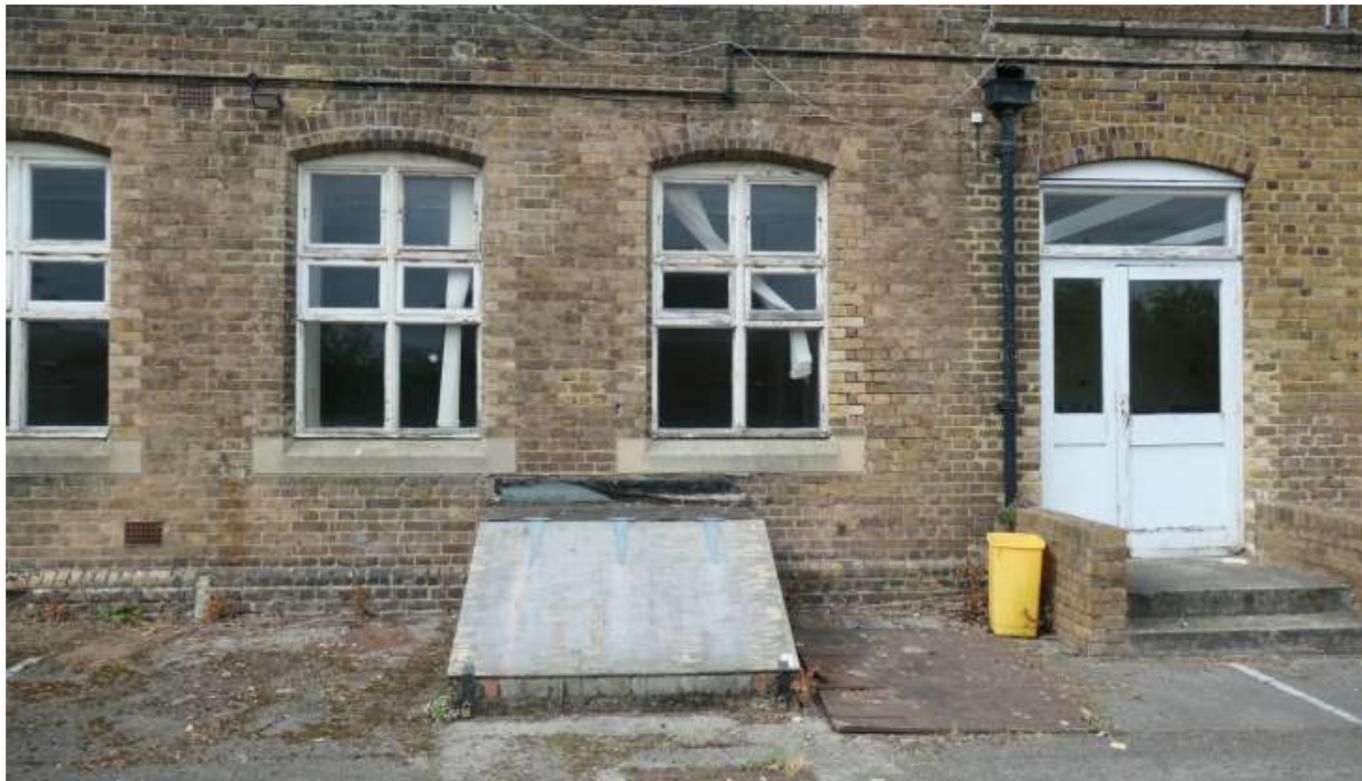
**Photo 4:** A detail of the rear elevation showing the non-original windows and the infill extension (on the right) as well as the tarmac car park and the clutter to the elevation.

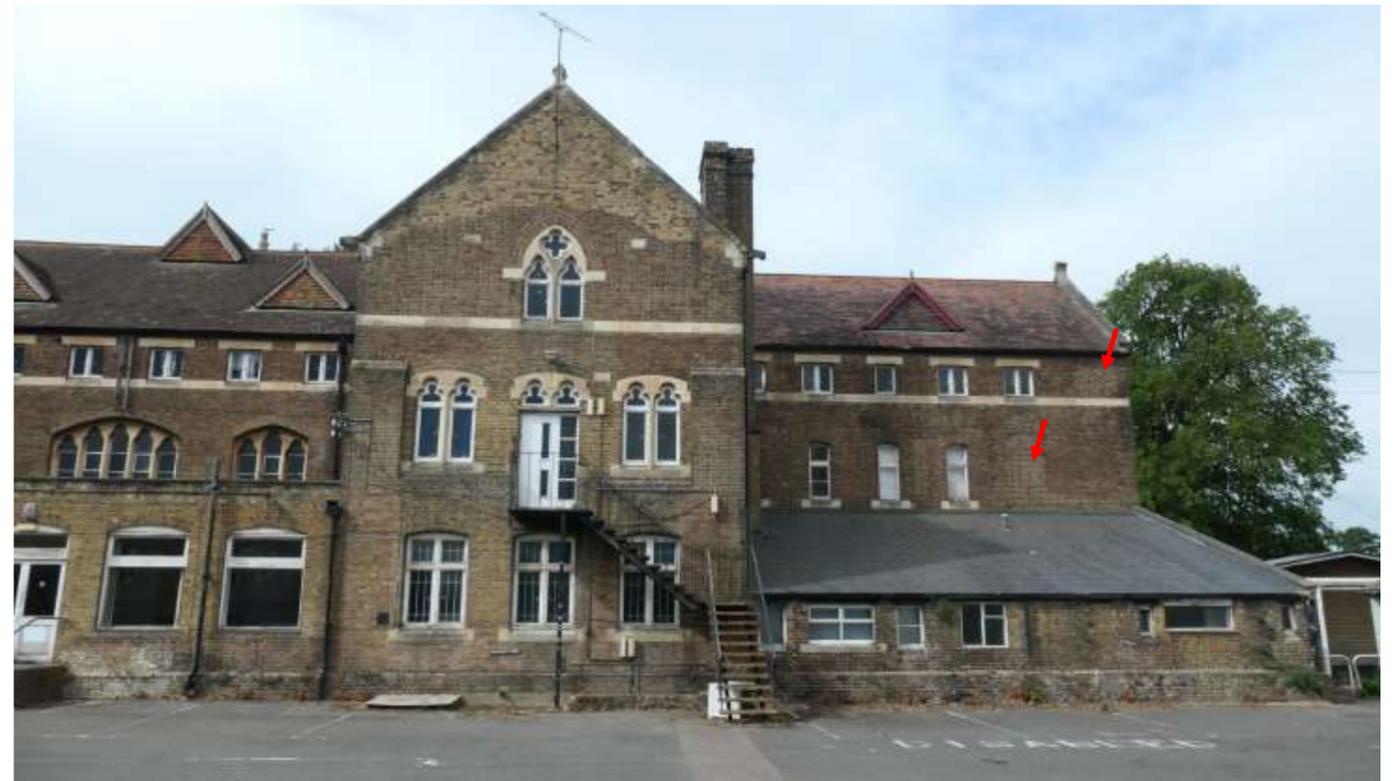
**Photo 6:** The northern part of the rear elevation showing the clutter to the elevation and the heavily altered single storey lean-to. The red arrows show blocked windows.

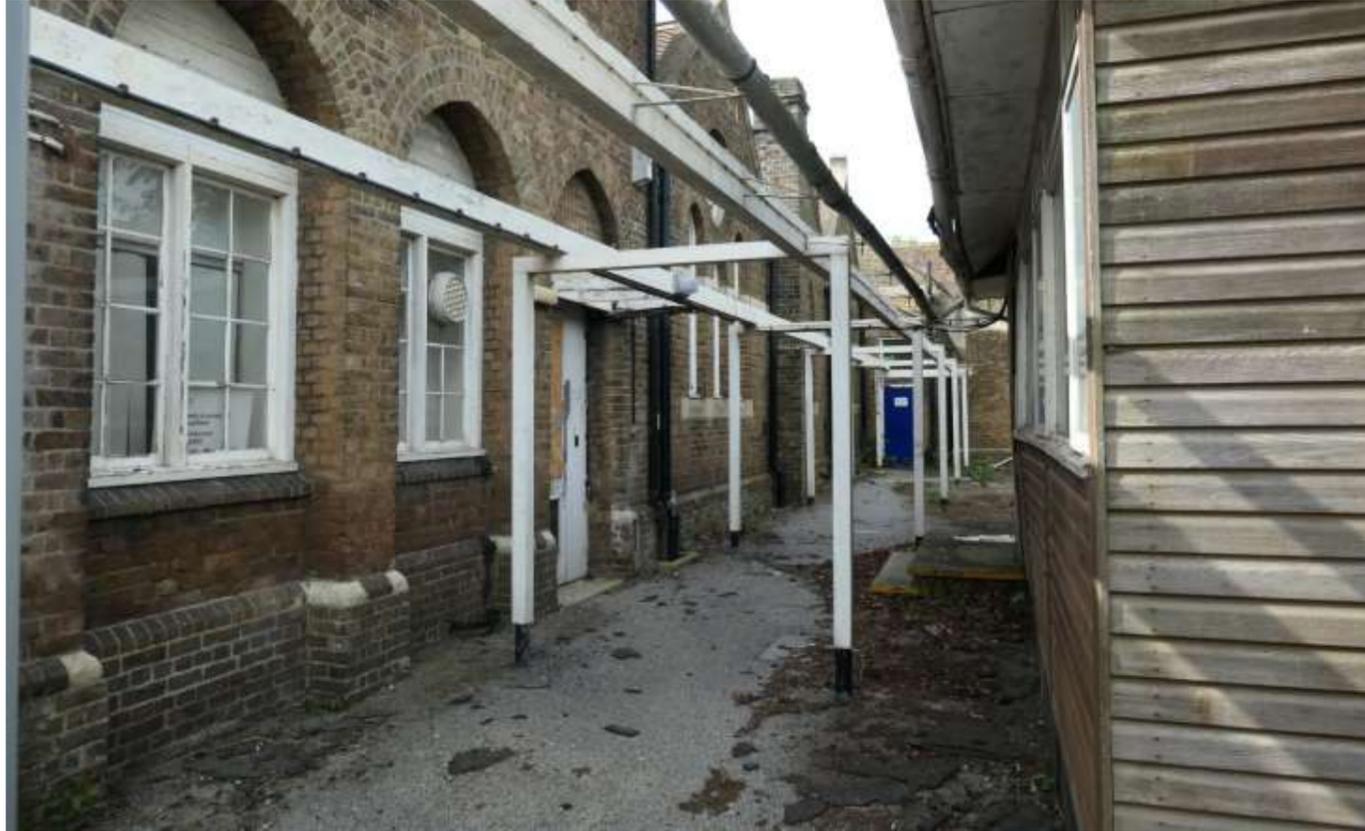
**Photo 7:** The covered walkway frame, attached to the NW elevation.

30. A covered walkway frame, together with the modern modular units that it linked to, largely obscure the building's NW elevation (**Photo 7**), where the windows are replacements, as is common across most of the building (with only a very few exceptions). The elevation here has not been modified to a great extent, except for the unsympathetic insertion of a doorway at the end of the covered walkway (**Photo 7**).

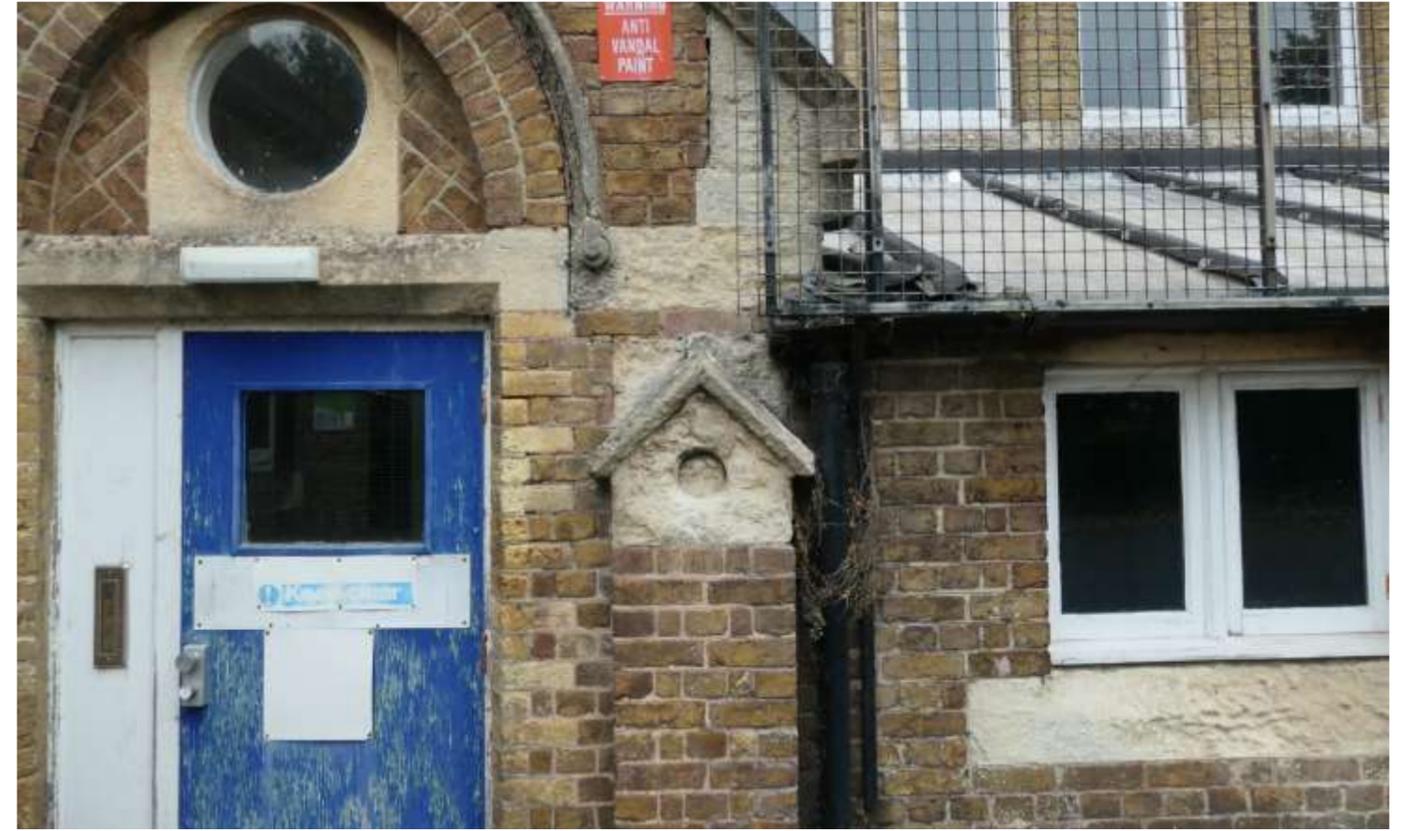
**Photo 8:** Detail of the former main entrance at the single storey staggered school room ranges.

31. The façade of the main entrance at the single storey classroom range is disfigured by modern clutter and the stonework here has degraded noticeably (**Photo 8**). With the bell tower now gone, this no longer reads as a main entrance.

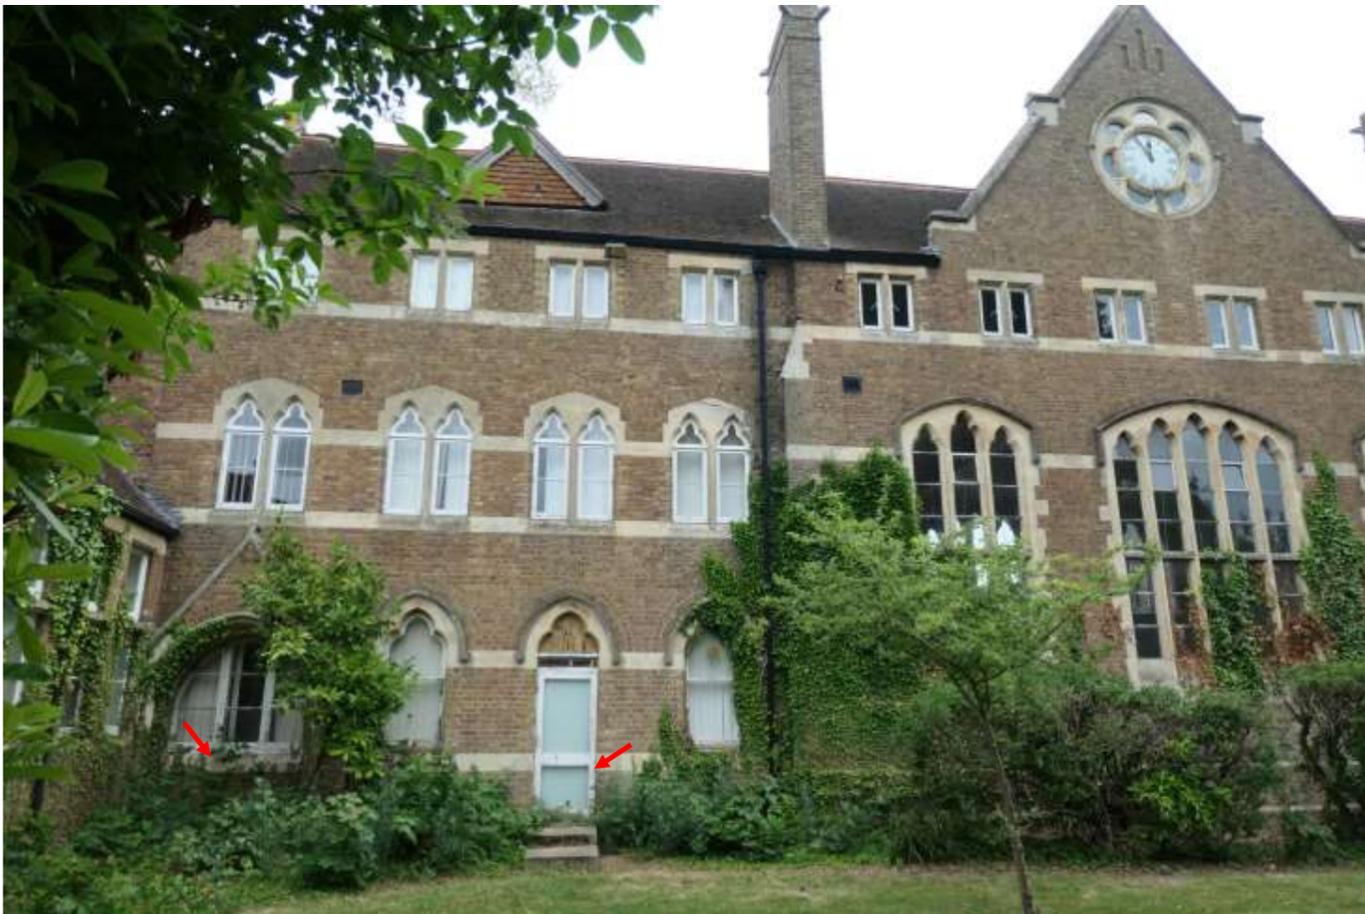
**Photo 9:** Modified openings to the façade of the main frontage, adjacent to the hall.

32. The façade of the main hall and flanking ranges appears largely intact, although a doorway has been created at the northern end, by modifying a former window opening (the right hand red arrow on **Photo 9**). The doorway to the adjacent gabled portal has been blocked (the left hand red arrow on **Photo 9**) and the portal structure is overgrown, affecting the sense of symmetry it would have had with the southern one, which is still an entrance. As elsewhere on the building, the windows are all modern. The only exceptions are the hall windows, which have rudimentary steel frames to the opening lights and glazing bars (the steel shows corrosion damage), but the glass panes are otherwise set directly into the stone and some of these are now coming loose (e.g. **Photo 10**, which shows one of the more accessible rear windows).
