## **Sittingbourne Adult Education Centre, Sittingbourne**

**On behalf of:** Frankham Consultancy Group

**Date:** October 2020

**Cogent Heritage Ref:** 0151

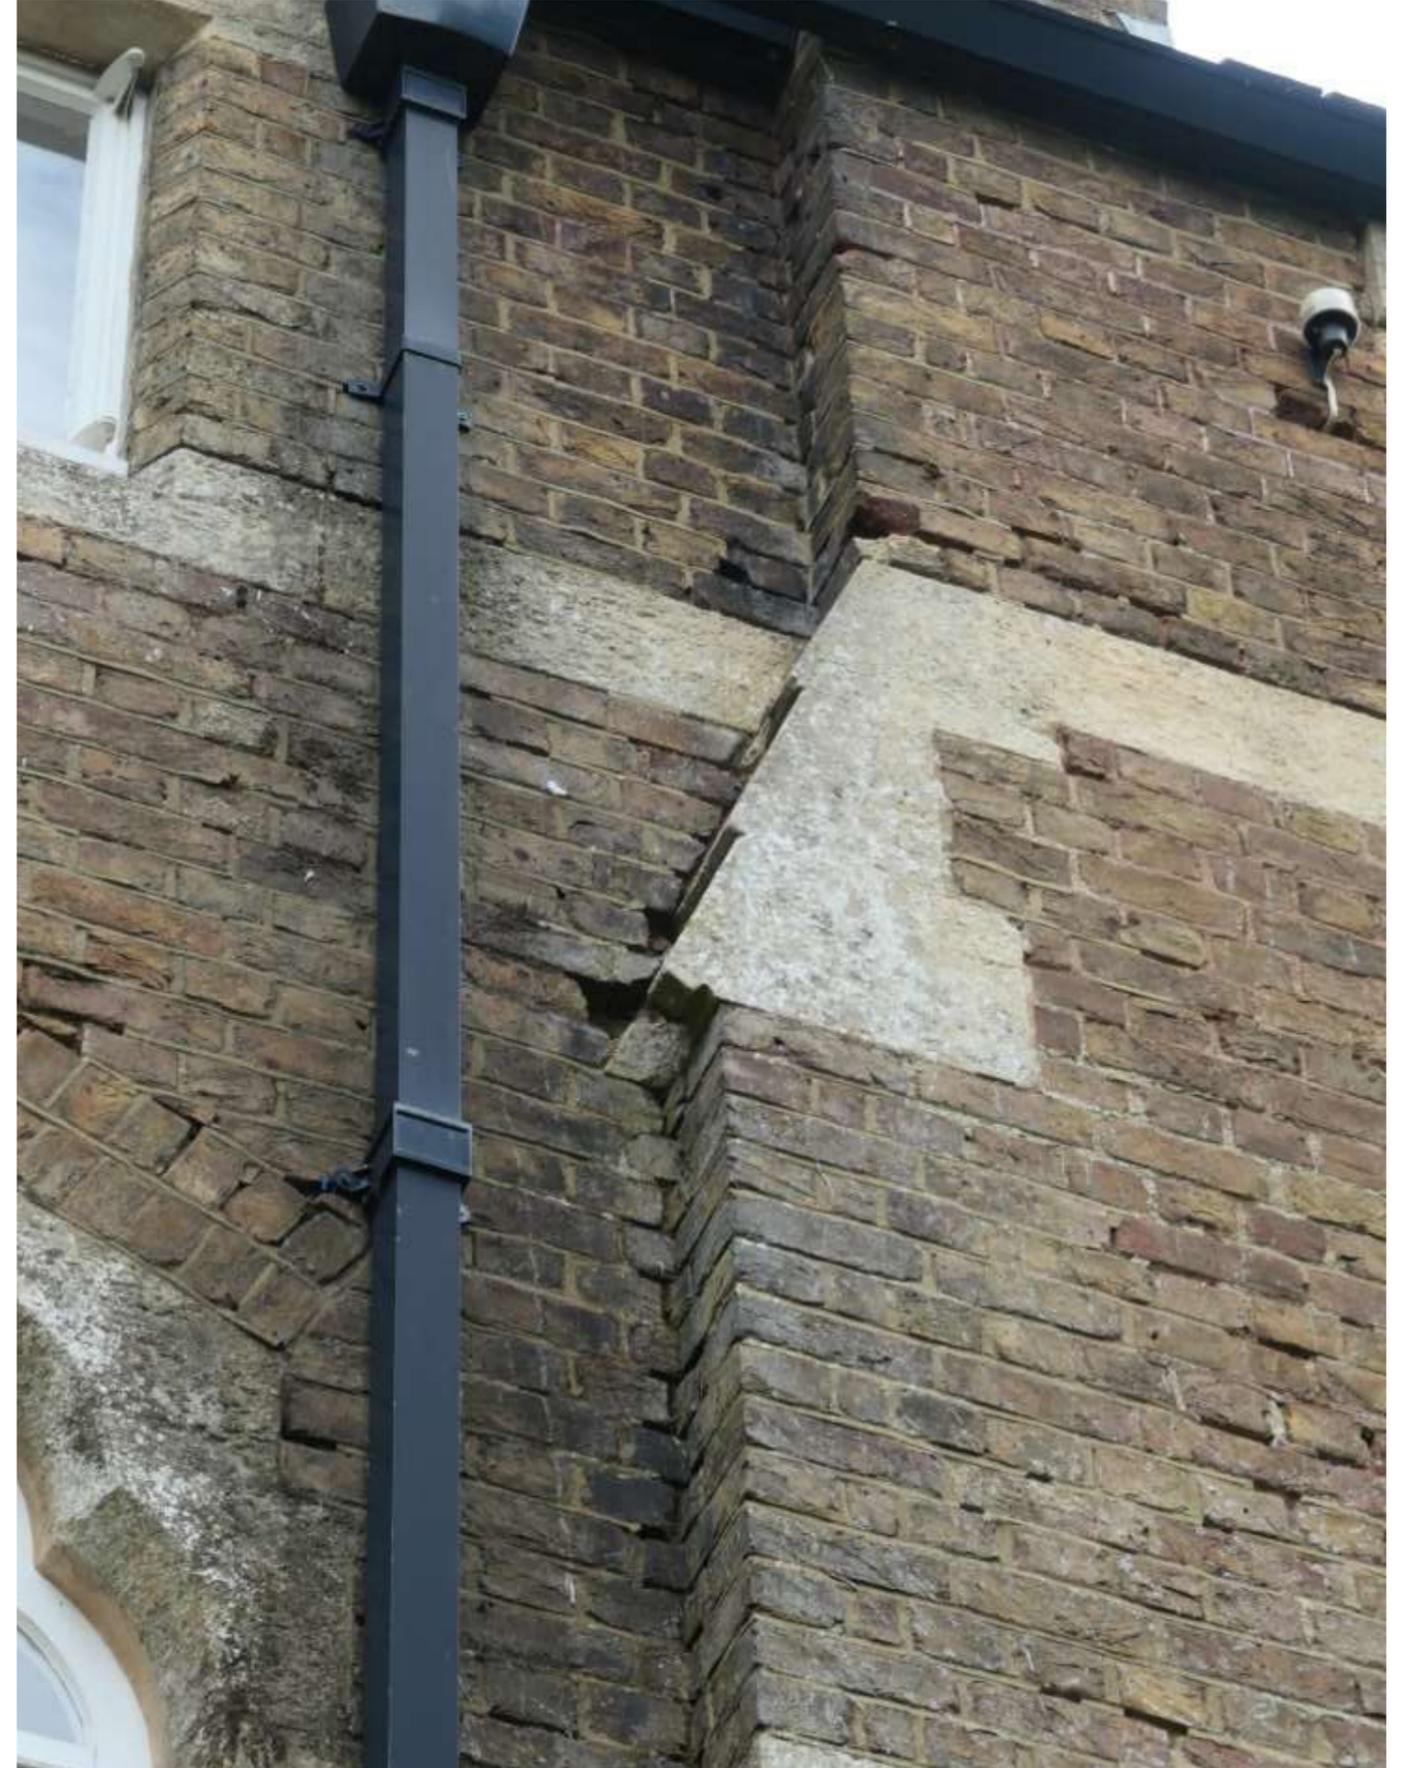
33. Although the elevation is largely unaltered, the roof vents (which would have been timber louvered) have been tiled over, as at the rear, and there are obvious signs of disrepair (**Photo 11**). The original 1878 clock by Gillett and Bland of Croydon is a good feature (**Photo 12**), although the paint on the clock face is showing signs of flaking/degradation and the stonework of the rosette it is set within is now pitted with erosion.

**Photo 11:** Detail of damage to the façade of the main frontage, adjacent to the hall.

74. It would also be possible to reinstate louvres to the roof vents, with scalloped barge boards and finials, as recorded on old photos. It is anticipated that some of the non-original windows would also need to be replaced and, where that is done, the new windows would be sashes to match the original design. Both of these would enhance the significance of the listed building.

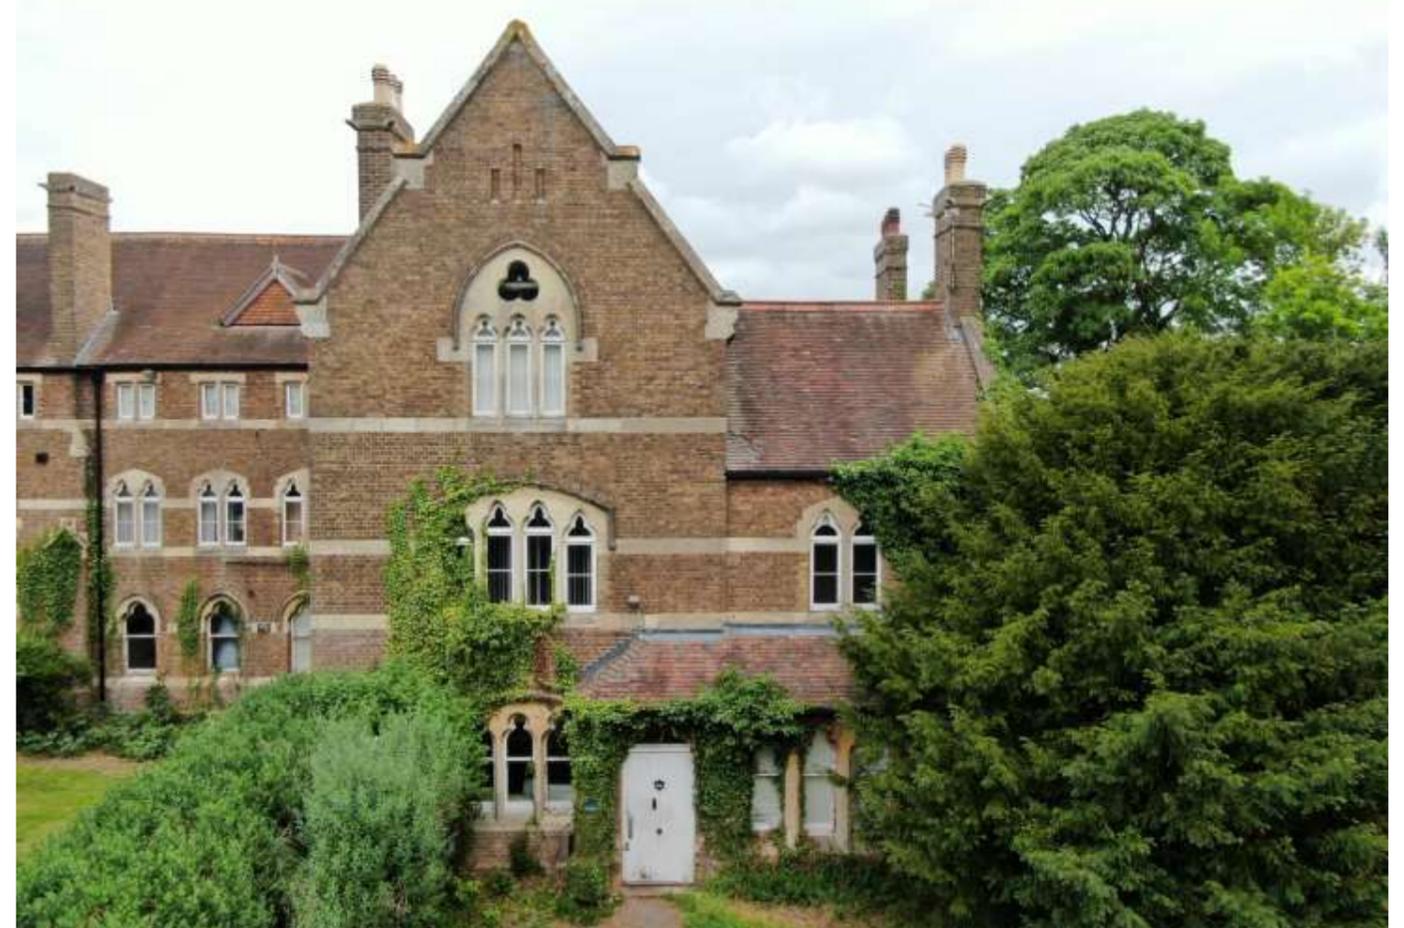
34. The headmaster's house has a pleasing, but more domestic character (**Photo 13**). It sits slightly at odds with the rest of the school, with a 'tacked-on' feel despite the use of matching materials and details. There are some modern replica sashes to the lancet windows at the ground floor of the headmaster's house, instead of the ubiquitous and somewhat clumsy replacement casements seen elsewhere on the building. There is still a section of hedge that separates it from the school, something that has endured from the original configuration.
35. The scar of the little lean-to to the SE of the headmaster's house, which is recorded on the old photo (**Figure 8**), can still be seen as a white 'shadow' on the flank (**Photo 14**) and this appears to have overlapped one of the windows.

**Photo 13:** The façade of the headmaster's house.

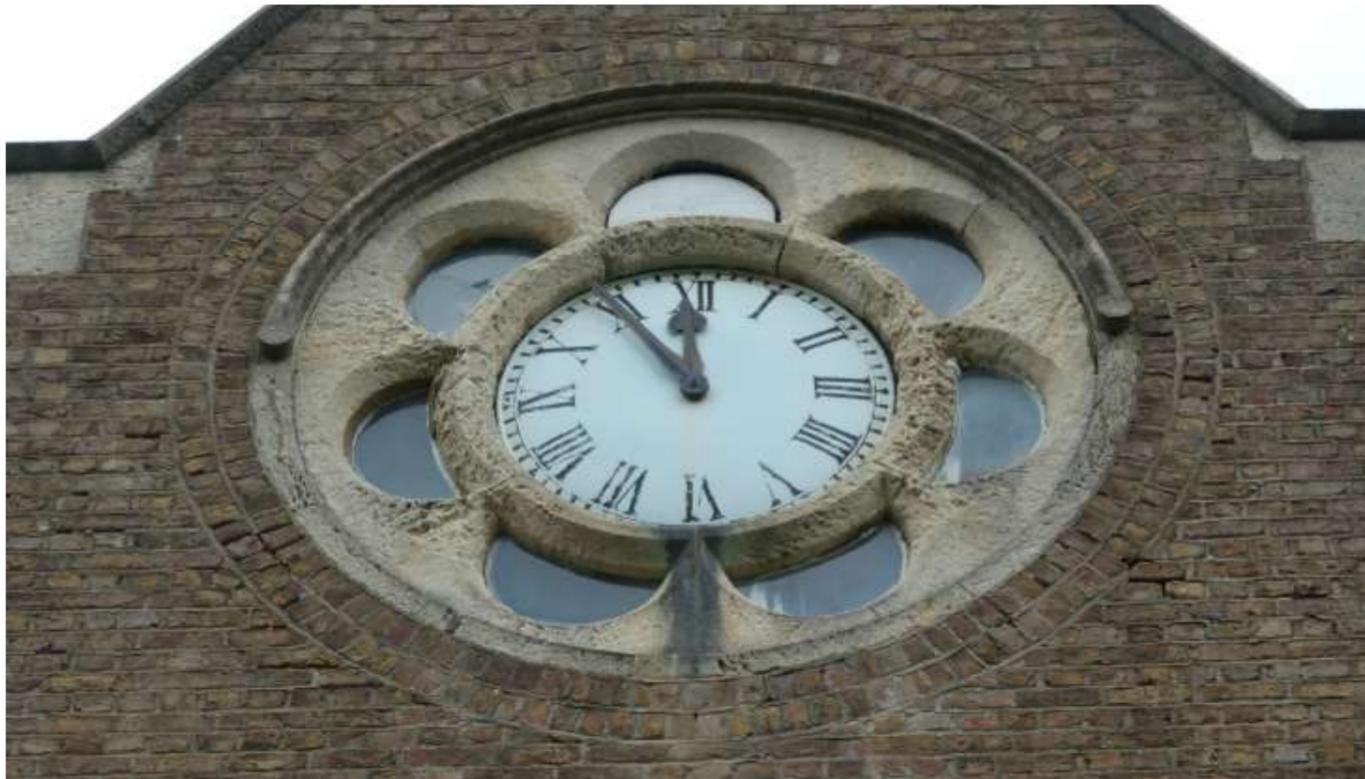
**Photo 12:** Detail of the original clock to the hall gable.

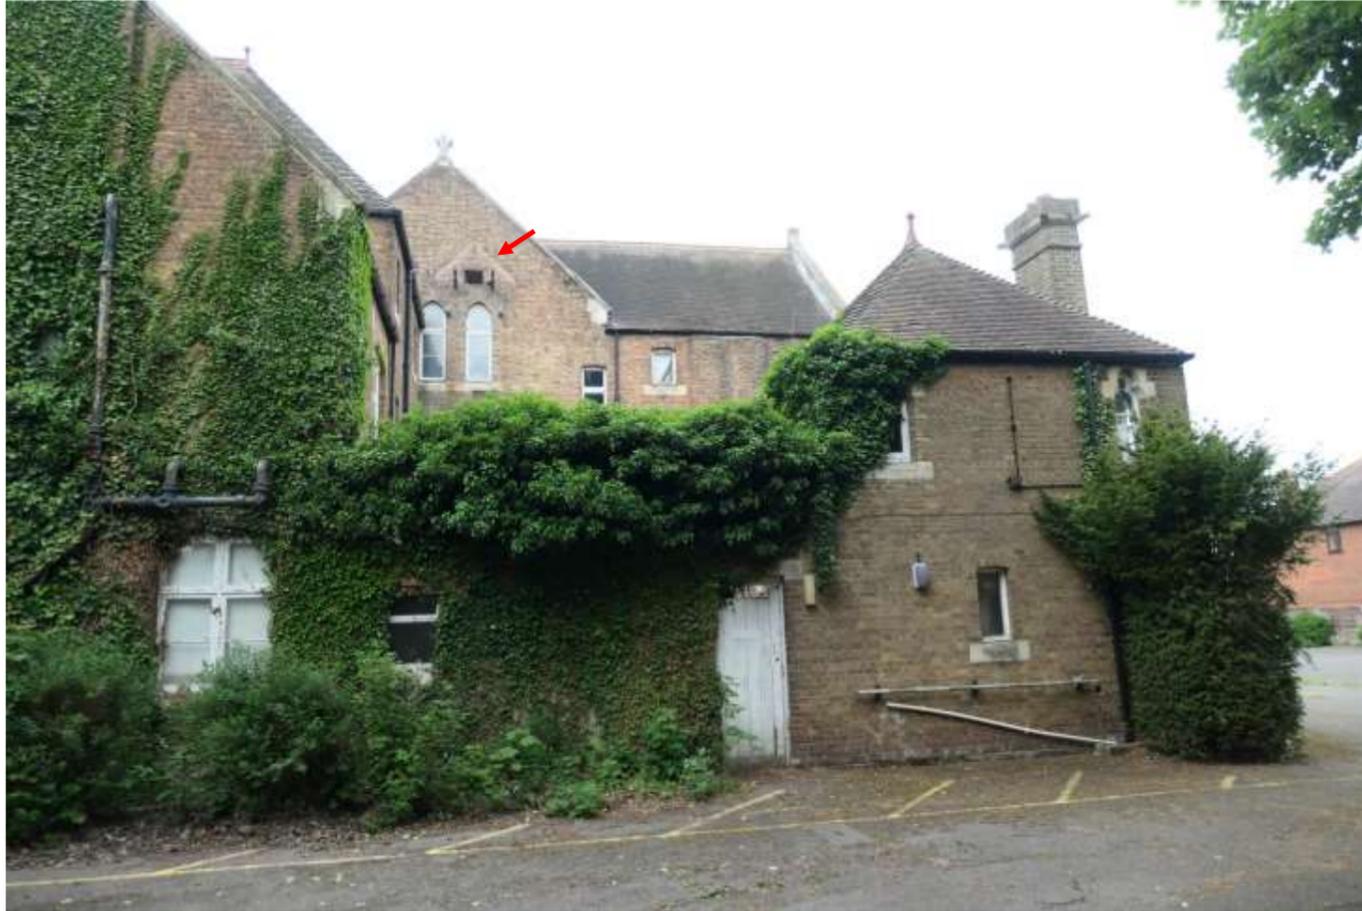
**Photo 15:** The courtyard at the headmaster's house. The red arrow shows the location of the missing rear bell.

36. The service wing of the school is separated from the back of the headmaster's house by a small courtyard, enclosed by a wall (**Photo 15**) and now partially taken up by a modern infill structure (**Photo 16**). The SE elevations of the headmaster's house/service wing are largely plain, enlivened only by the odd window and this subservient part of the building, which also faces a tarmac car parking area, has limited interest. The gable of the school's central range was once fitted with a rear bell (the red arrow on **Photo 15**), the brackets of which are still *in situ*, along with a hole for the ropes, although the canopy is no longer intact—but a clear scar shows its form.

71. The proposed infilling of the courtyard between the headmaster's house and the service wing (**Photo 16** on page 17) would change part of an original arrangement and it is proposed to replace the wall (**Photo 15** on page 17) with glazing.

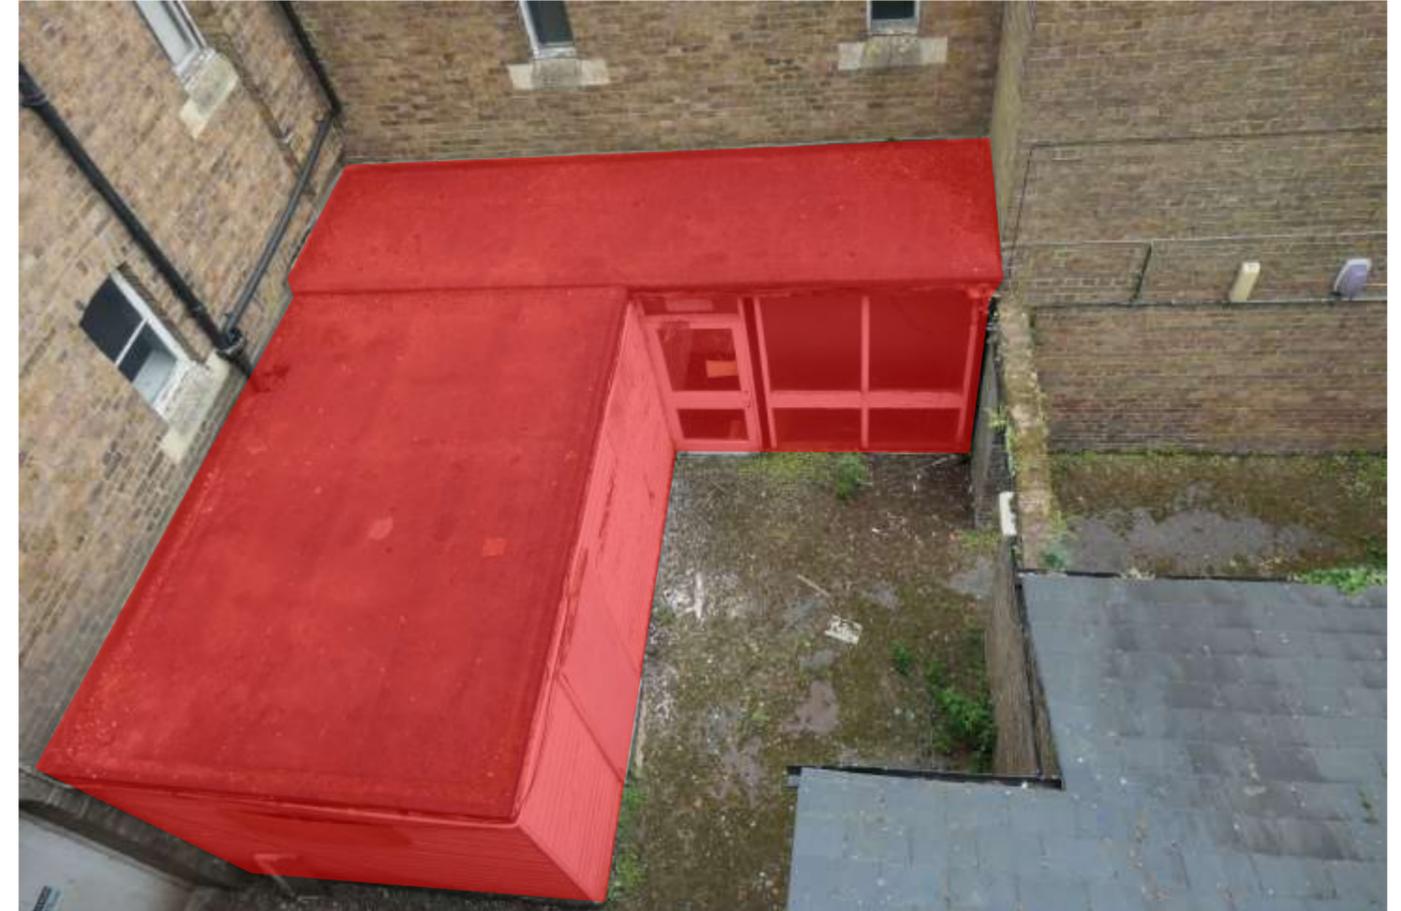
**Photo 16:** The courtyard between the headmaster's house and the service wing, with the modern timber structure highlighted red.

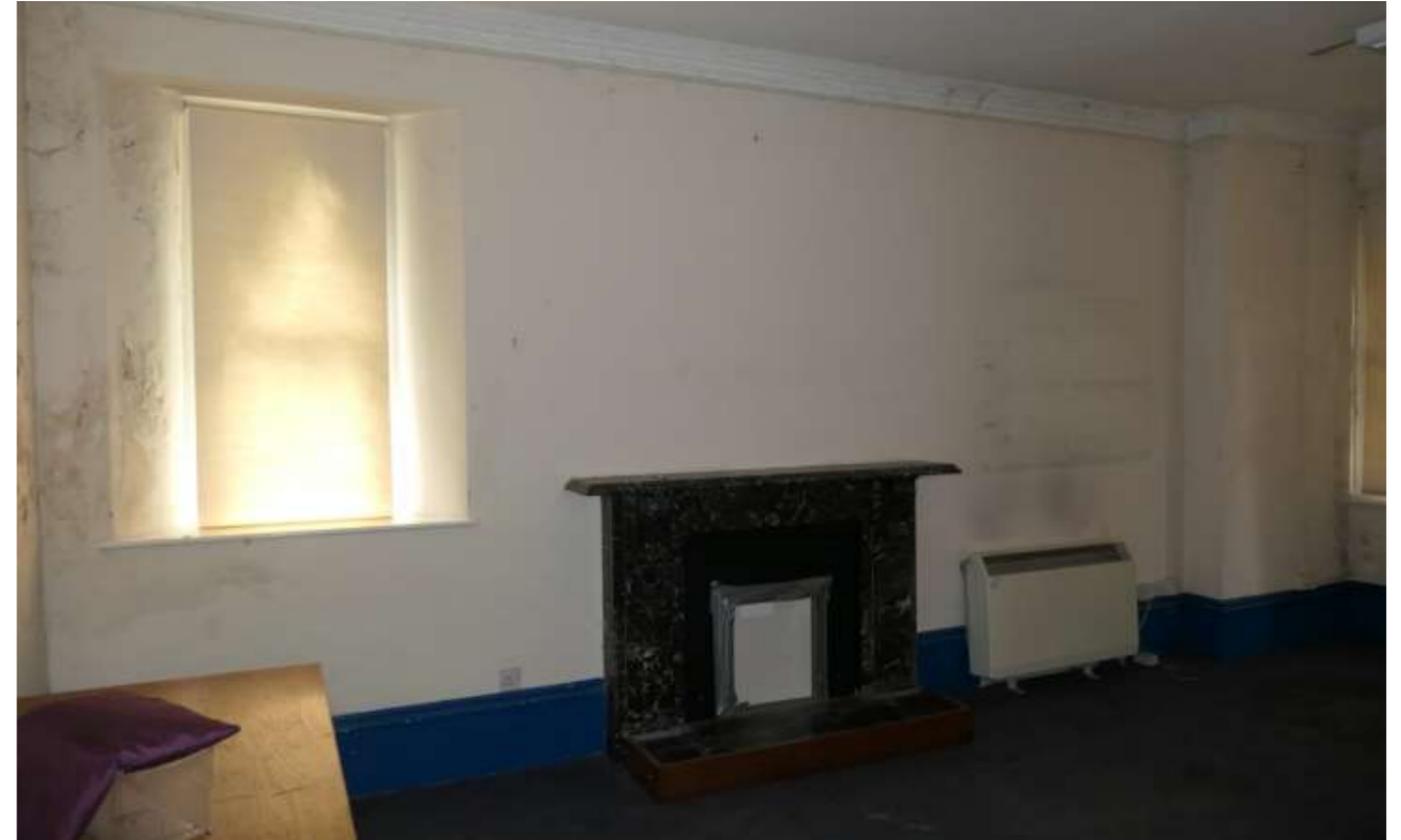
**Photo 18:** The ground floor southern room with black marble chimneypiece in the headmaster's house.

40. **Ground floor:** The rooms at the SW of the headmaster's house, closest to the entrance, contain original corning, skirting and joinery (**Photo 19**), with a black marble chimneypiece to one of the rooms, probably original (**Photo 18**). There is a discernible plan form of rooms accessed off the central passageway; high status rooms at the front and plain ones at the back. The staircase looks to be original, but it is unremarkable.

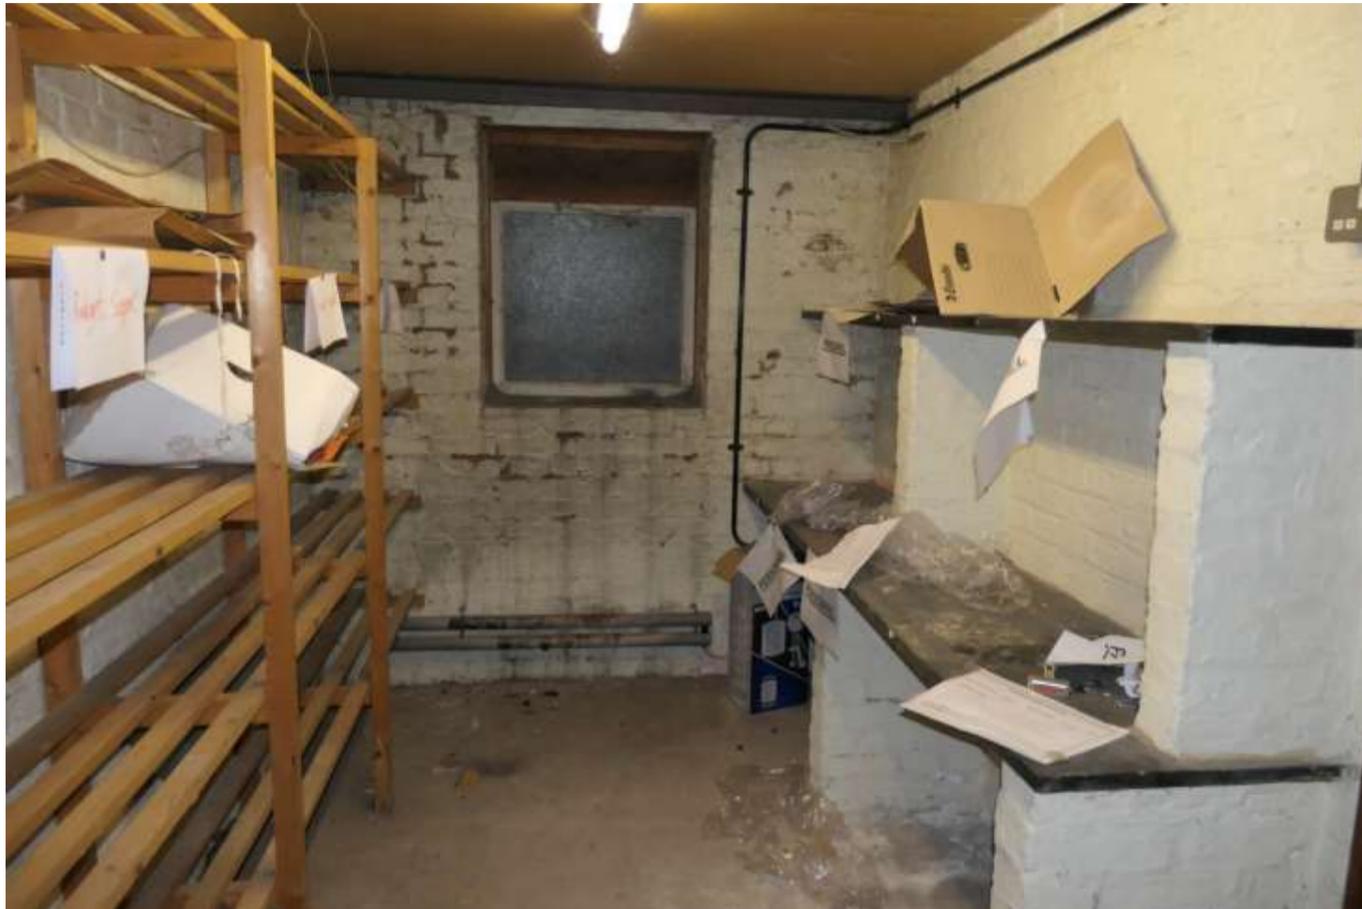
**Photo 17:** The small basement with slate shelves under the headmaster's house.

38. The following section briefly considers the building floor-by-floor, starting with the small basement under the headmaster's house.
39. **Basement:** The small basement under the headmaster's house is reached via a plain staircase. It has exposed brick walls and is unremarkable, save for some slate shelves, typical for the period (**Photo 17**).

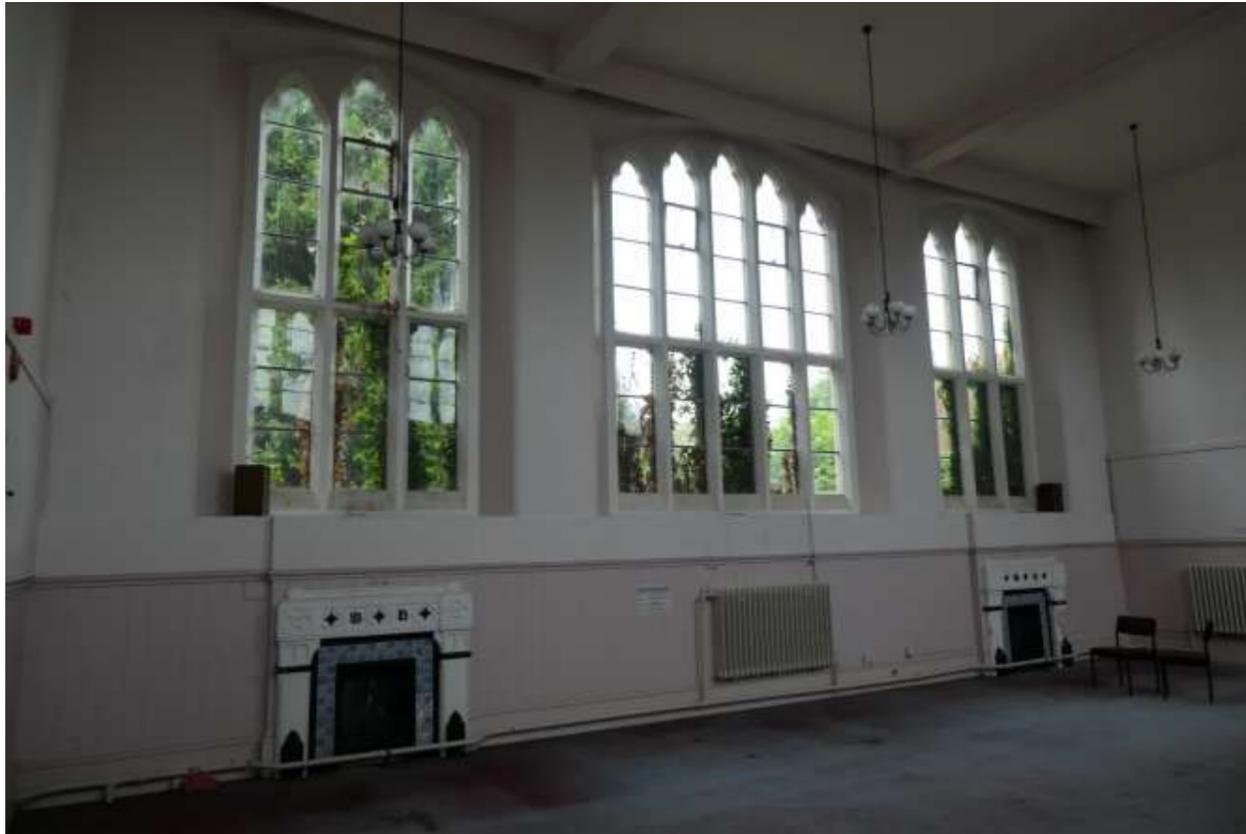
**Photo 20:** The hall, looking towards then front windows.

41. The hall (**Photo 20**) is still an imposing double volume space, but conversely it is rather plain and in some respects bland and disappointing; some schools of this period would have had well-detailed and ornate features to the hall. This one is largely devoid of features, other than the two fairly plain chimneypieces (albeit with pleasing detailing and bearing the initials of the Barrow Trust's founder—**Photo 21**) and the very plain dado panelling of vertical boards. As has been noted, the windows to the rear have been modified by heightening them, no doubt when the rear infill structure was added; this has affected the integrity and authenticity of the space.

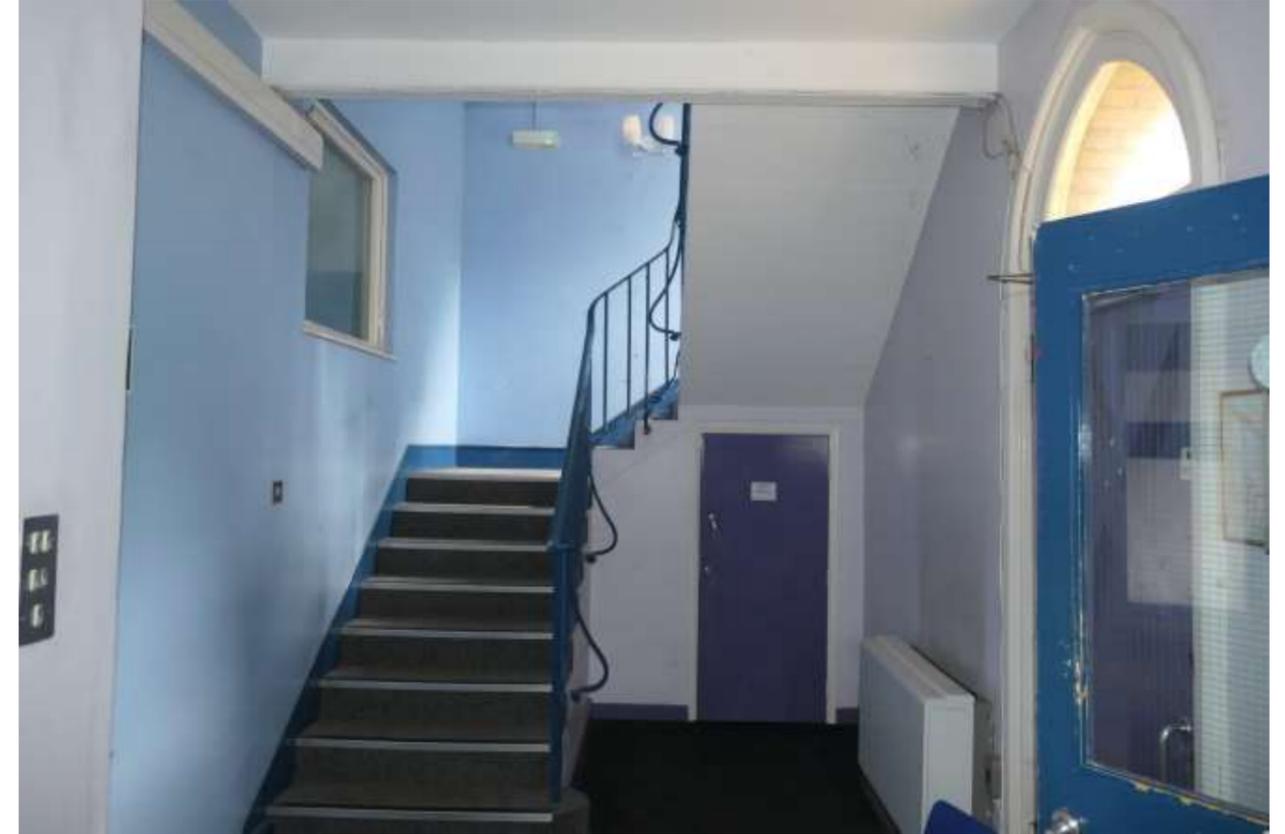
**Photo 24:** The replacement staircase to the south of the hall.

43. There has evidently been changes to the plan to the south of the hall, where the main staircase seems to have been moved. The present staircase is, in any event, non-original and may date from the time of the Kent Farm Institute (**Photo 24**). There is a glazed screen in this area which is also of c. early-mid 20th century date. The northern staircase is original, but unremarkable in the context of Victorian/school stairs (**Photo 25**). Generally the area to the north of the hall has been modernised and changed, with very little (if any) original character or features (**Photos 26 & 27**). The lift has been inserted in this area. Some of the toilet stalls in the lean-to are probably early 20th century in date.

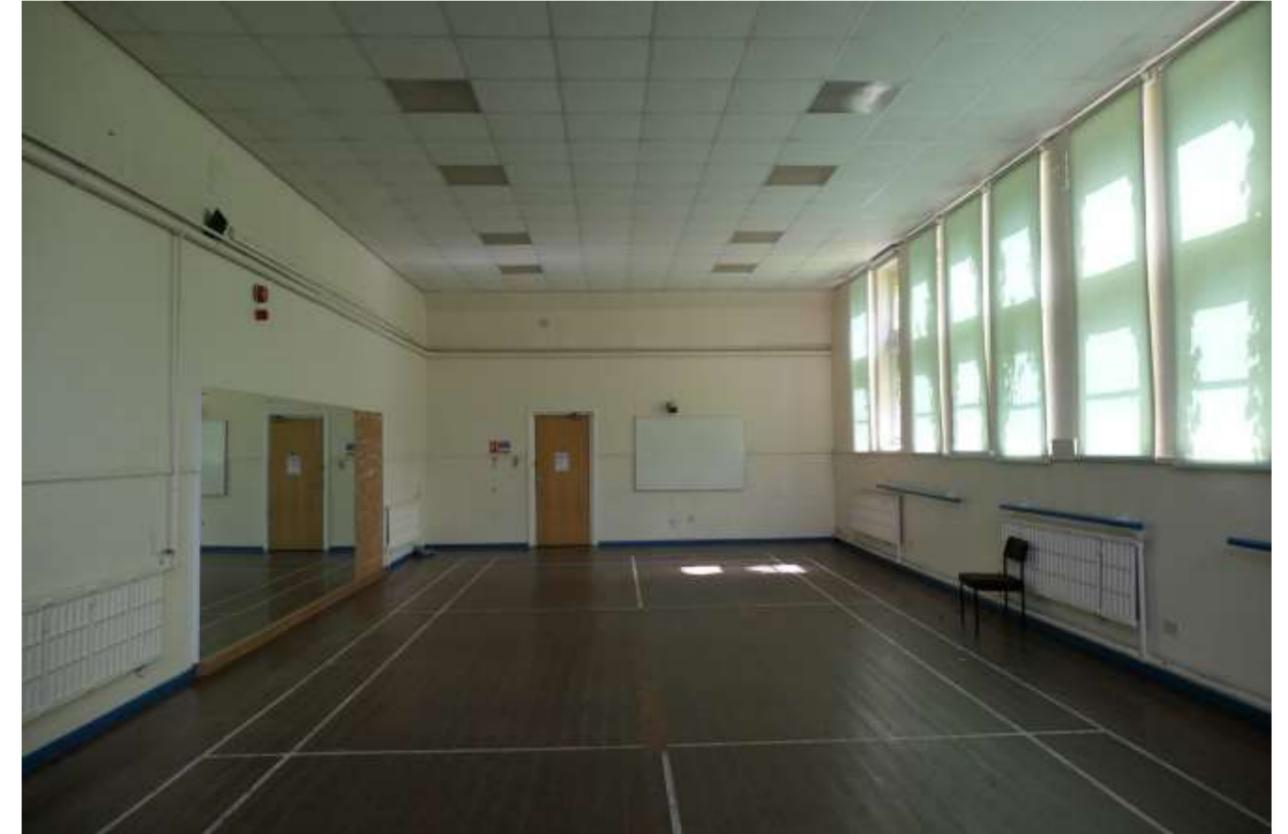
**Photo 28:** The large modern classroom in the classroom range.

44. The classroom range is arranged as two large rooms, with an entrance lobby, circulation space and small ancillary rooms. Again, the character here is modern, with false ceilings etc. (**Photo 28**), and devoid of features of interest. The same can be said of the NW extension in this area (**Photo 29**).

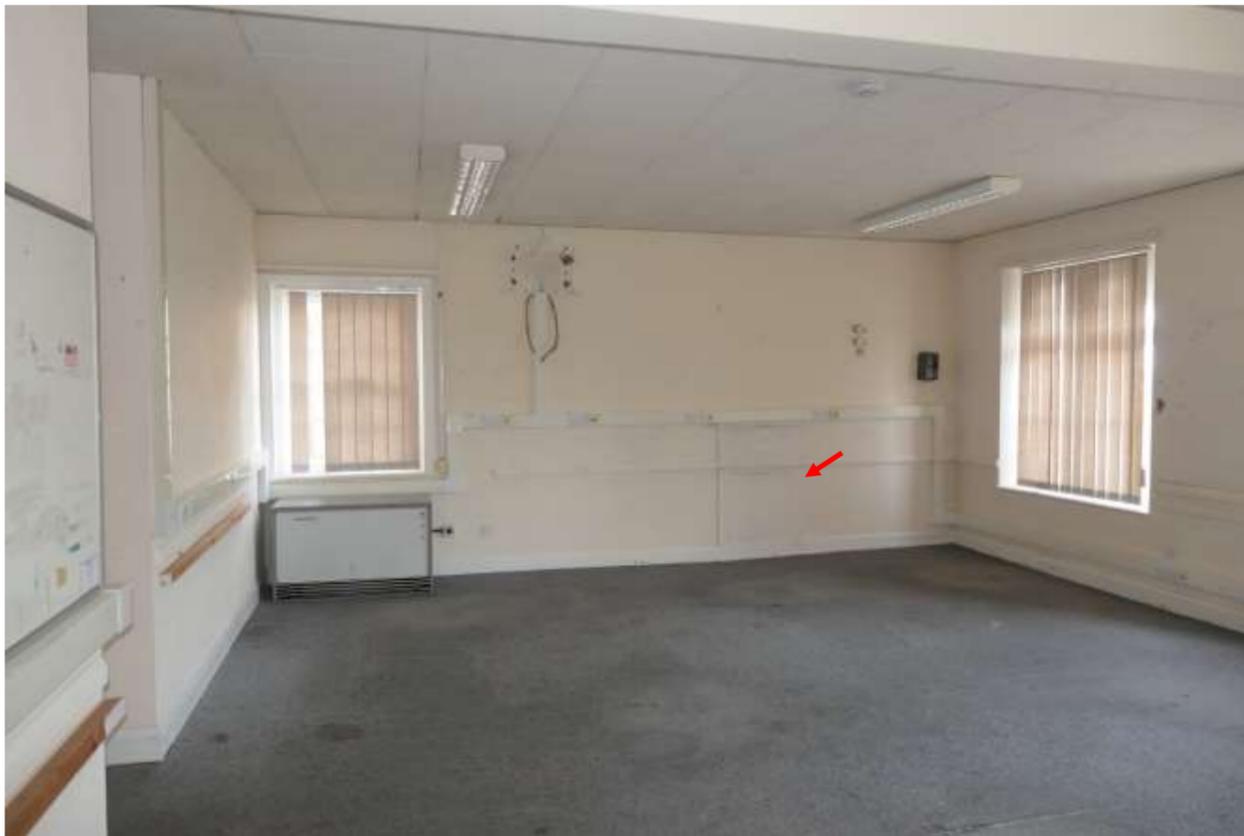
**Photo 34:** The interior of the room in the southern cross-wing. The red arrow highlights the location of a plain cast iron chimney piece.

47. Aside from one other Victorian chimneypiece, similar to the one at **Photo 32** and in a reconfigured room to the south of the hall, there is one plain cast iron chimneypiece to the southern of the cross-wings (**Photo 34**). These, together with the continuation of the original main staircase from the ground floor, are the only original features. For the most part, the first floor has a modern, institutional feel (e.g. **Photo 35**).

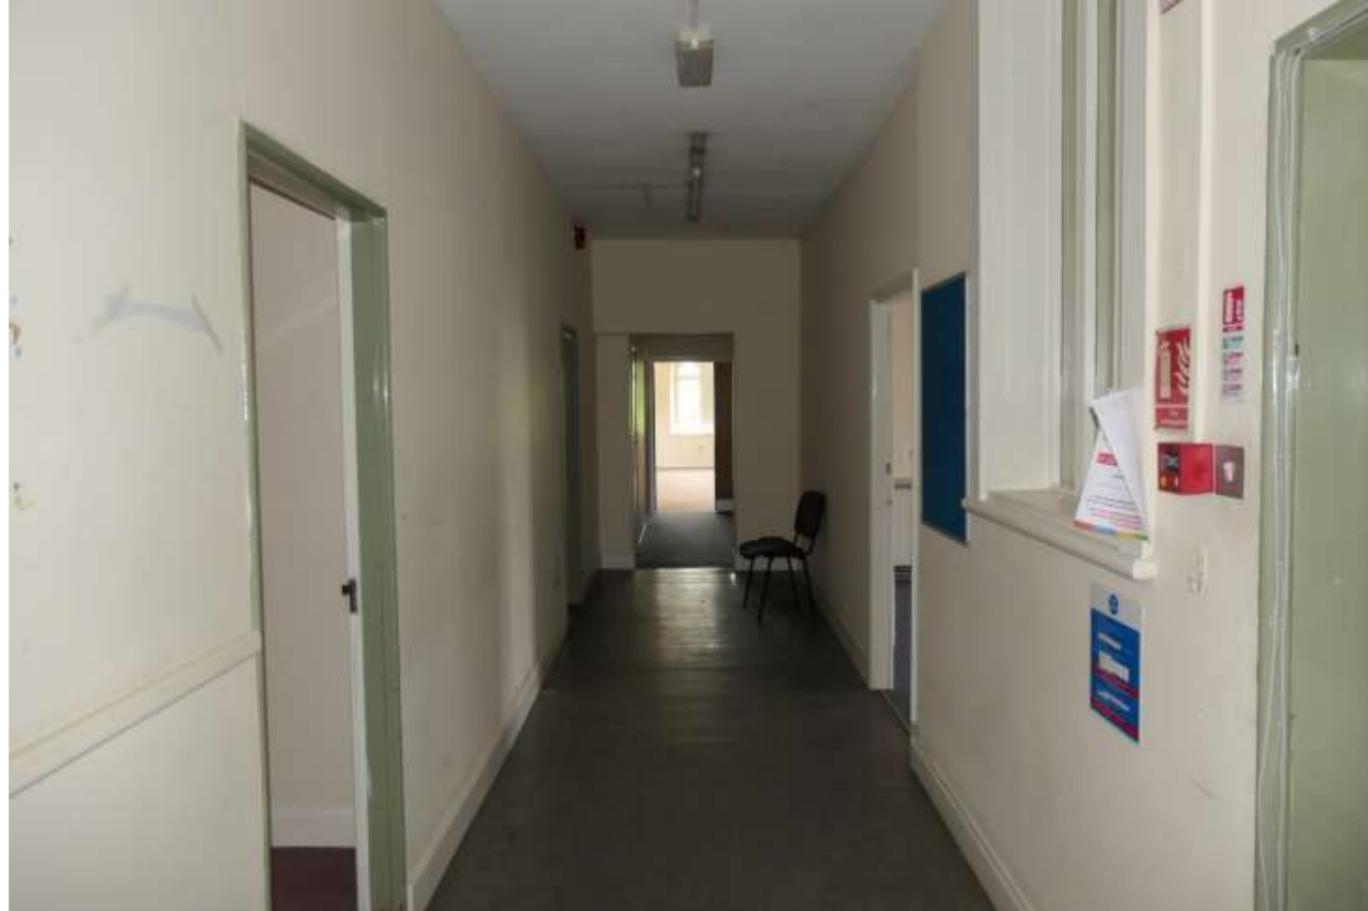
**Photo 36:** The view along the corridor to the north of the dormitory above the hall.

50. There is one plain cast iron chimneypiece to the north of the dormitory above the hall, and the cross-wings are largely given over to open plans (**Photos 38-40**). Exceptions are the areas at the two main staircases, which are more compartmentalised and where the modern institutional character of the building is strongly felt (e.g. **Photo 36**).

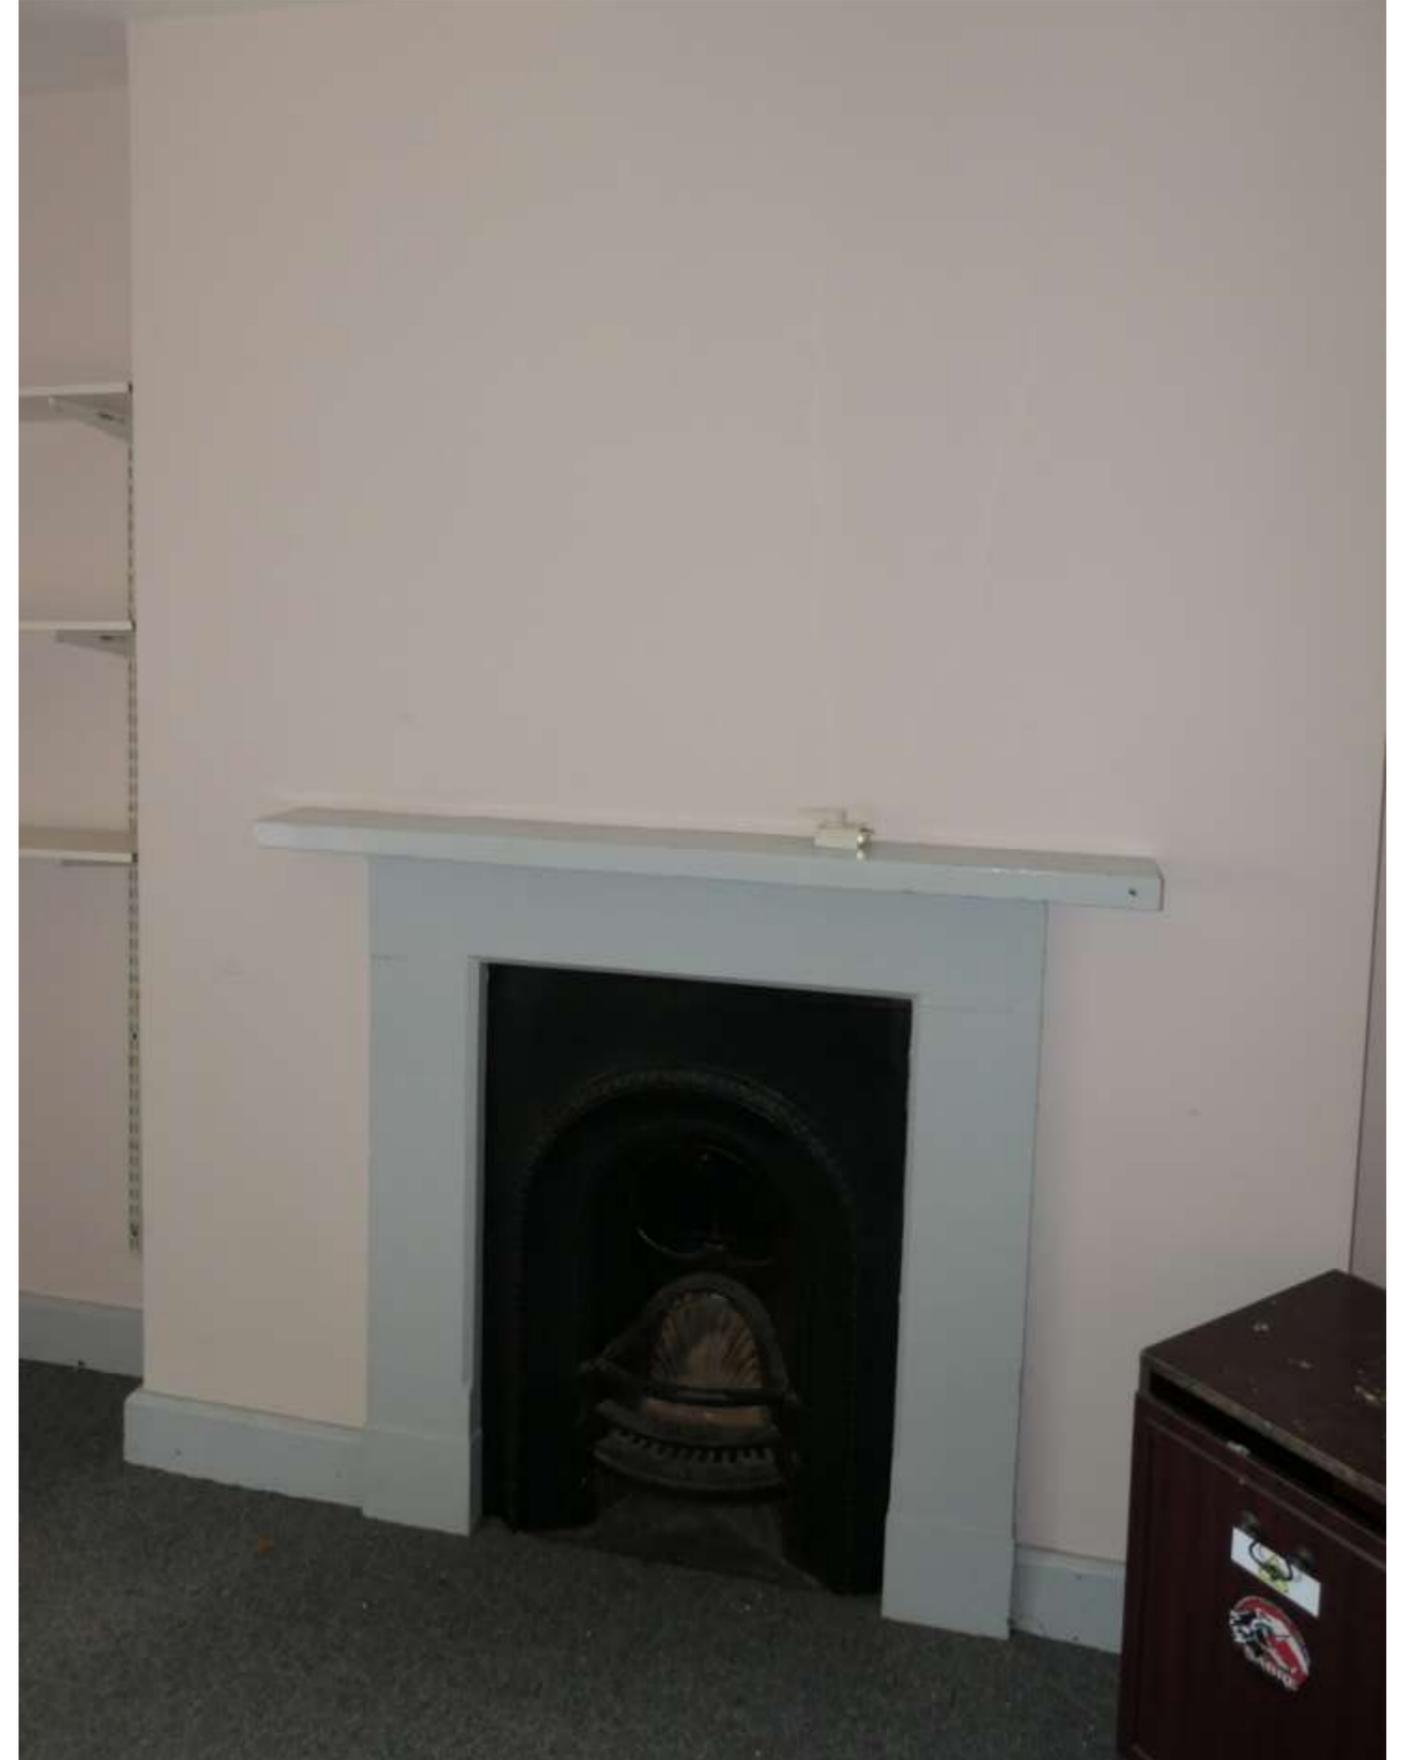
**Photo 37:** One of two similar chimneypieces in the headmaster's house.

49. The headmaster's house has clearly been reconfigured, with the present room configurations at odds with the fireplaces, of which there are two original Victorian ones (e.g. **Photo 37**). The staircase, as described earlier, and unremarkable as it is, is the only other original feature.
