## **Sittingbourne Adult Education Centre, Sittingbourne**

**On behalf of:** Frankham Consultancy Group

**Date:** October 2020

**Cogent Heritage Ref:** 0151

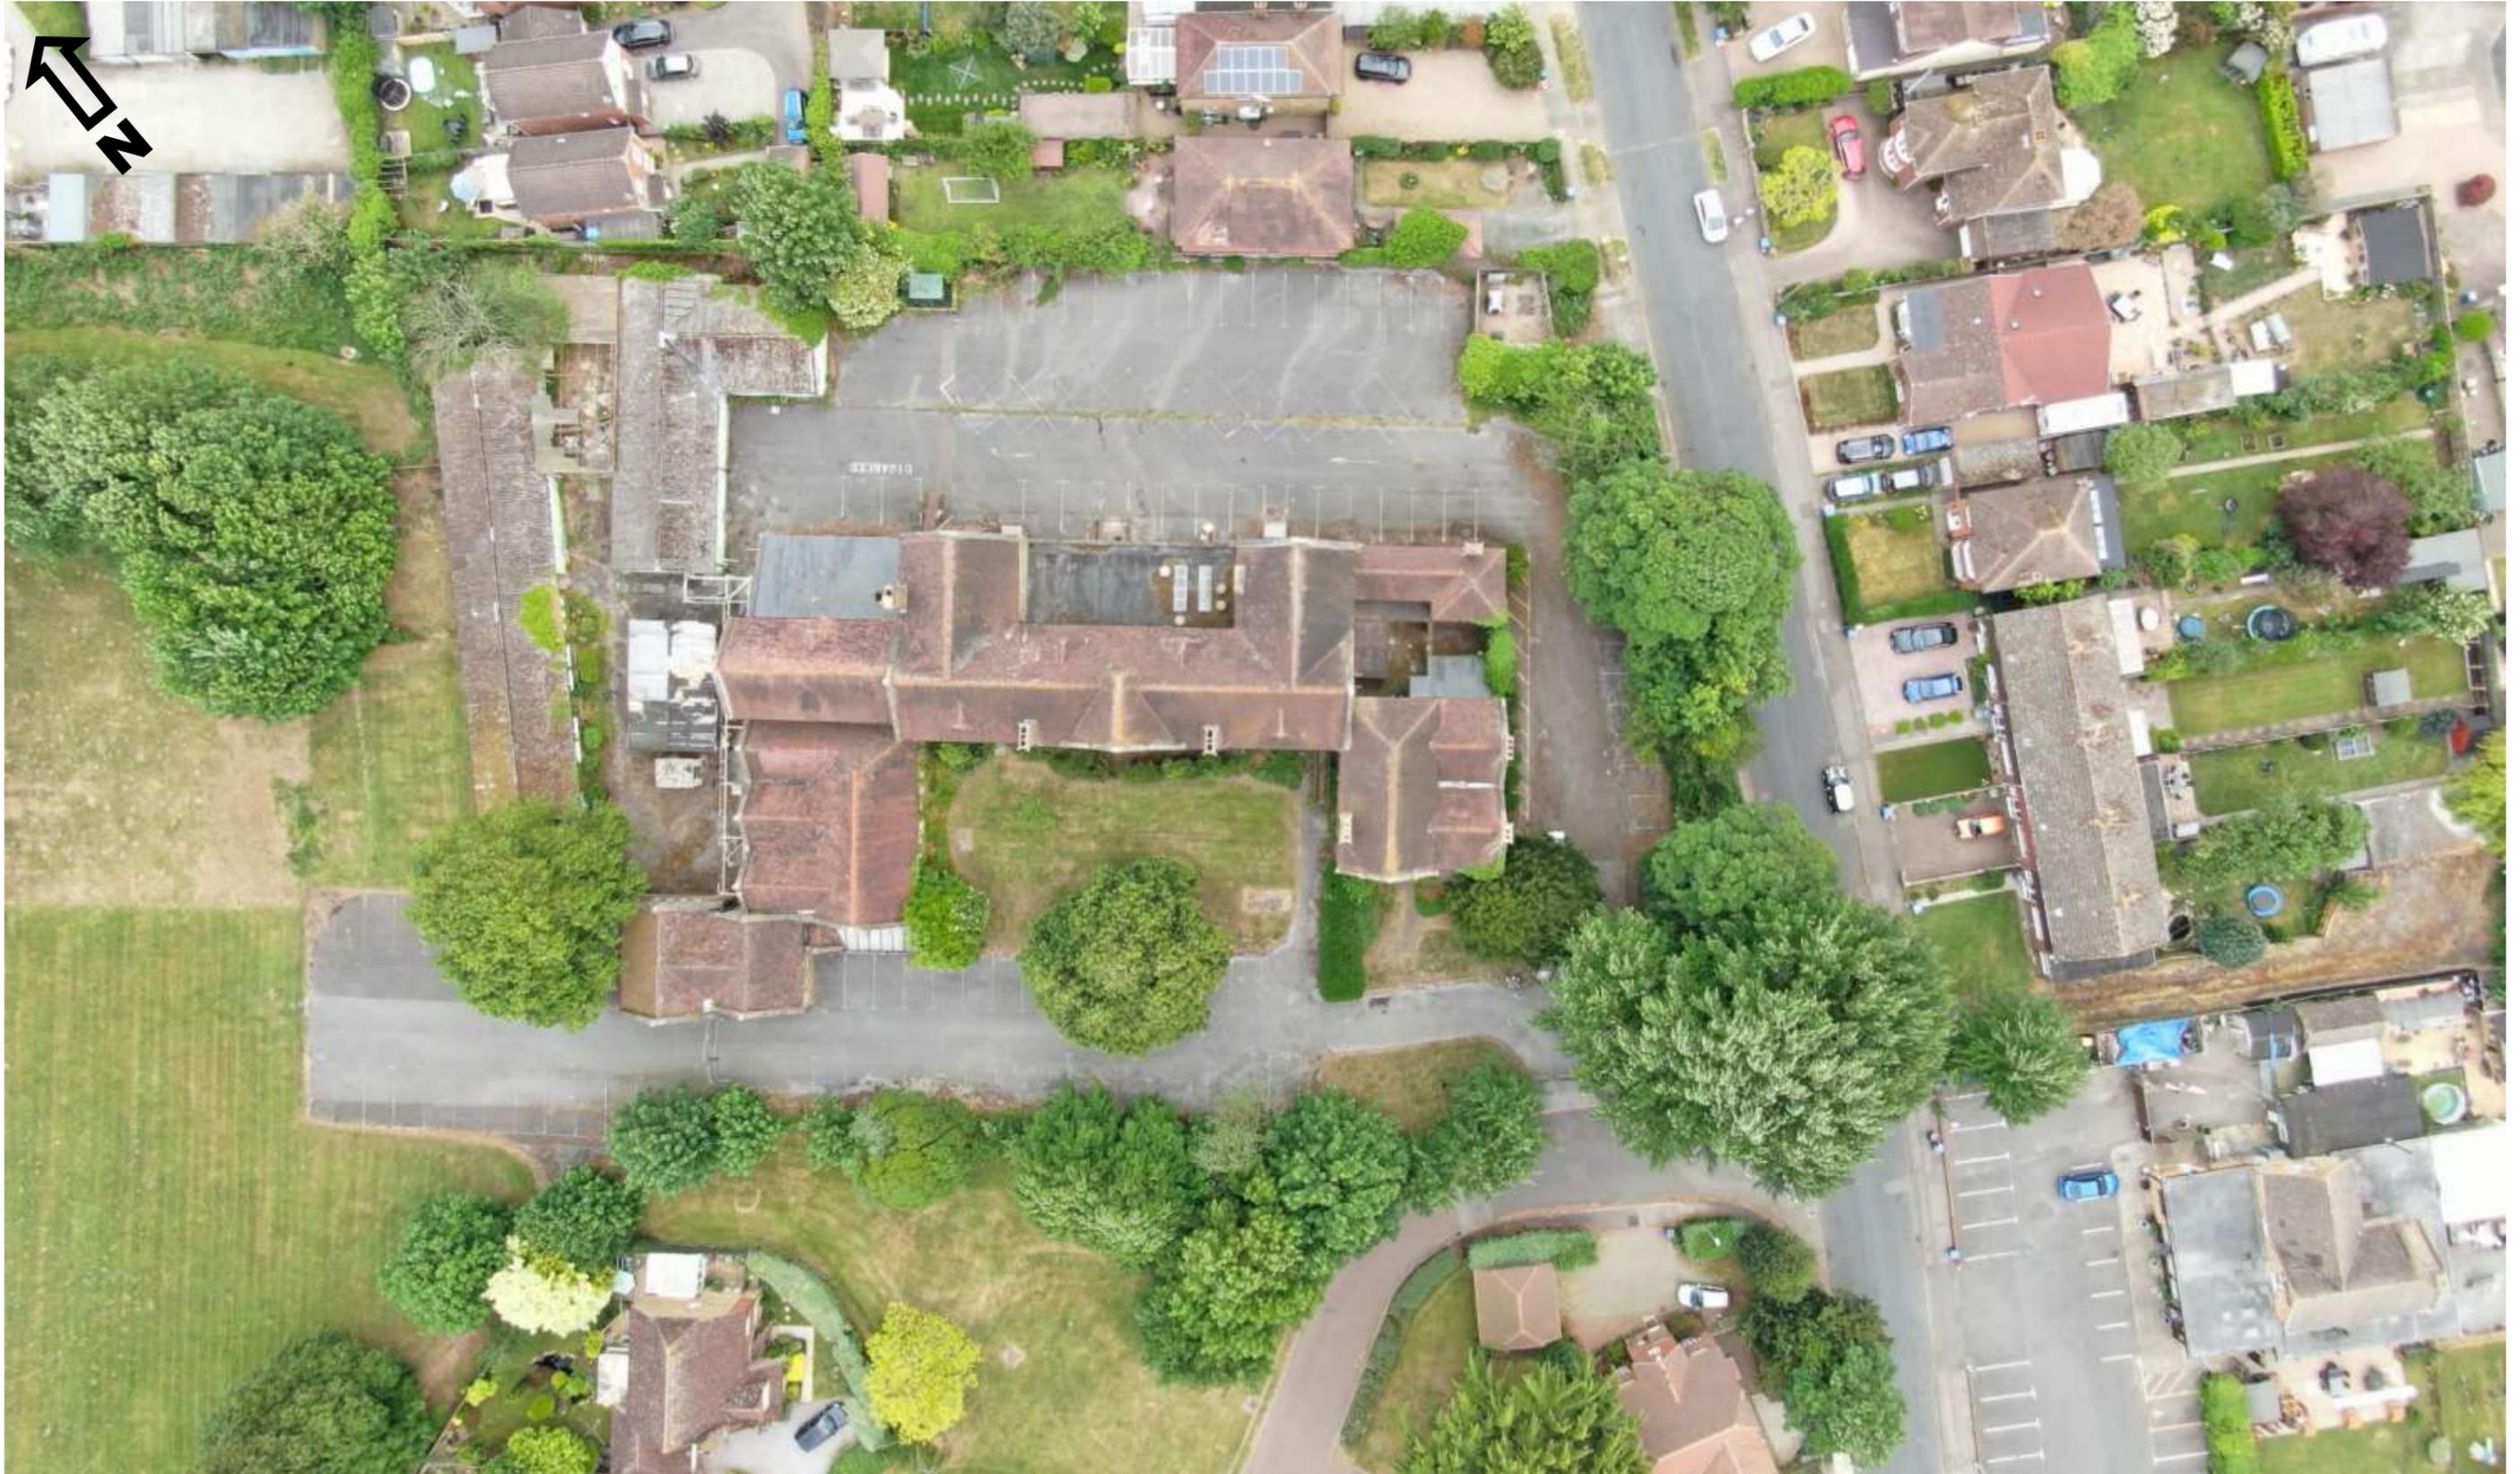
54. Aside from the modern housing to three sides of the school's grounds—which was originally rural and much larger—the listed building is now effectively surrounded by an apron of tarmac, with the exception of the front courtyard.

**Photo 41:** A drone photo of the immediate setting of the school (approximate north indicated by the black arrow).

88. The proposals will see the replacement of much of the tarmac car parking with landscaping, and the transformation of the group of modern buildings to two good quality, traditionally designed new low-rise buildings, pulled back as far as possible from the listed building and with landscaping between them. This would make for a much more visually integrated and better quality space, defined by high quality new buildings. The area around the building will be carefully landscaped, with planting and quality hard landscaping. The result will be a positive transformation of the setting of the building. This would be considerable enhancement and a notable heritage benefit.

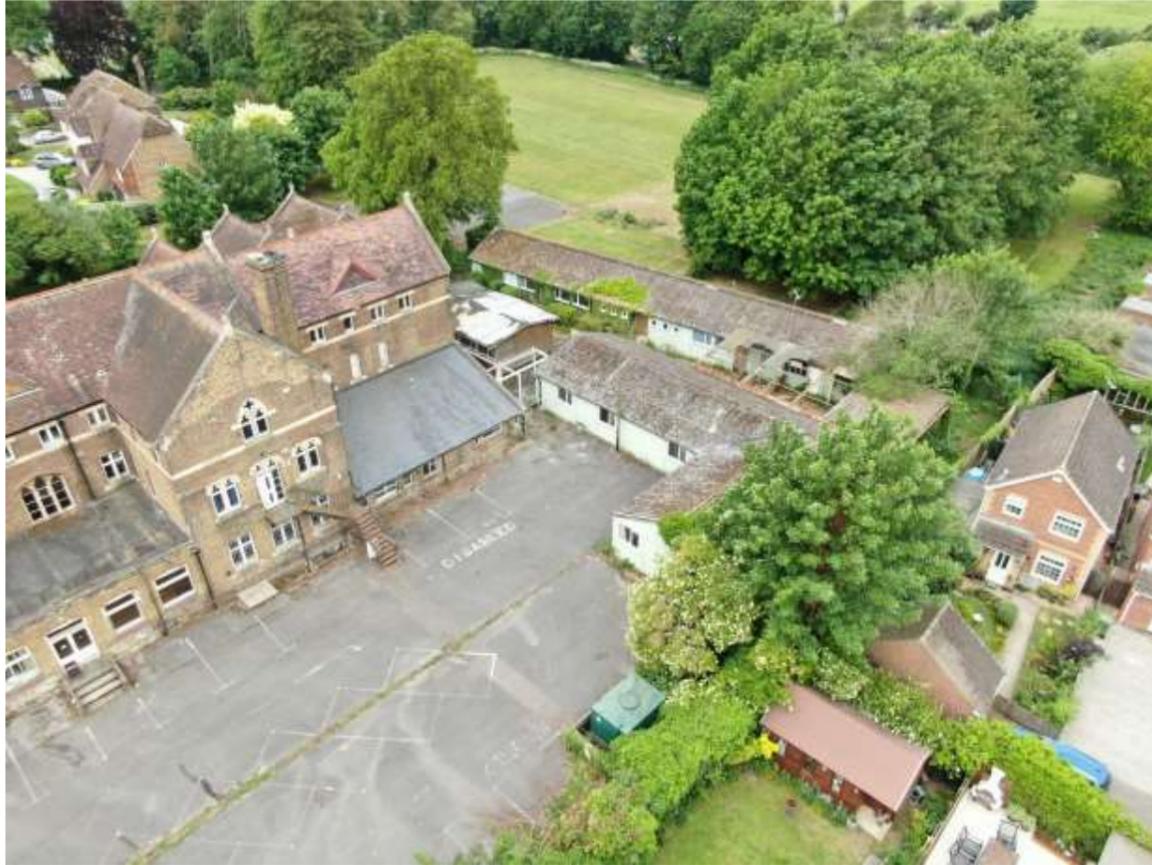
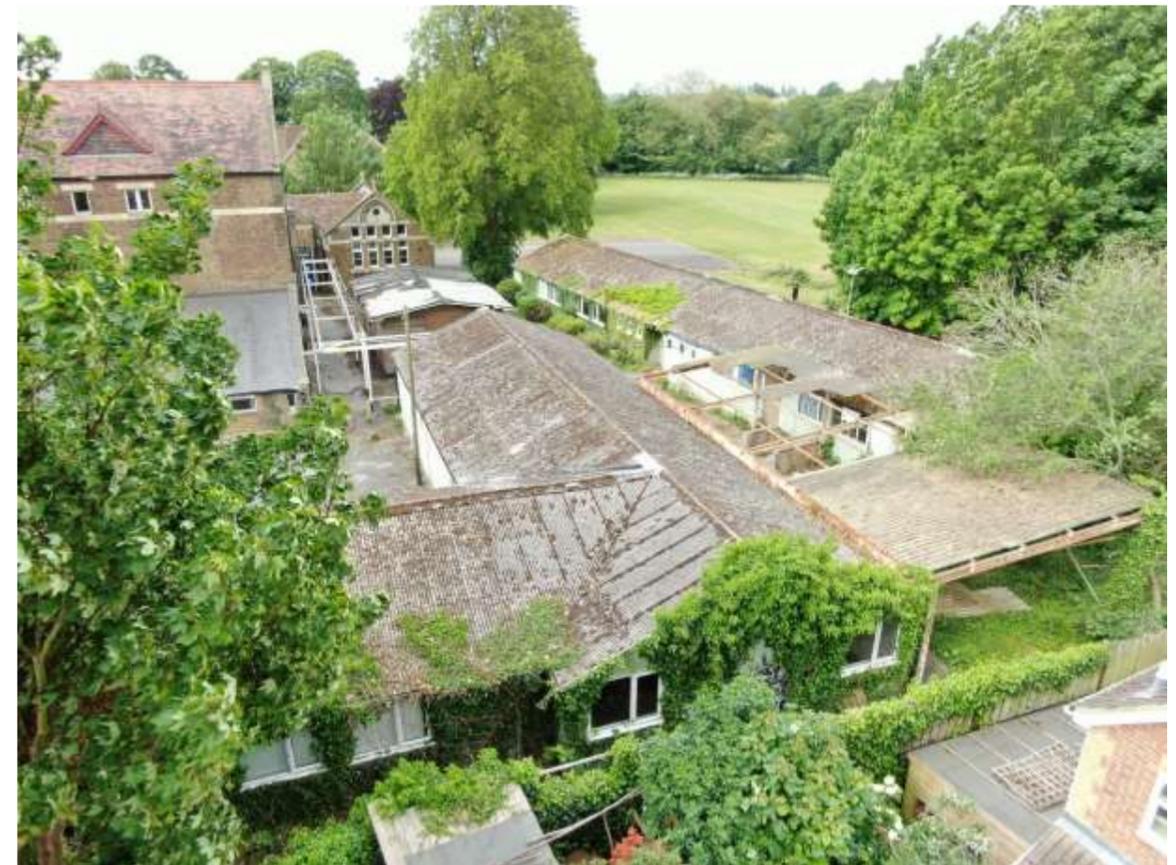
**Photo 42:** A drone photo of the immediate setting of the northern end of the school, from the east.

56. These buildings were constructed very close to the listed building (e.g. **Photos 42 & 44**), no doubt to enable ease of movement between them and the main school, but that has encroached on the setting of the listed building in a most unfortunate way. It is now difficult to get any real sense of space or separation between the listed building and these poor quality structures, which hem in the listed building to the NW. Whilst this is far from ideal, the low quality and dilapidated state of the structures also severely detract from the quality of the listed building's setting and the sense of stature of this imposing building. Although it is fortunate that the structures are contained in a localised area away from the main frontage of the listed building, and they are to some extent shielded by the NW extension, it is plain that they markedly detract from the contribution of the building's setting to its significance.

**Photo 44:** A drone photo of the modern buildings to the NW of the school, looking SW.

60. Whilst the replacement buildings will inevitably obscure some of the views of the listed building, this would not be very different from the existing situation, and the arrangement would still allow more space, and greatly improve the quality and character of this area, resulting in a much improved setting.

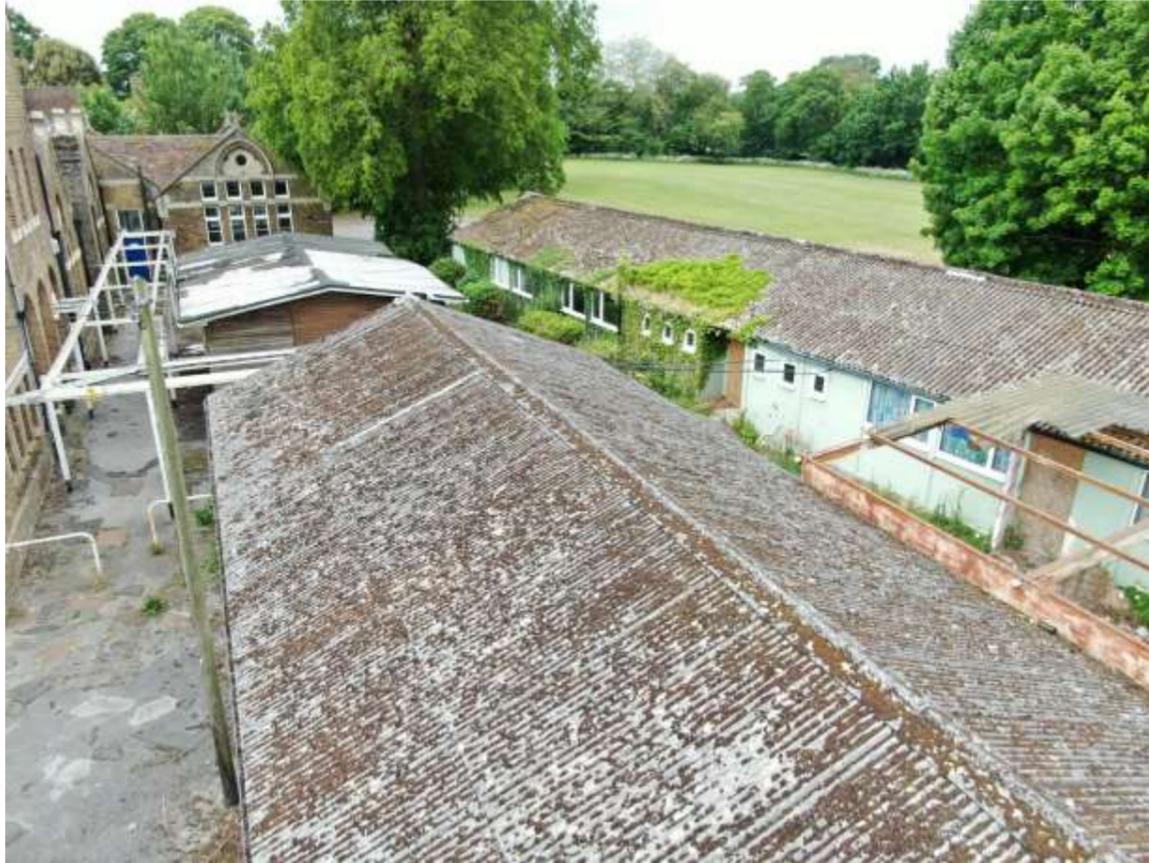
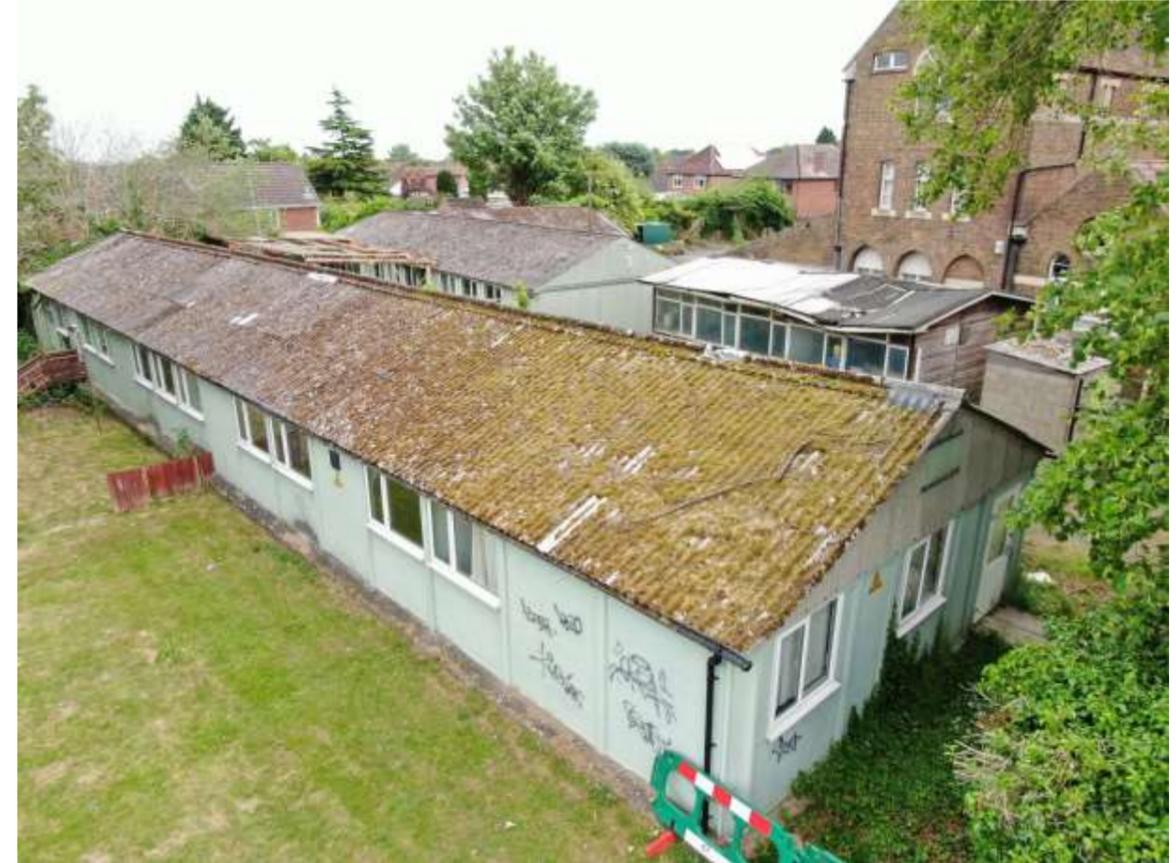
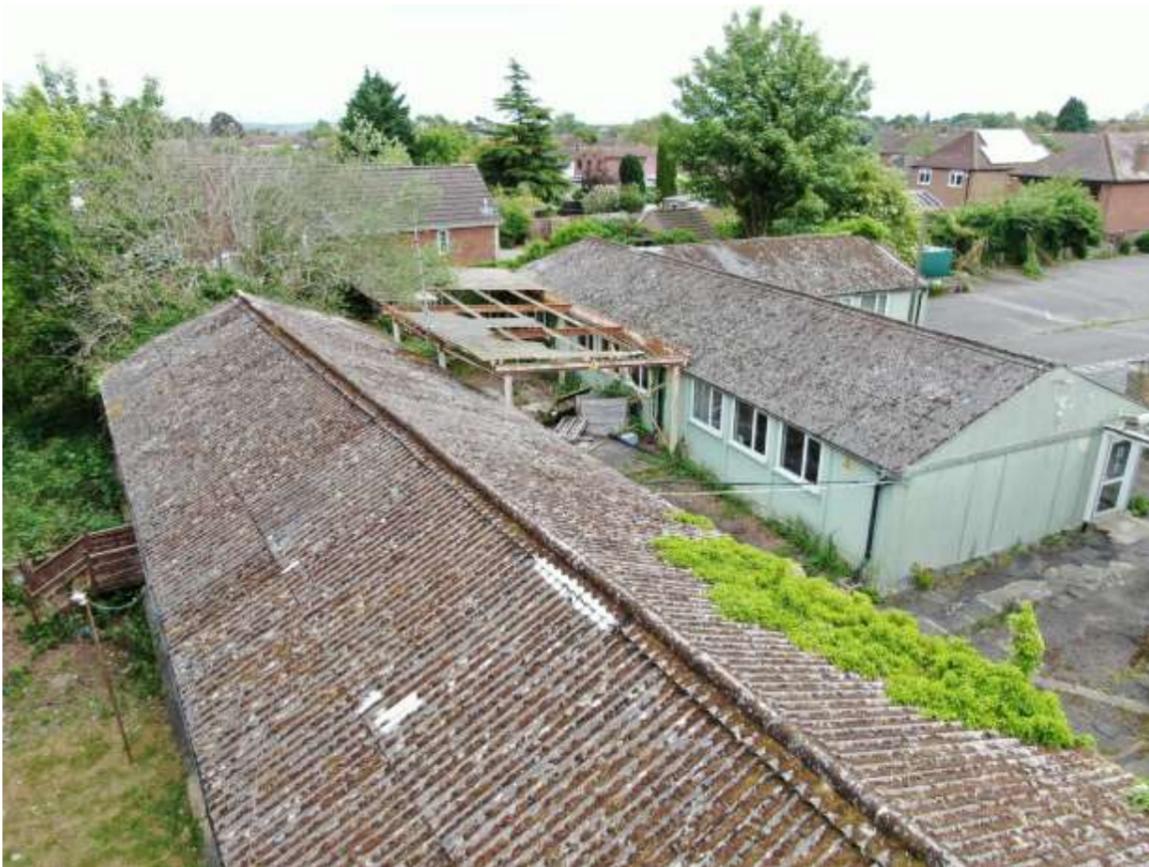
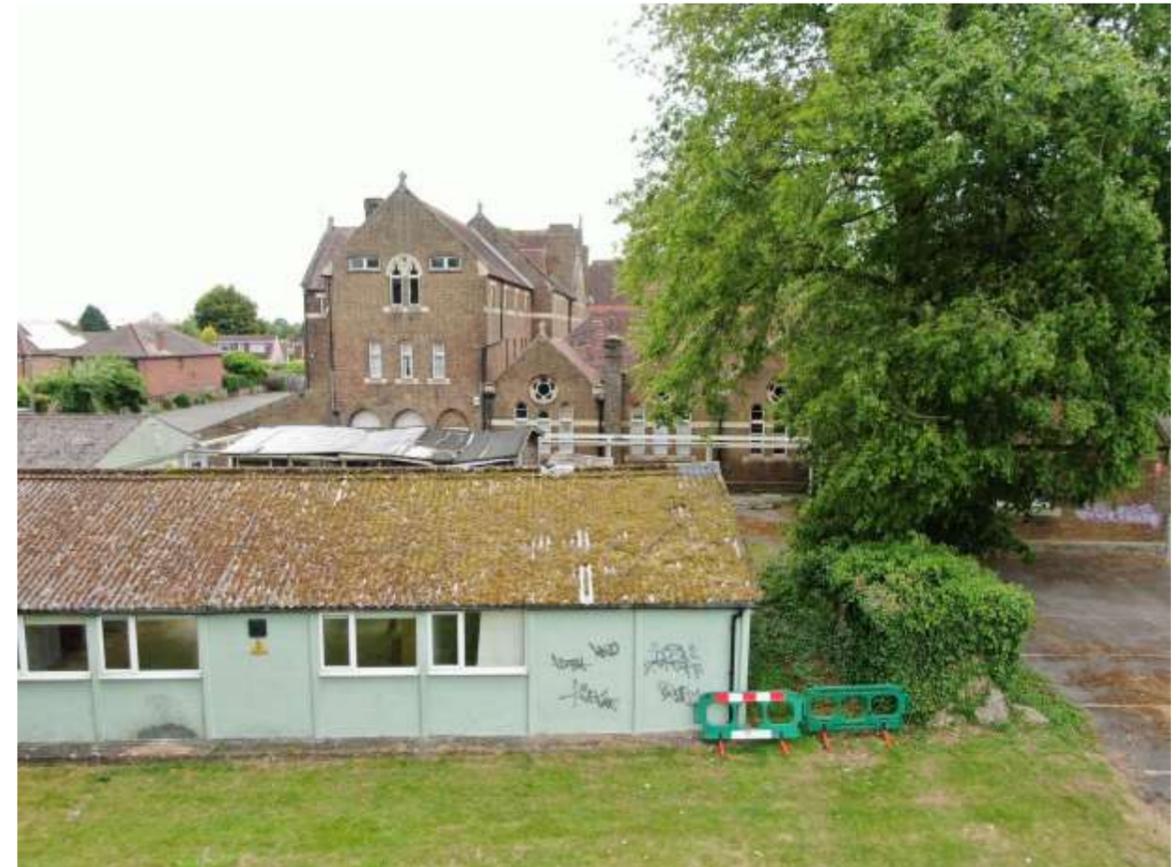
**Photo 45:** A drone photo of the modern buildings to the NW of the school, looking SW.

**Photo 47:** A drone photo of the modern buildings to the NW of the school, looking NE.

**Photo 46:** A drone photo of the modern buildings to the NW of the school, looking NE.

**Photo 48:** A drone photo of the school, juxtaposed with the modern buildings in the foreground.
