TABLED PAPERS Keycol Farm
Planning Working Group

Application - SW/15/500330/FULL/EM
Location - Keycol Farm, Keycol Hill, Bobbing, Kent ME9 8NA
Proposal - Change of use of land for the stationing of four mobile homes with associated parking.

Location: A2 Keycol Hill, Bobbing

3 years personal injury crash data up to 30/04/2015

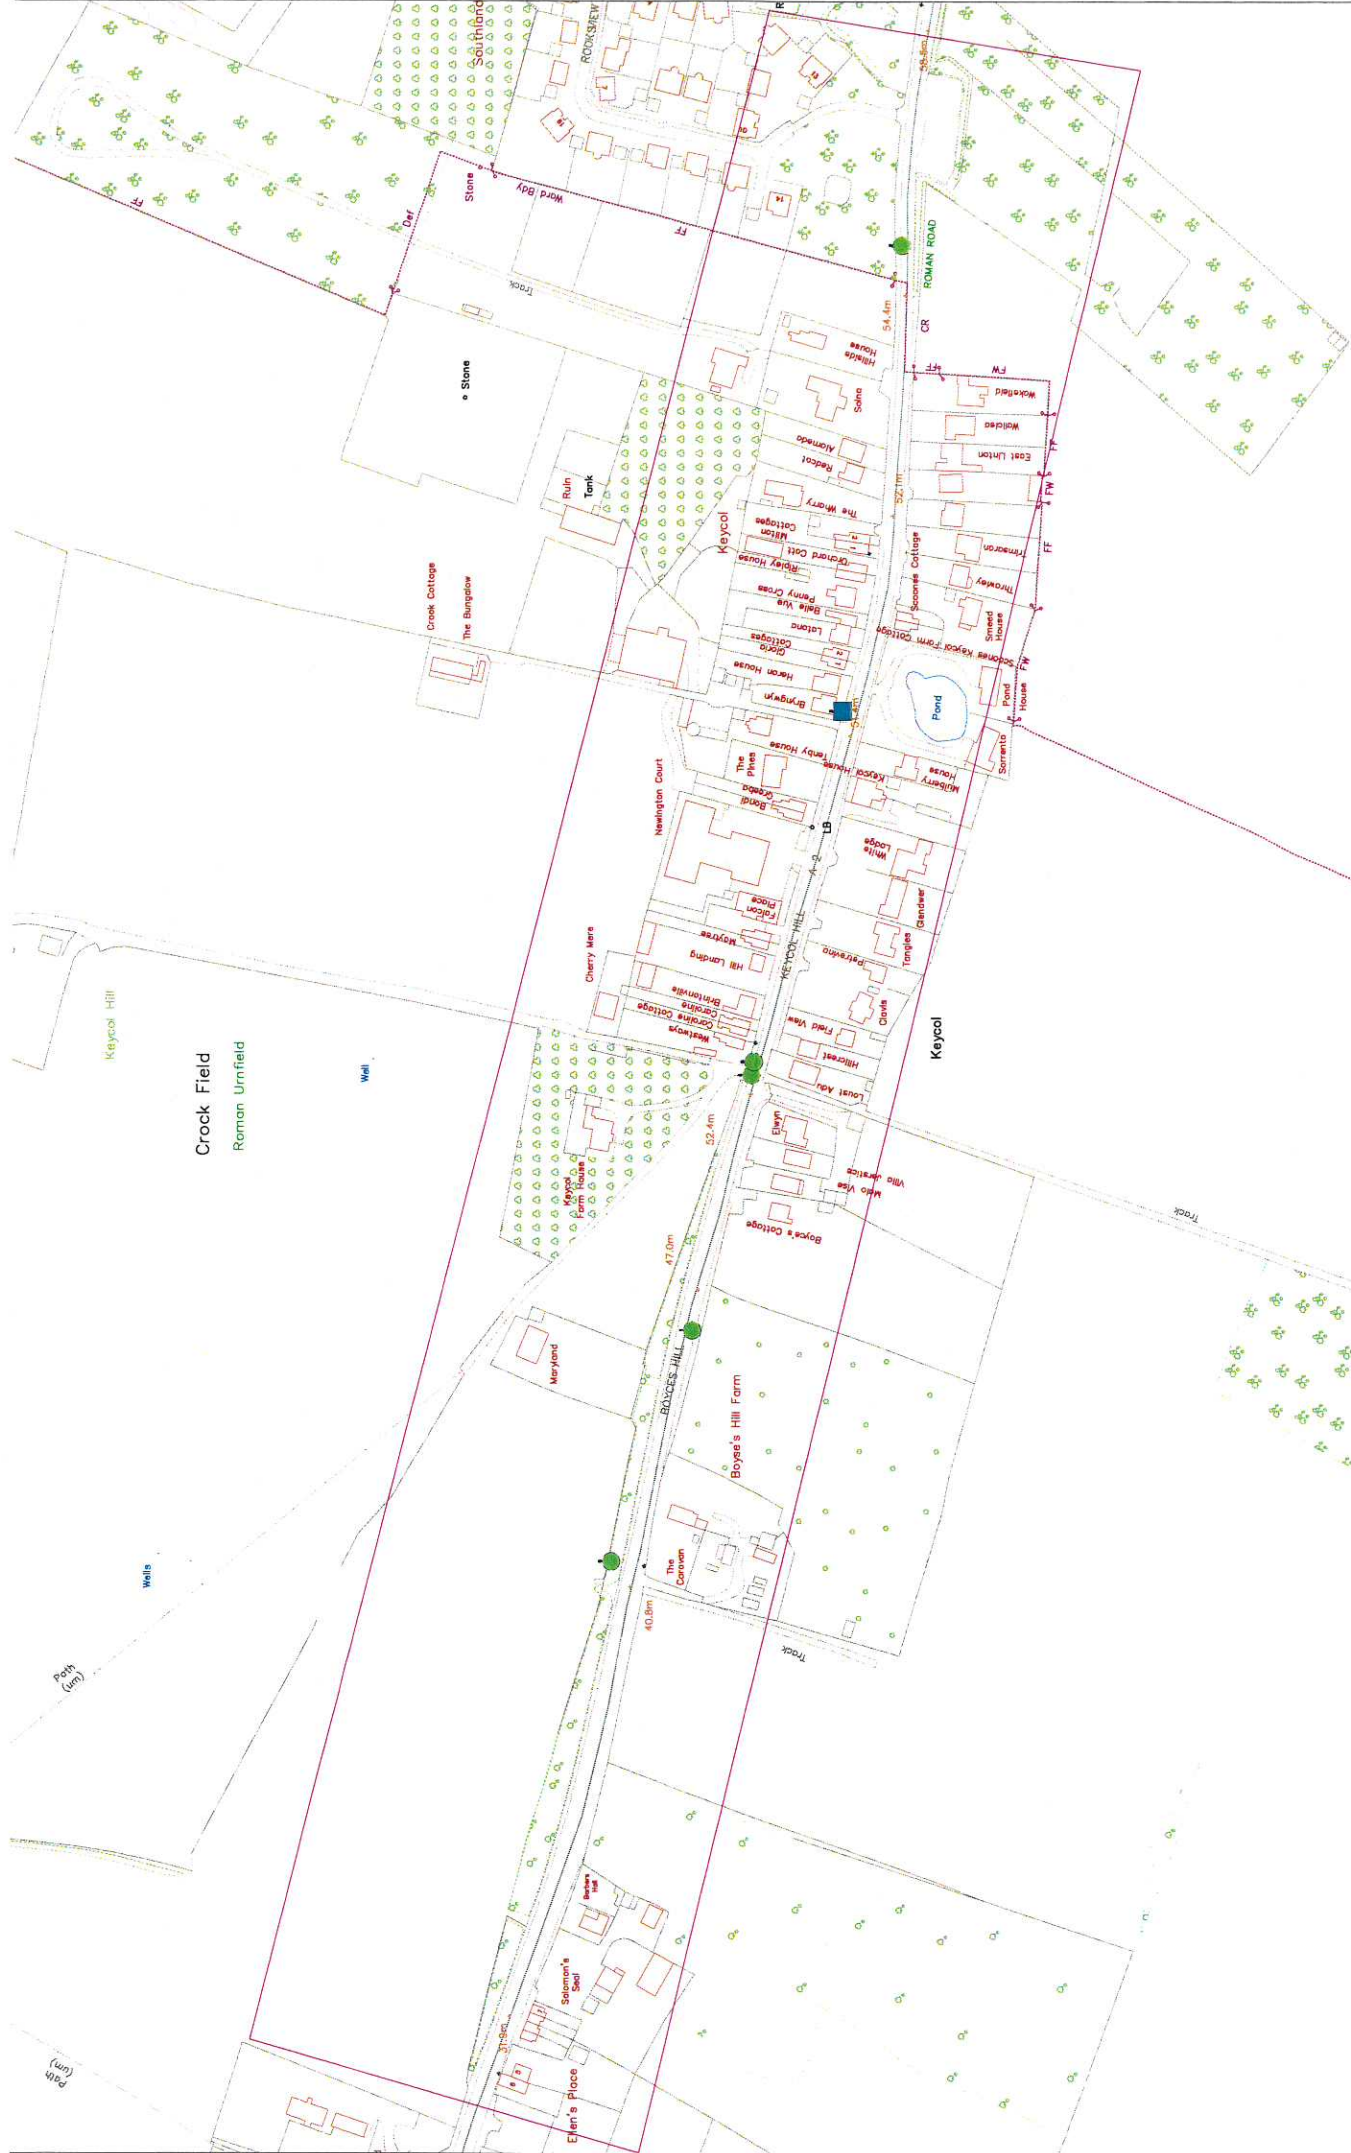
Crash Severity

●	Slight
■	Serious
▲	Fatal

I have obtained the most recent crash data for this stretch of the A2, as I understand from you that Members requested the information at their site meeting earlier this week, and I have attached this for your records. The statistics are up to date as far as the 30th April 2015. Anything after that date will not have been validated yet to confirm the accuracy of the stated location or any of the specific details of the incident, so newer incidents are not made available. The records show that in the past year, only 1 accident occurred nearby, and this involved a driver of an HGV losing control of his vehicle on Boyces Hill after being hit in the face by a bird that had flown through their open window.

There have been no accidents involving vehicles using accesses in the local vicinity over the past year, but a review of accidents over a longer period shows 2 accidents involving vehicles leaving accesses on this stretch of the A2 between Keycol Hill and Boyces Hill in 2013. The first occurred at the main access to Keycol Farm House at the top of Boyces Hill, some 160m west of the current application site access. However, this was attributed a vehicle pulling out into the path of a motorcycle that had not been seen, as it was camouflaged against the colour of another vehicle travelling further behind it. The second accident happened at almost the same spot, but this time was due to a vehicle pulling out into the path of a vehicle travelling at excessive speed that had overtaken two other vehicles moments earlier. Both these accidents were therefore due to driver error.
